The Corporation of the City of Sault Ste. Marie  
Municipal Heritage Committee  
Agenda

Wednesday, November 5, 2025

### **2025 Inspector's Notes**

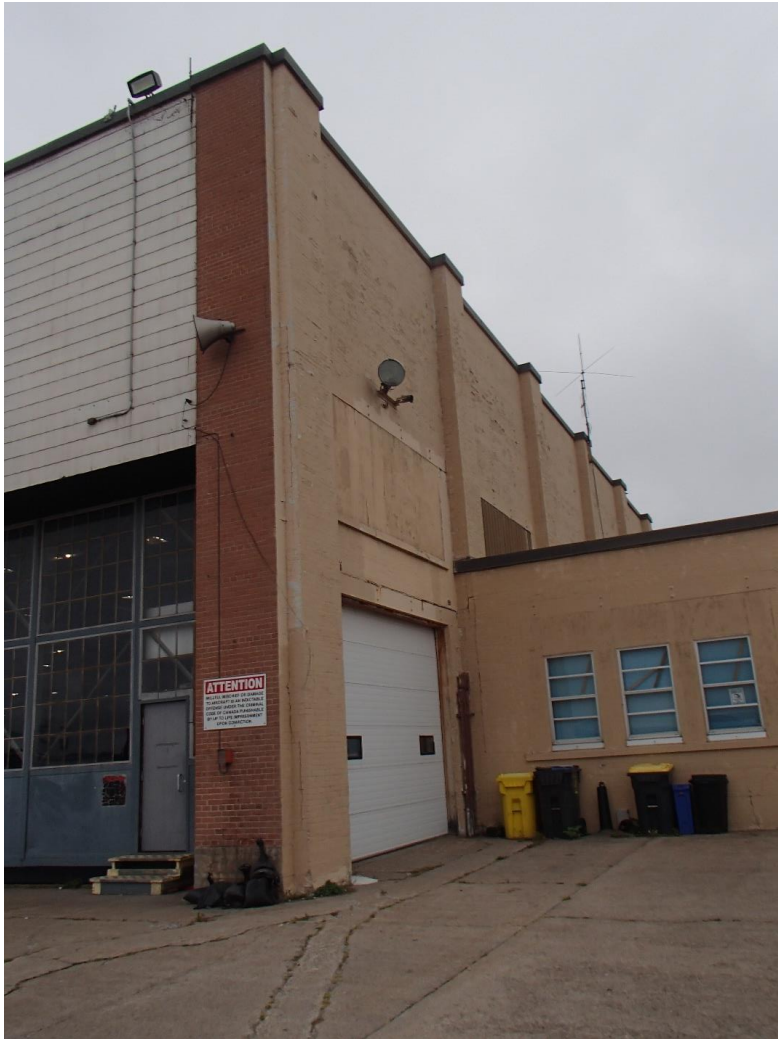
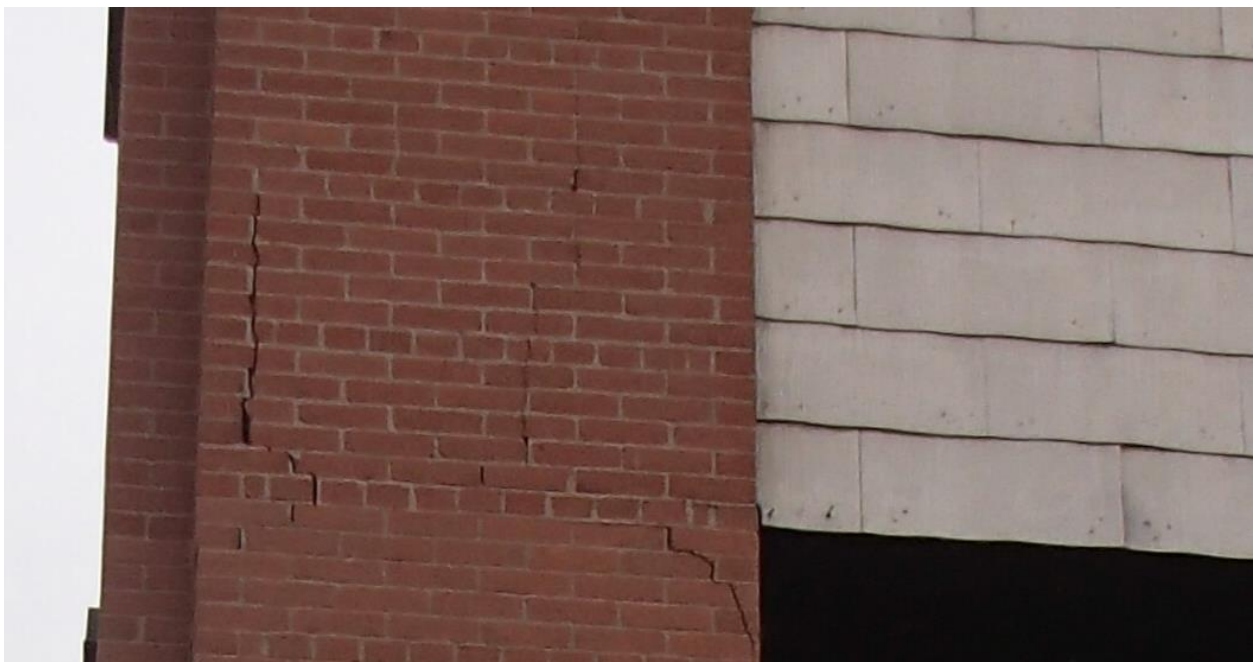
South wall

Crack in bricks - closeup

Same picture

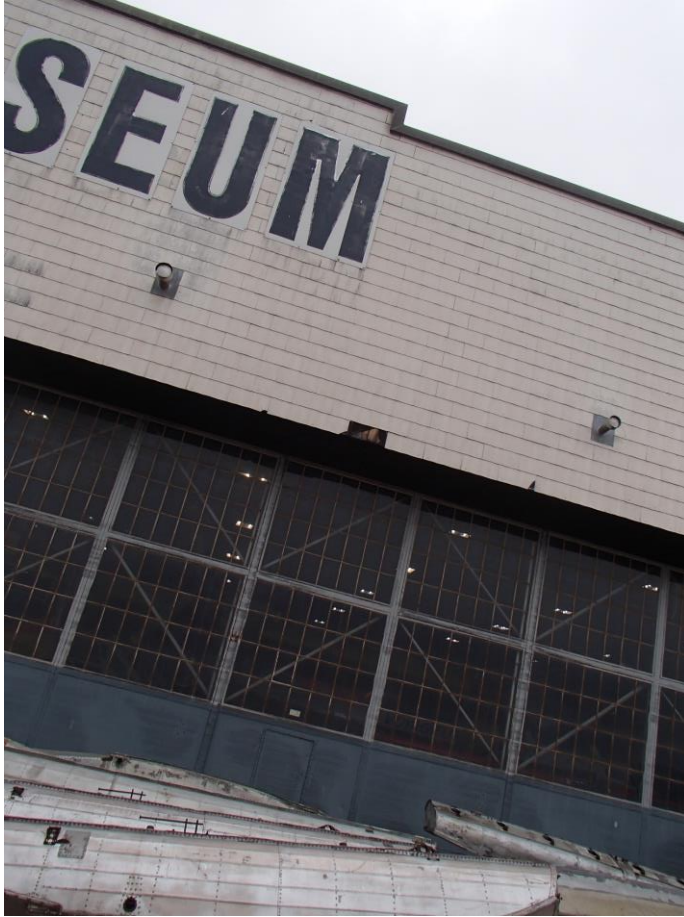
East Wall - Vent duct behind dumper is bent

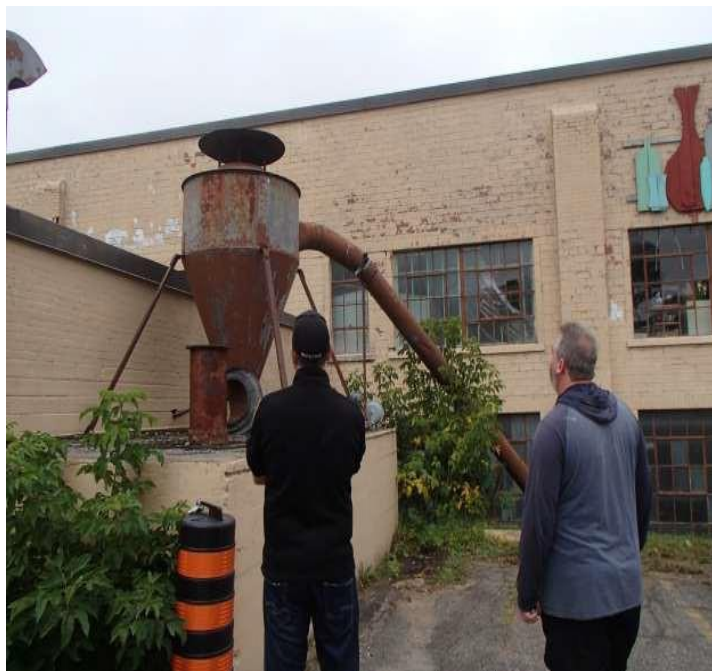
East side - Discussion about painting the metal

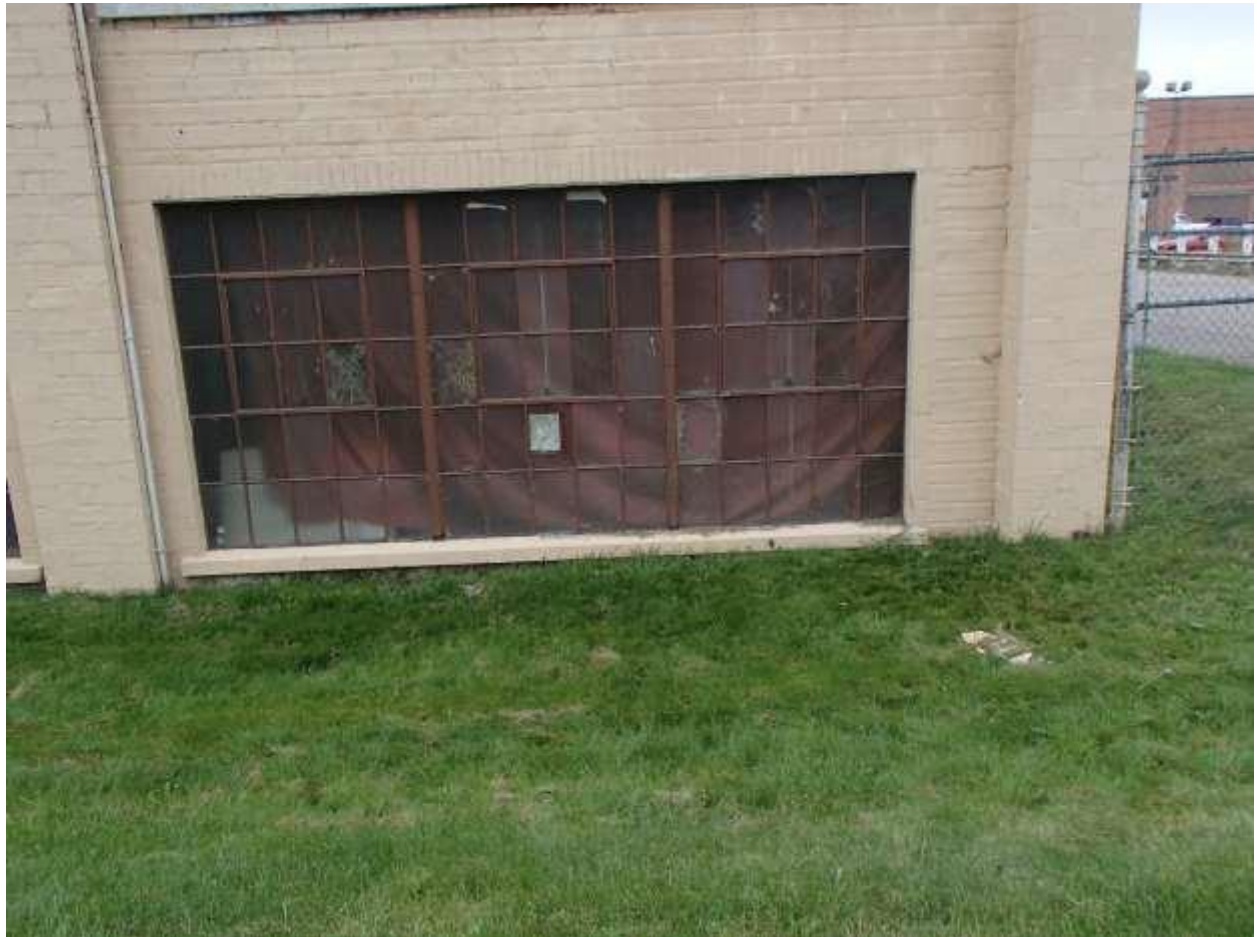
North wall - They have replaced 160 windows. Tenant needs to remove material stored here to work on these windows

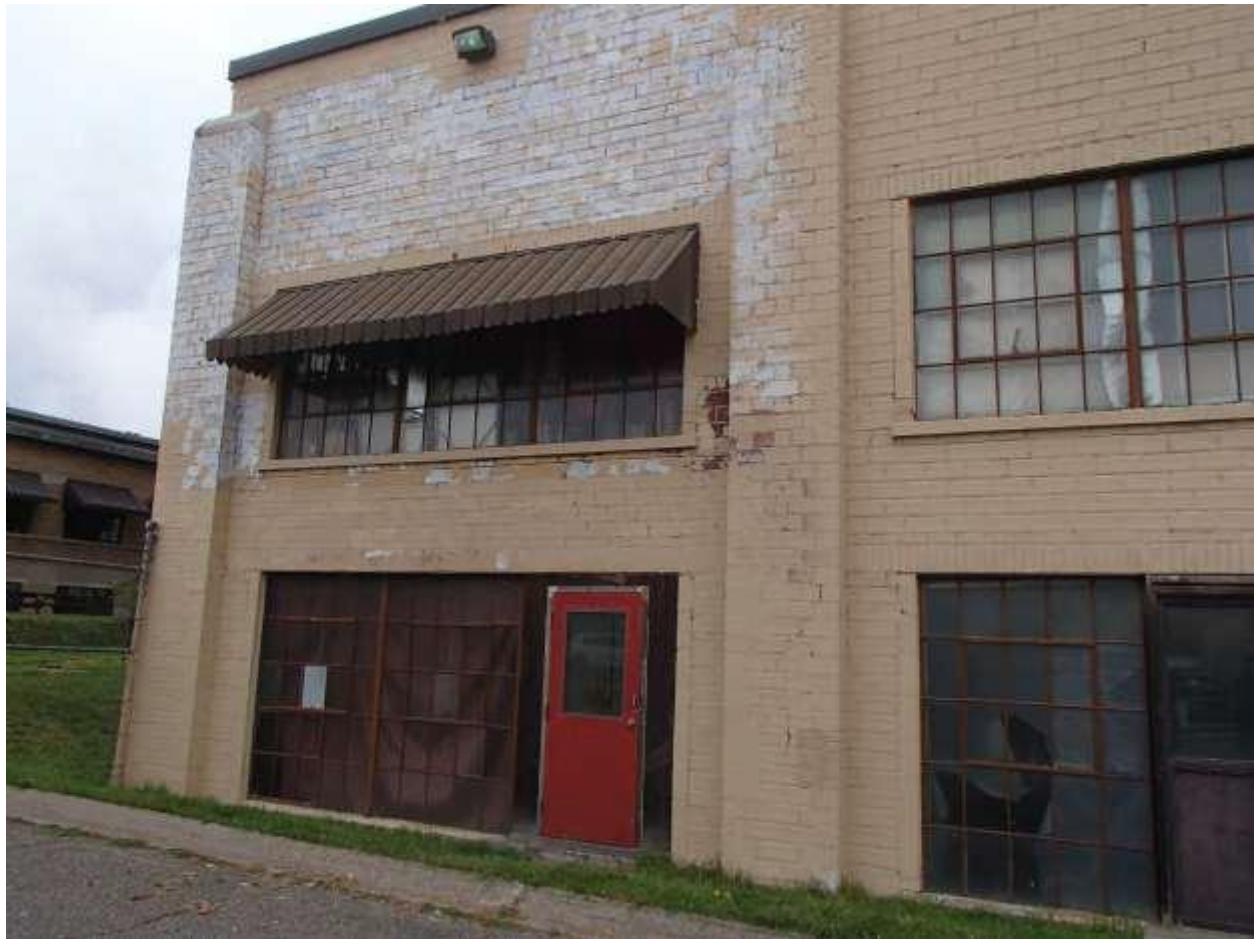
West wall - has been power washed and they plan to paint

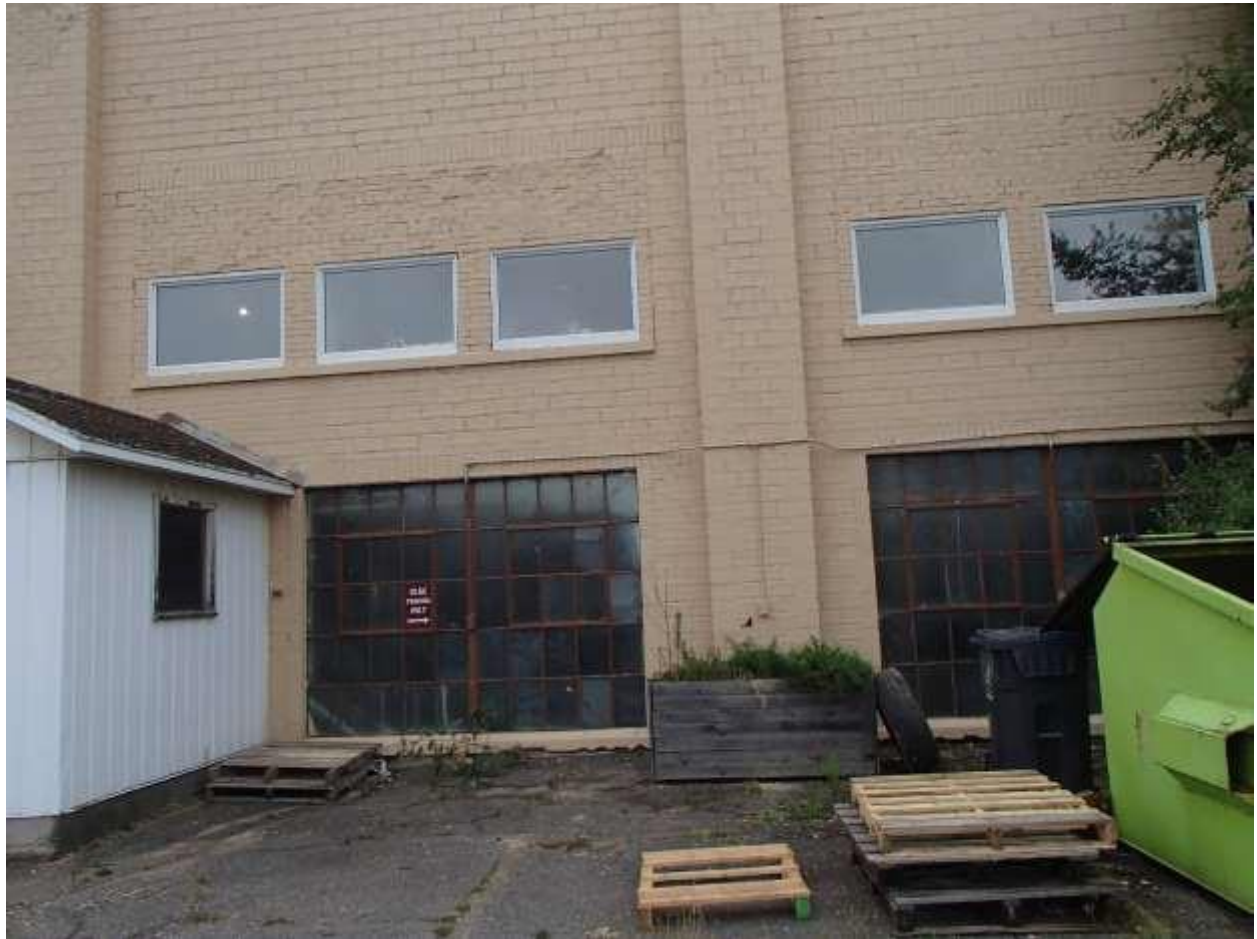
West wall – new windows – also power washed area ready for painting

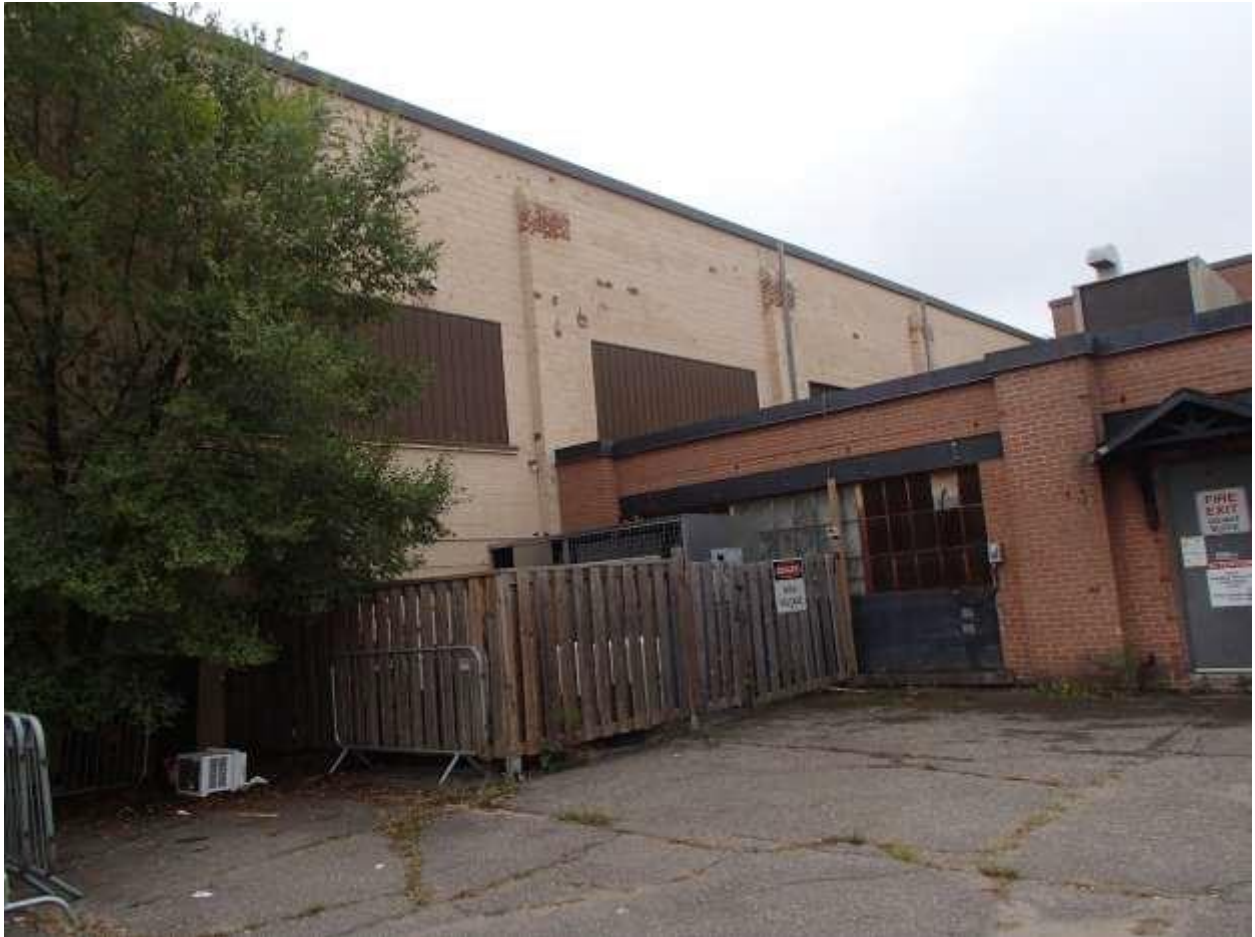
More exterior walls that need

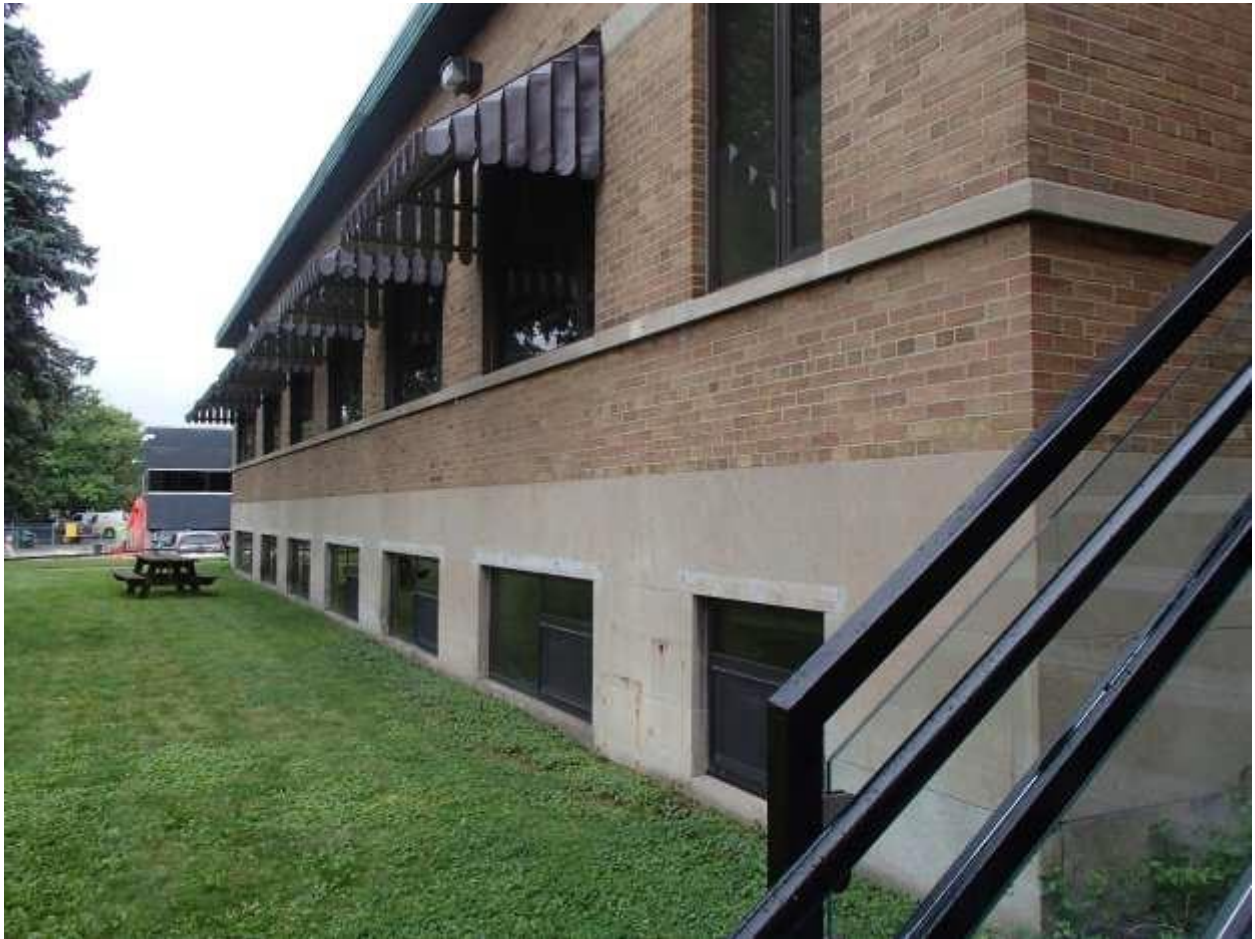
More awnings to be painted – south wall

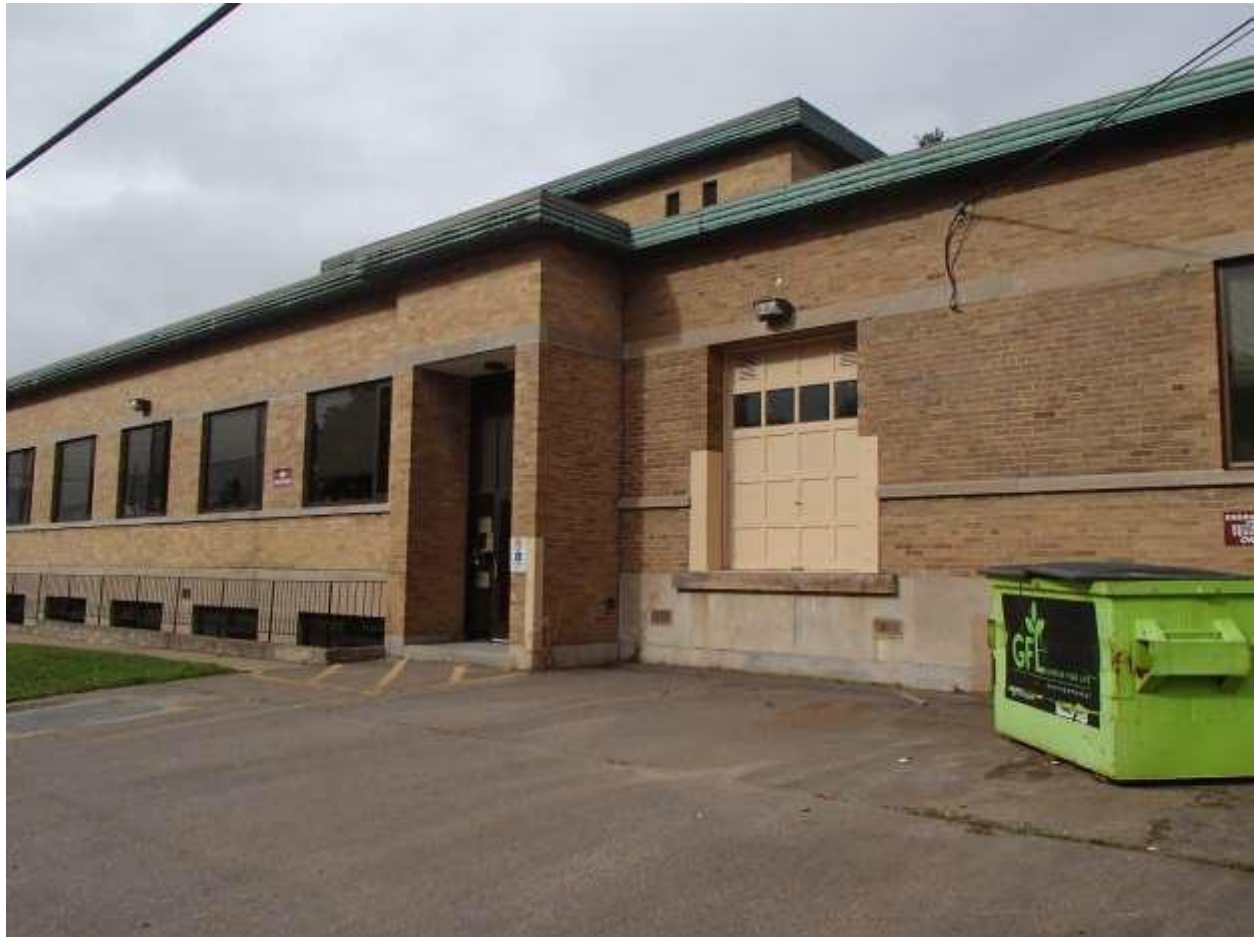
East wall - In this picture you can see the roofline on the left that has been repaired, and the one on the north end yet to be done

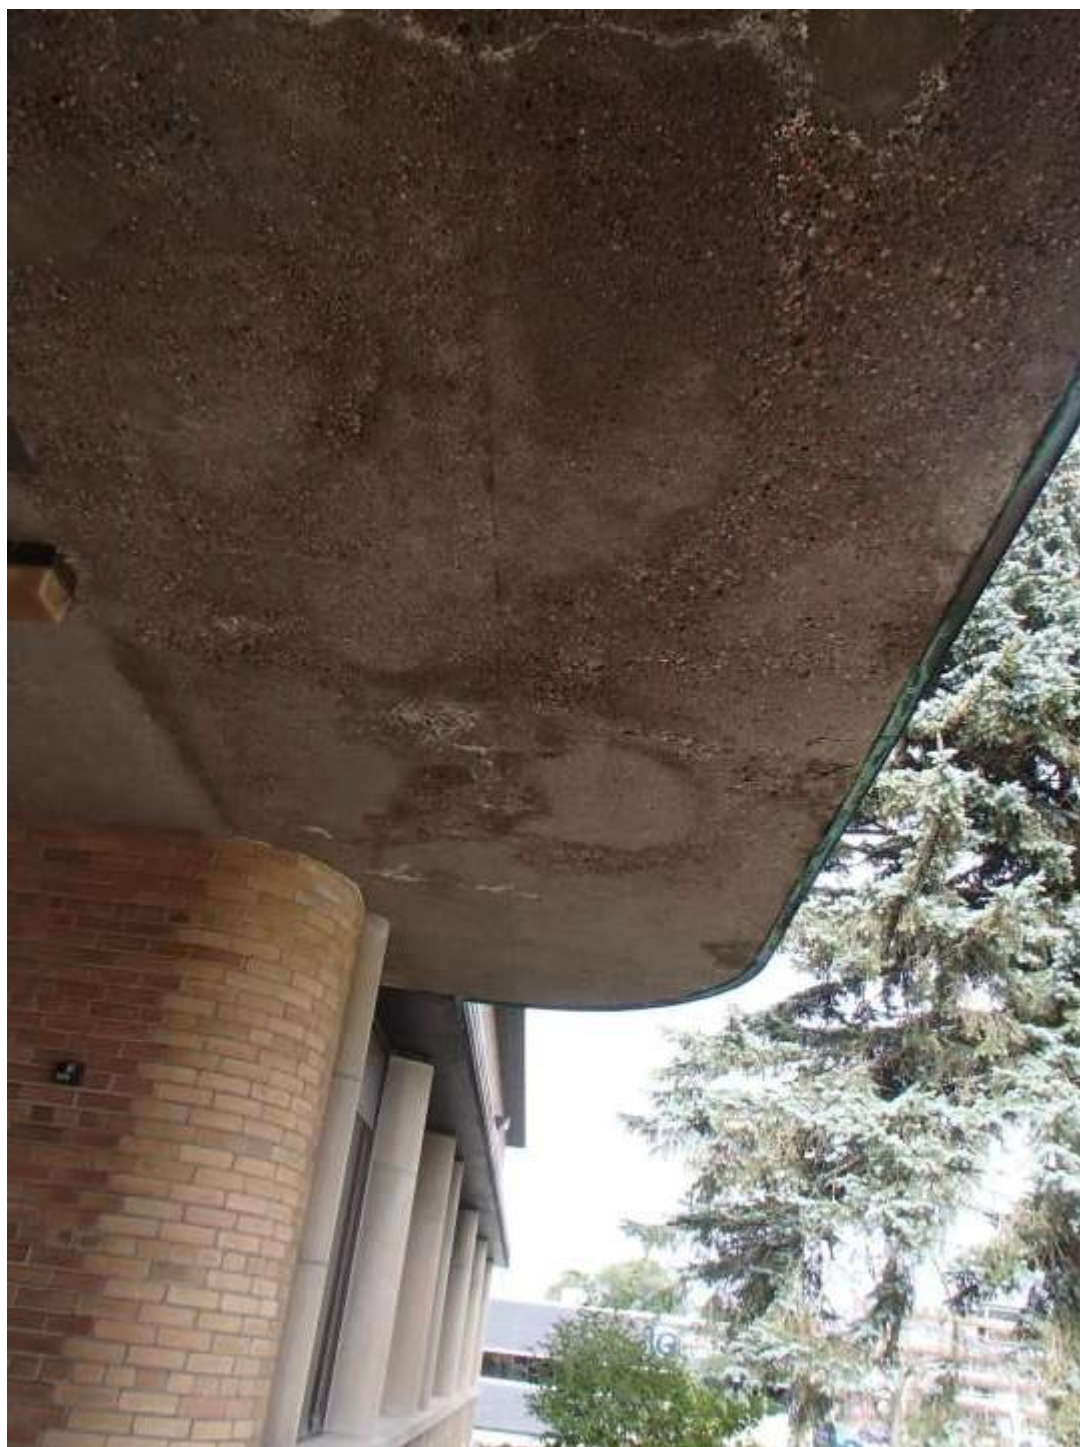
- Leaching at front entrance canopy suggests poor roof / water damage
- Flooding in the building recently points to foundation issues
- Soffit repairs: Paint from soffit dripping down brick and entry door soffit to be fixed (water damage)

North wide – canopy area is still leaking – noted in 2024

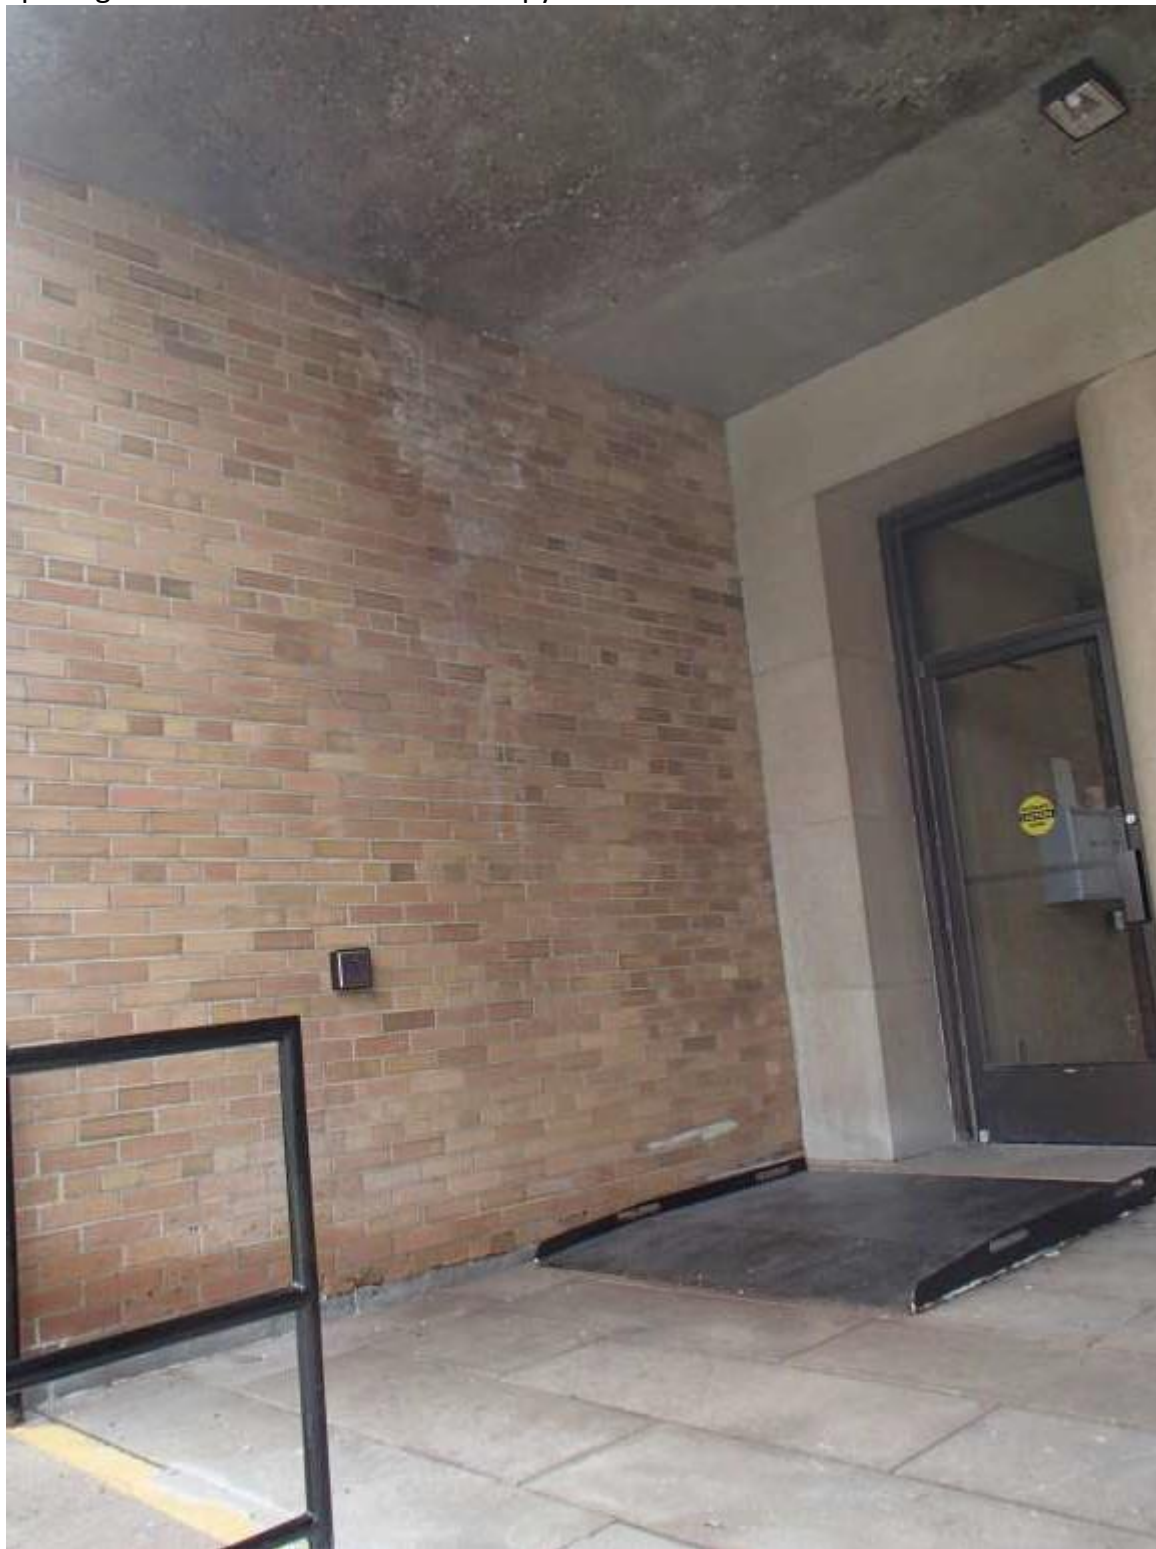
Spalling at front door – related to canopy

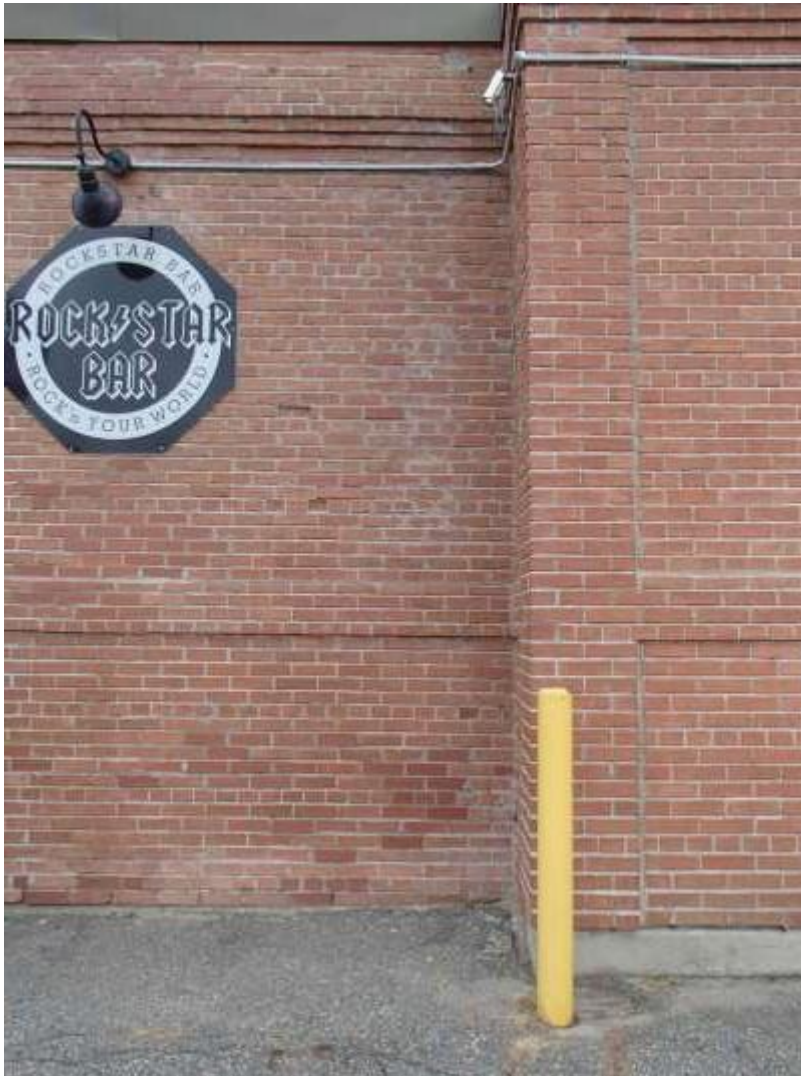
East wall – spalling issues (Roof repair scheduled for October)

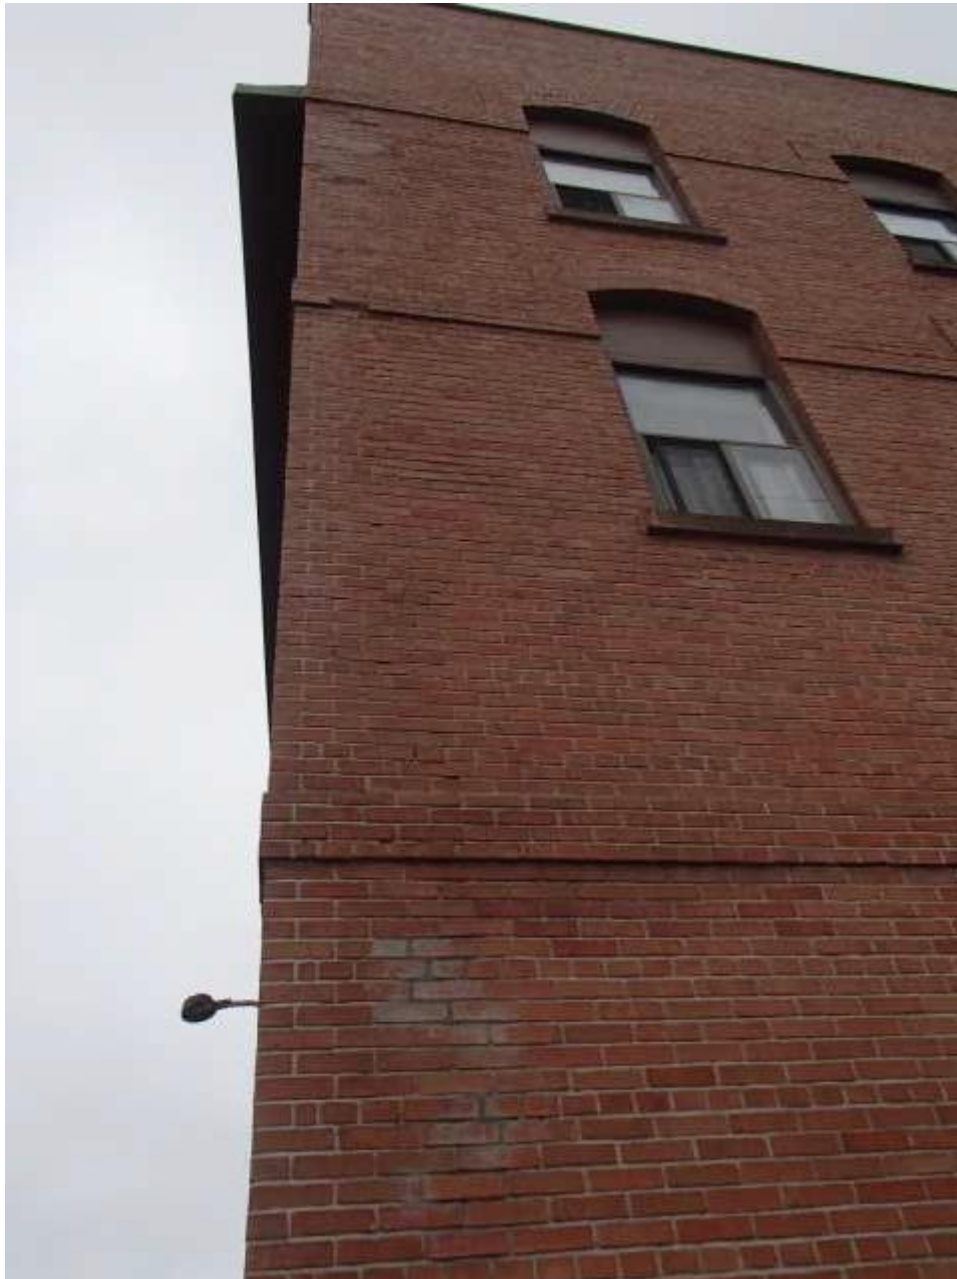
North wall - spalling

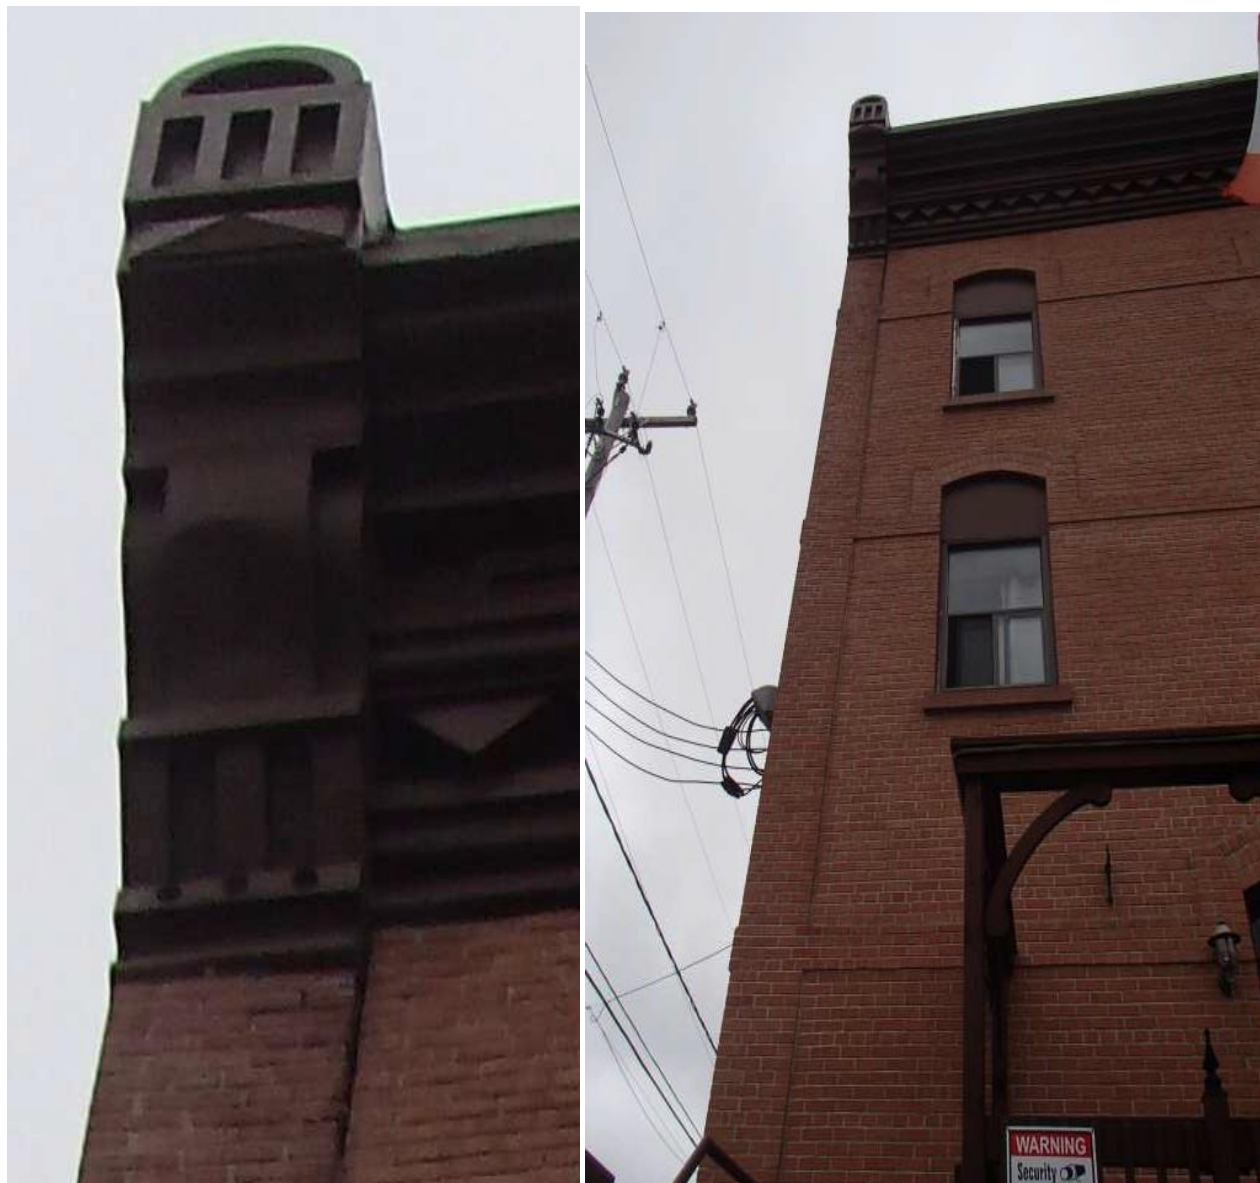
West wall - At top where column of brick joins roof we noted some separation and an indented brick

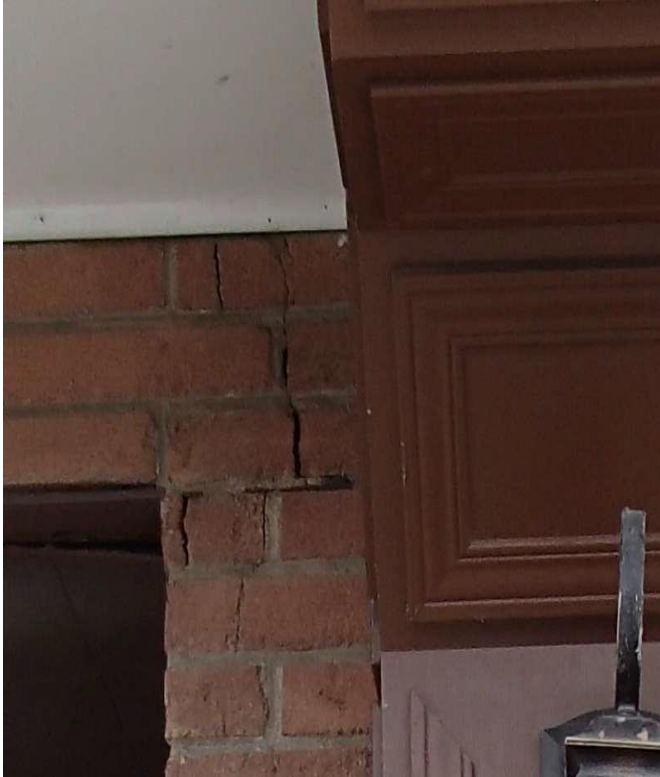
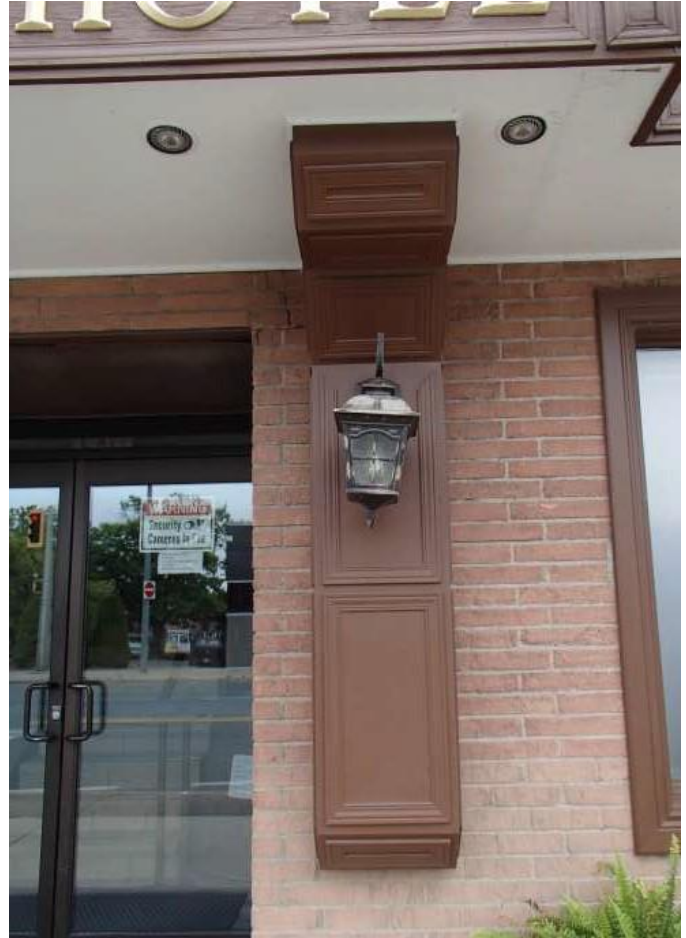
Cracks in brick above south entrance

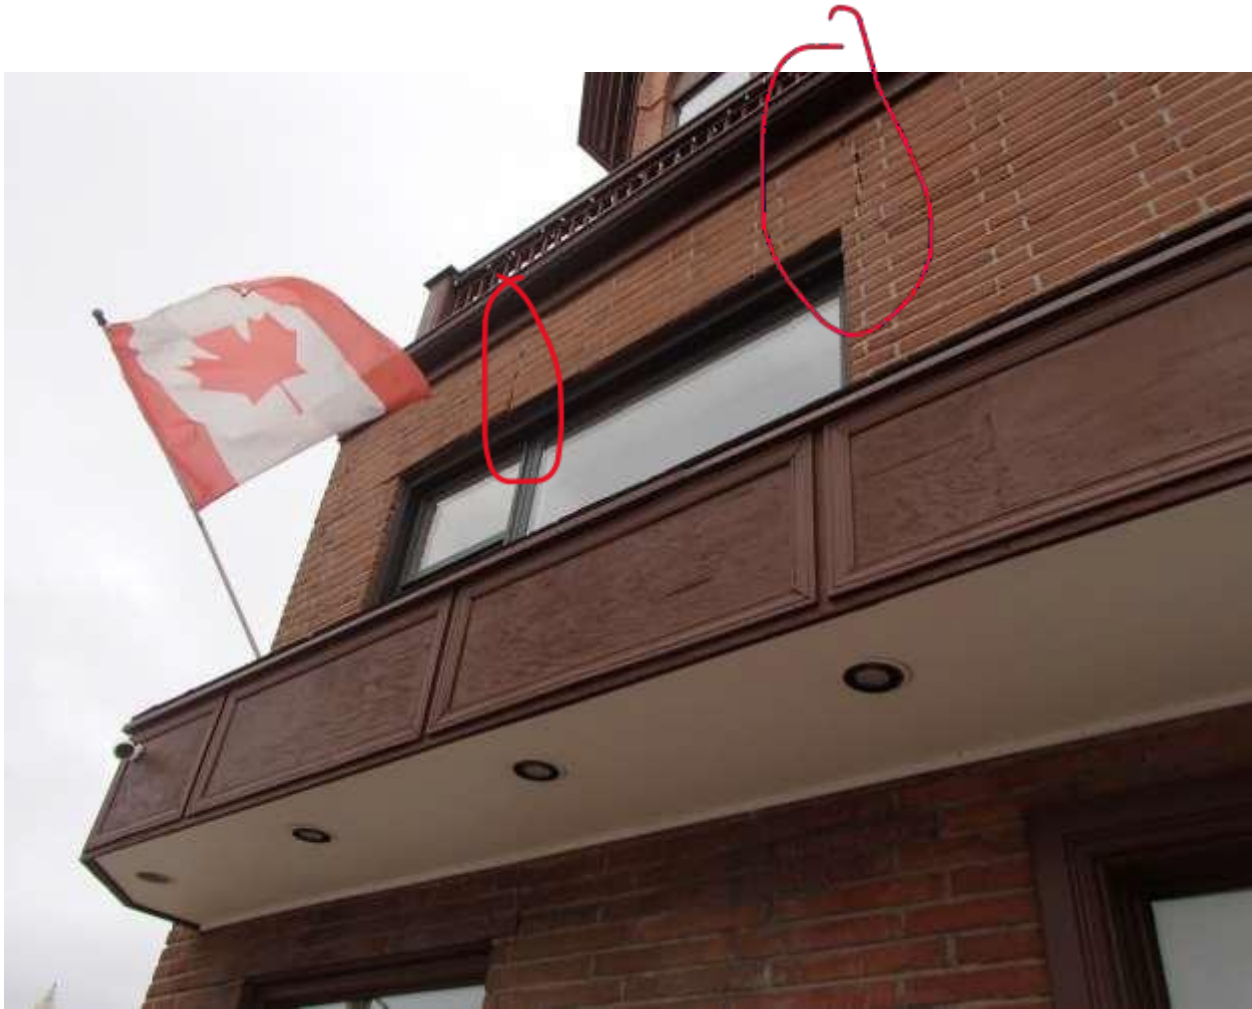
Three windows on south wall have vertical cracks on brickwork of the

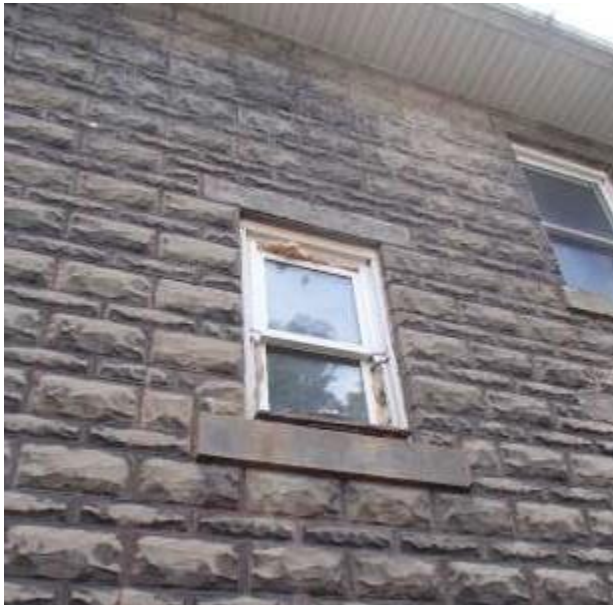
North side – window has insulation sticking out

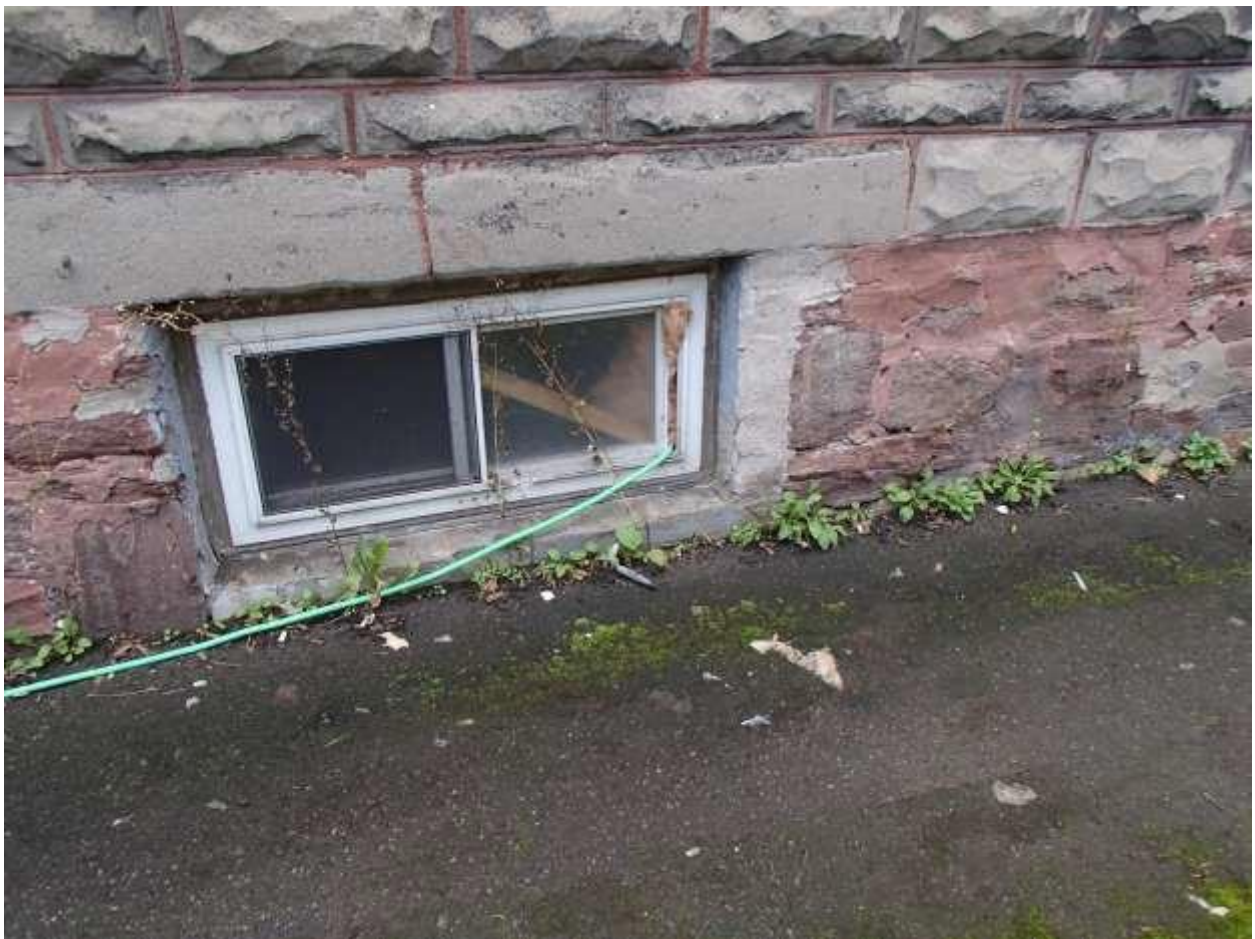
Basement window – more insulation sticking out

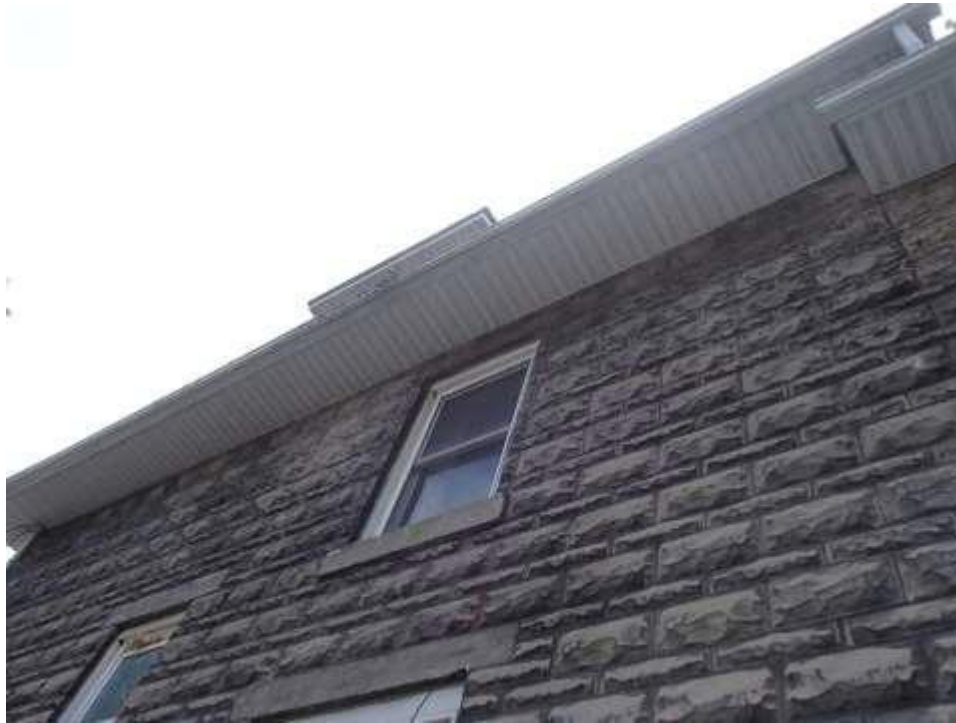
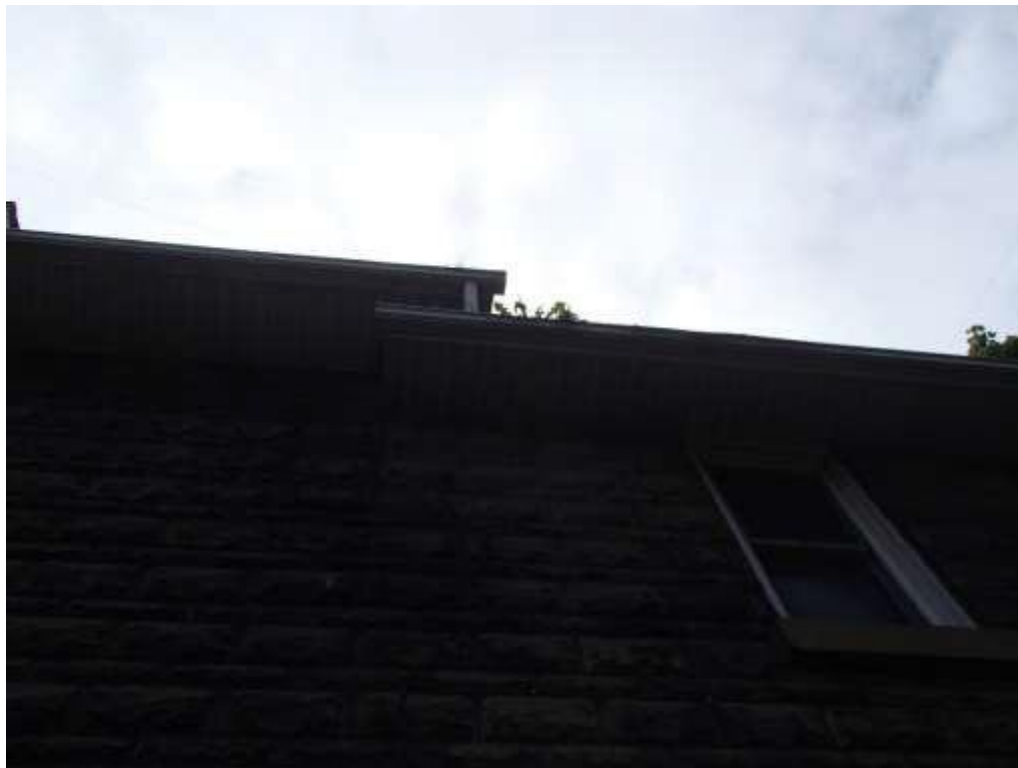
Plants growing in eaves ad gutters – possibly birds nesting too

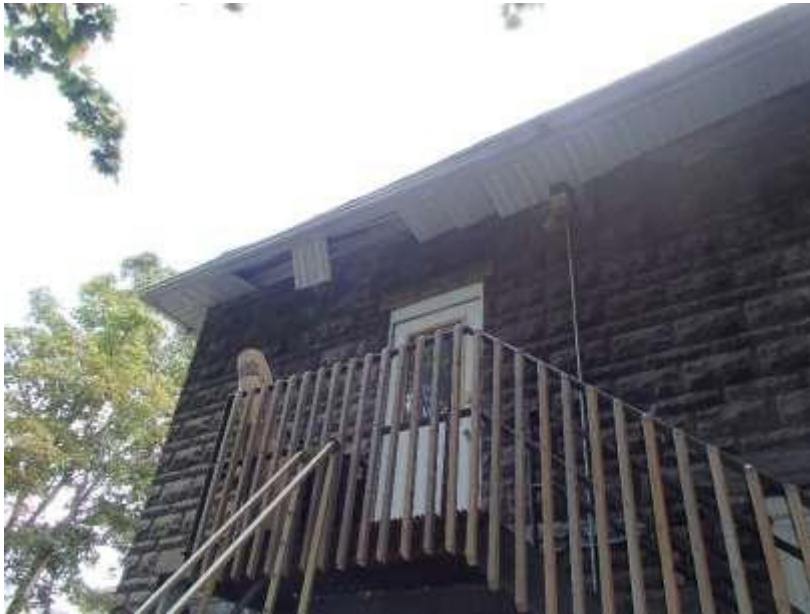
West wall – soffits are falling off
