The Corporation of the City of Sault Ste. Marie  
Municipal Heritage Committee  
Agenda

Wednesday, November 5, 2025

### **2025 Inspector's Notes**

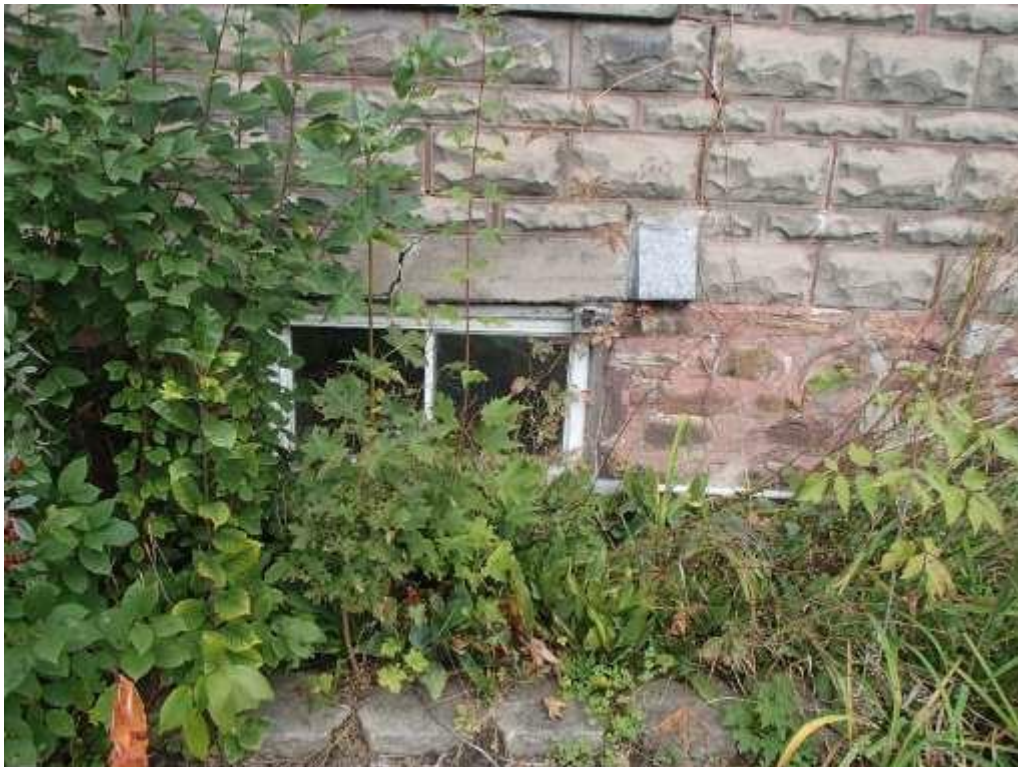
South wall – crack in cement above basement window

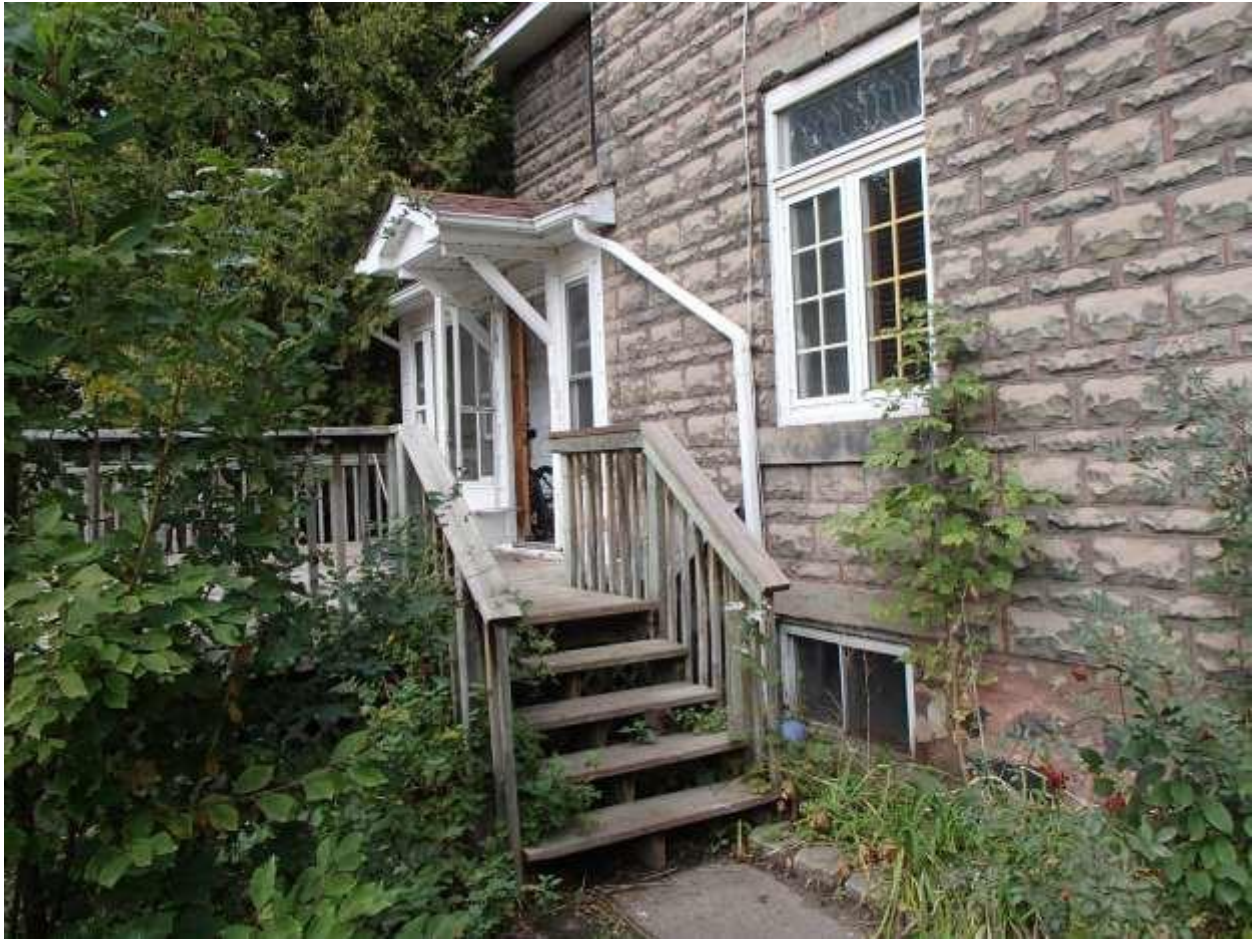
Porch roof shingles need replacement

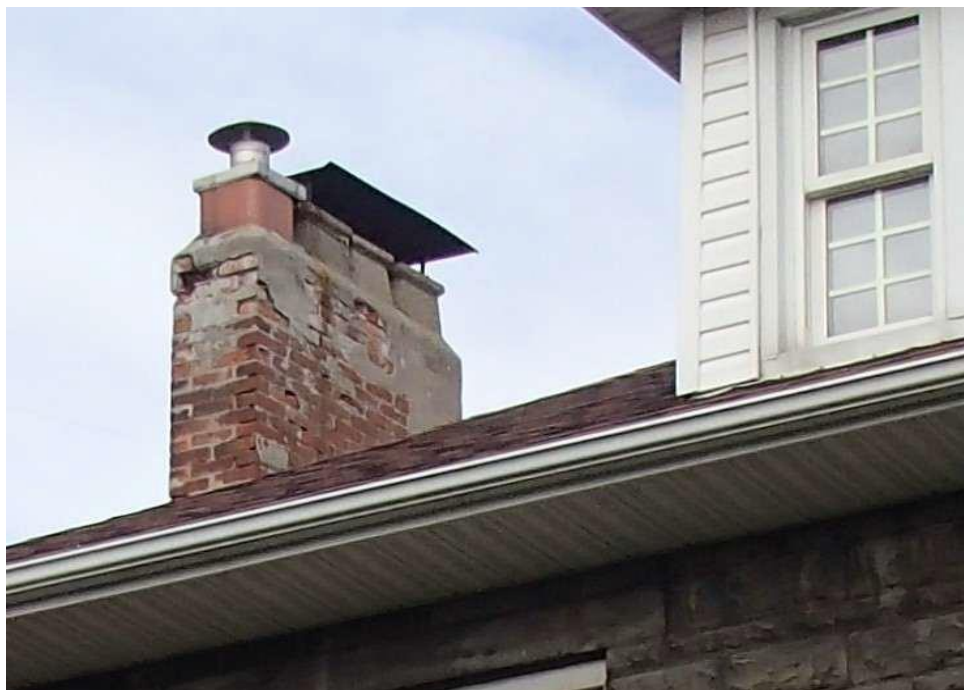
Chimney looks like it needs to have the mortar/bricks fixed

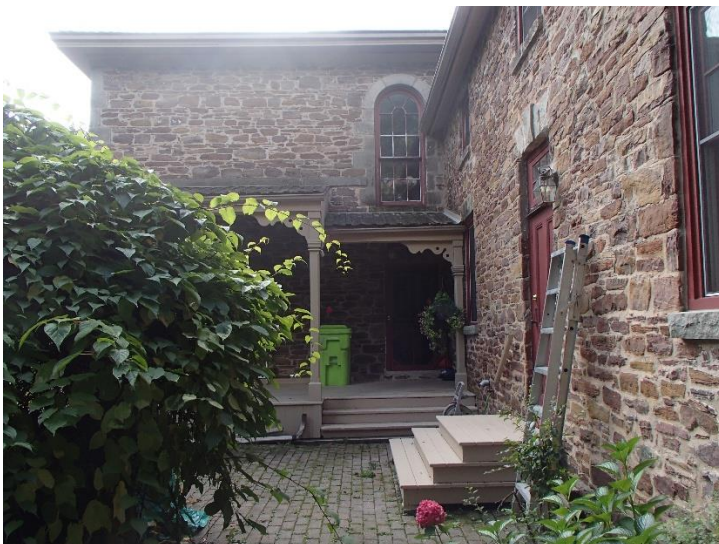
Porch needs to be monitored – over time it will need to be replaced

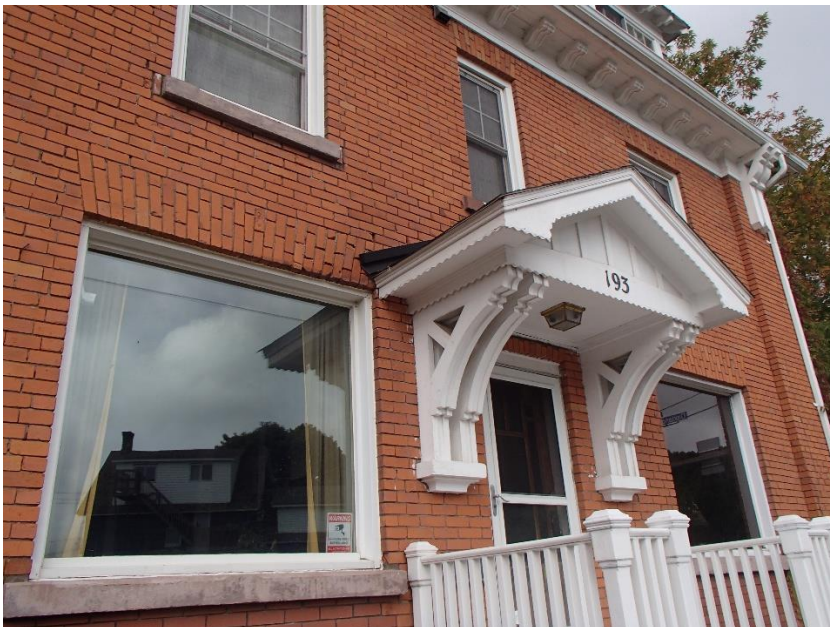
Brick work above porch roof has minor gaps and breaks.

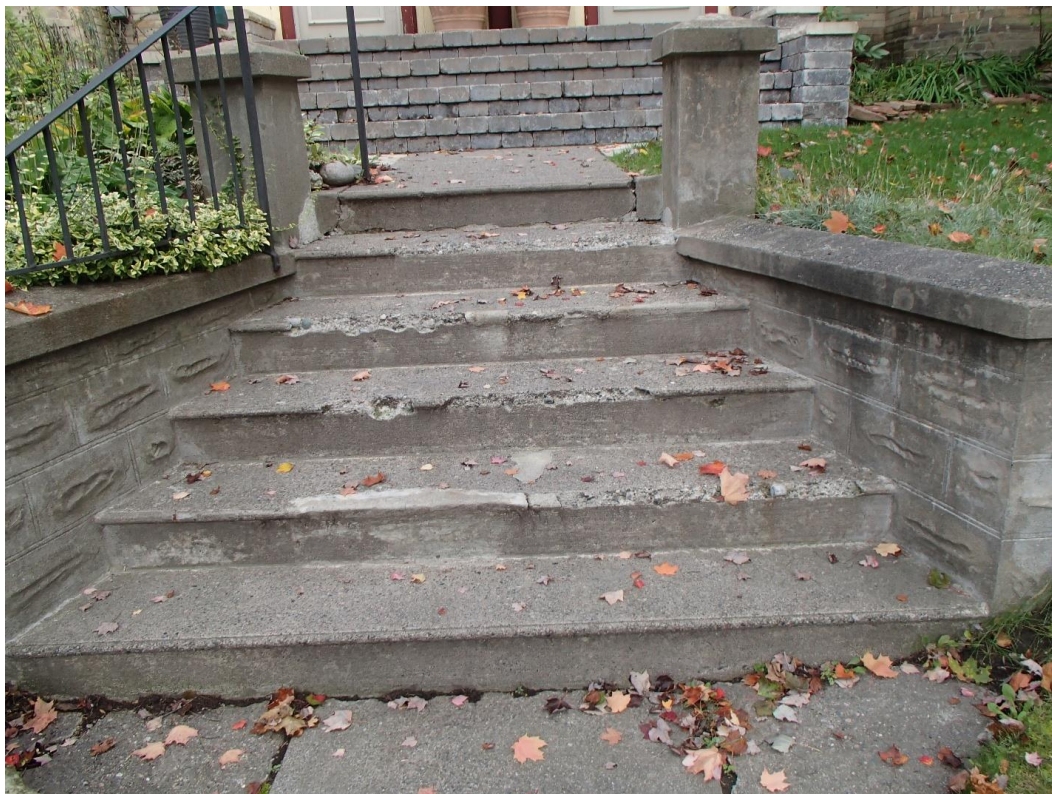
Shared set of lower stairs remains an issue – repairs have been attempted but are still crumbling

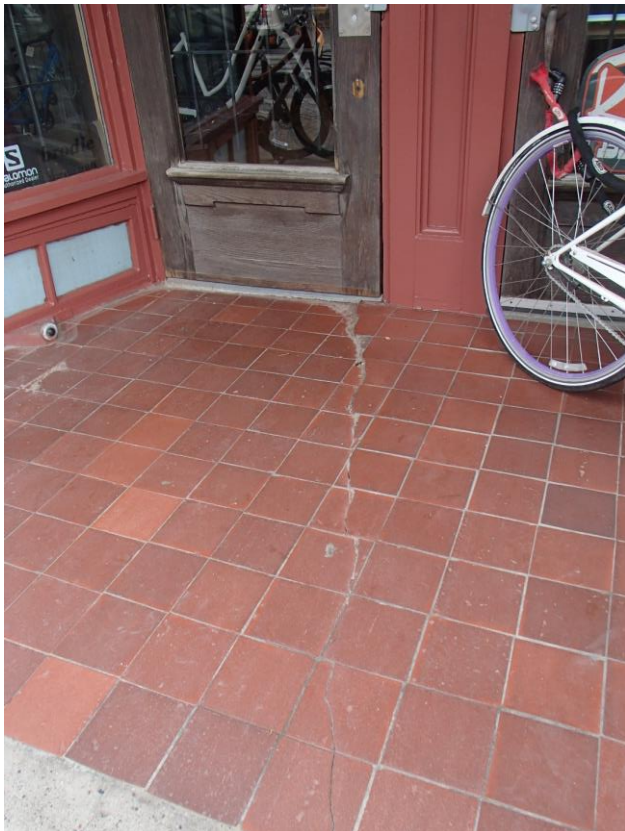
Crack in stone tiles outside entrance to Algoma Bicycles

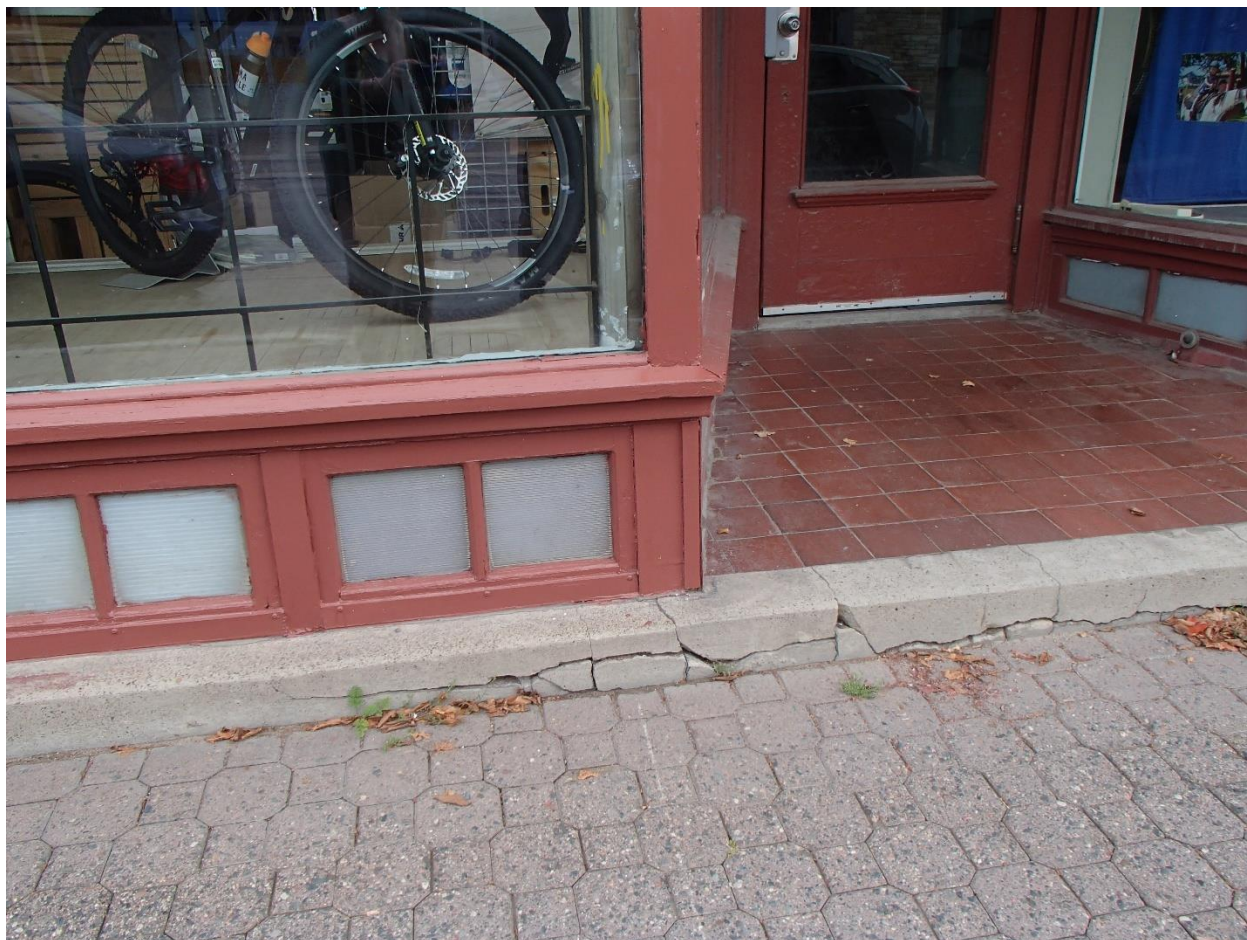
Cracked cement

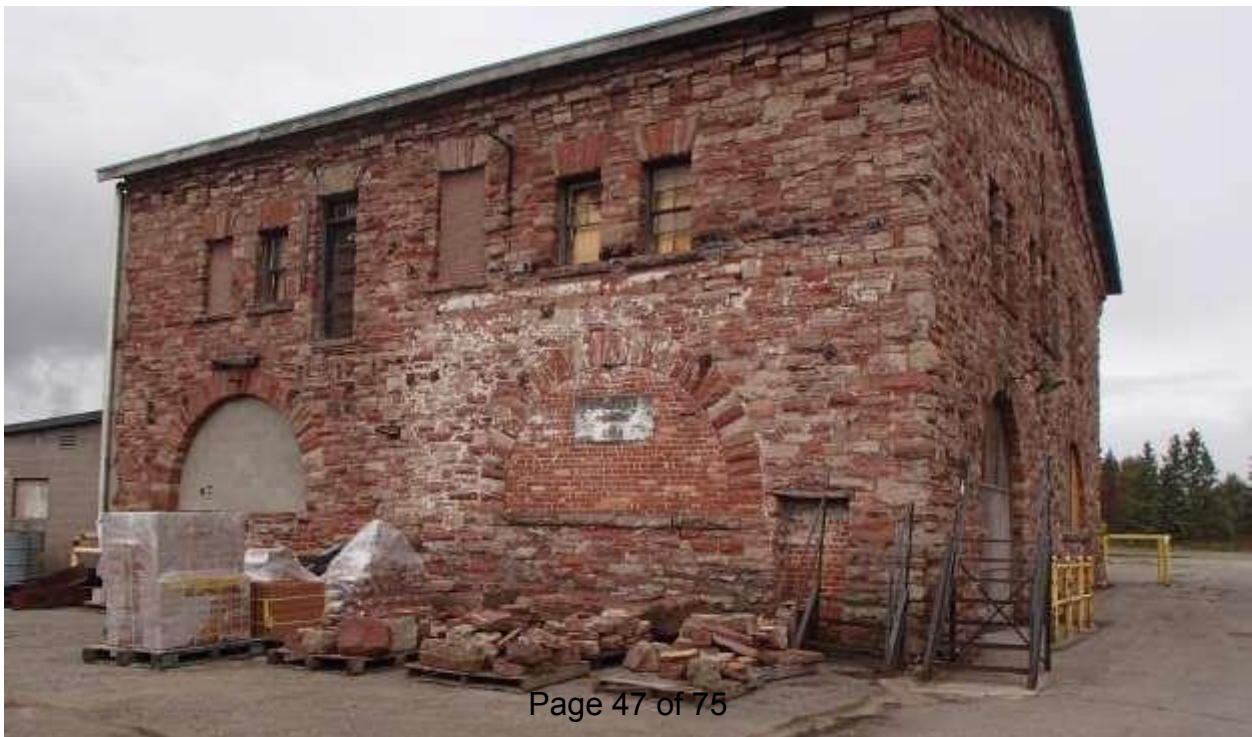
South side - Issues here are similar to those at Machine Shop in terms of mortar work and repair to broken stones.

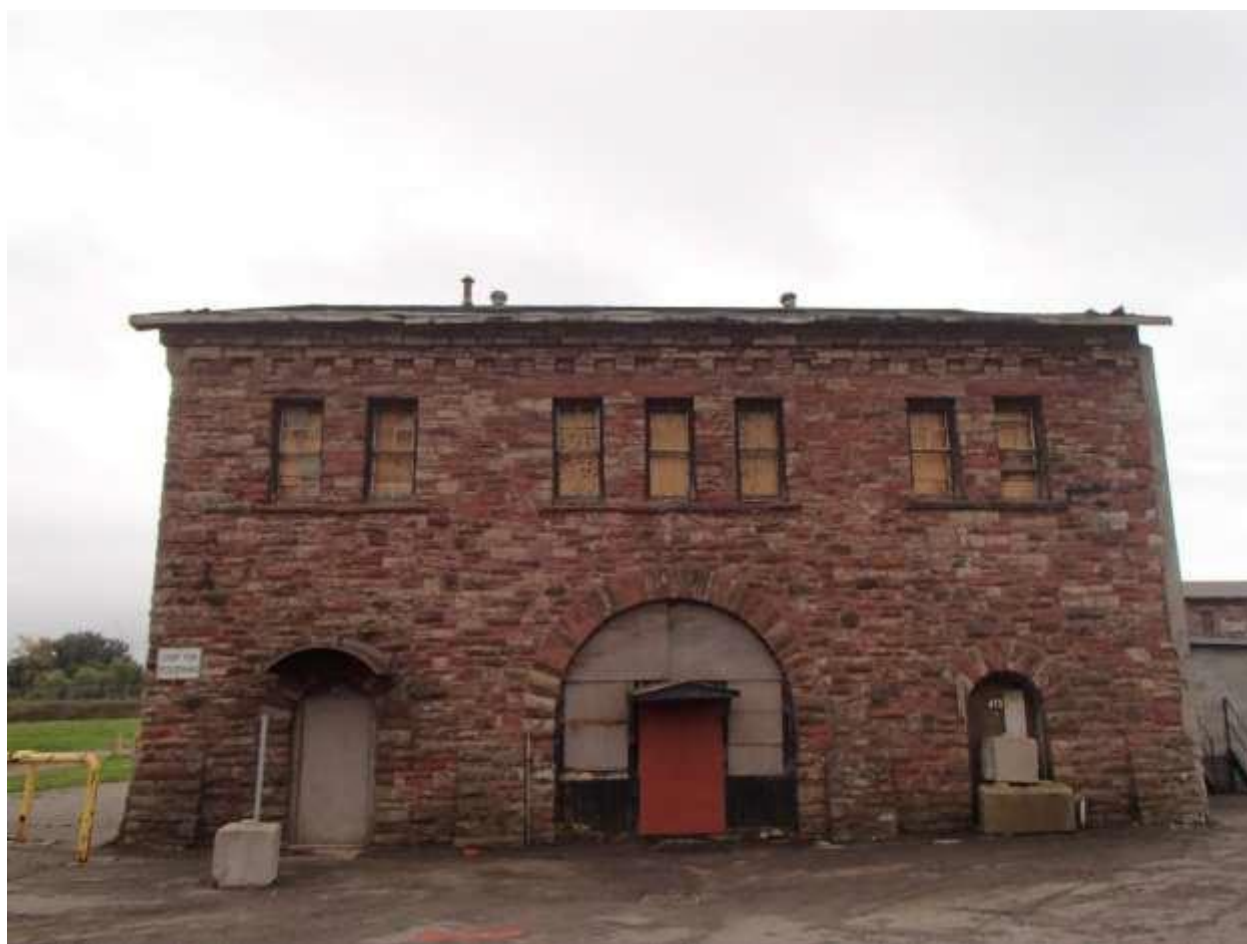
North side - Roof shingles need to be replaced, and repair needed for one roof vent

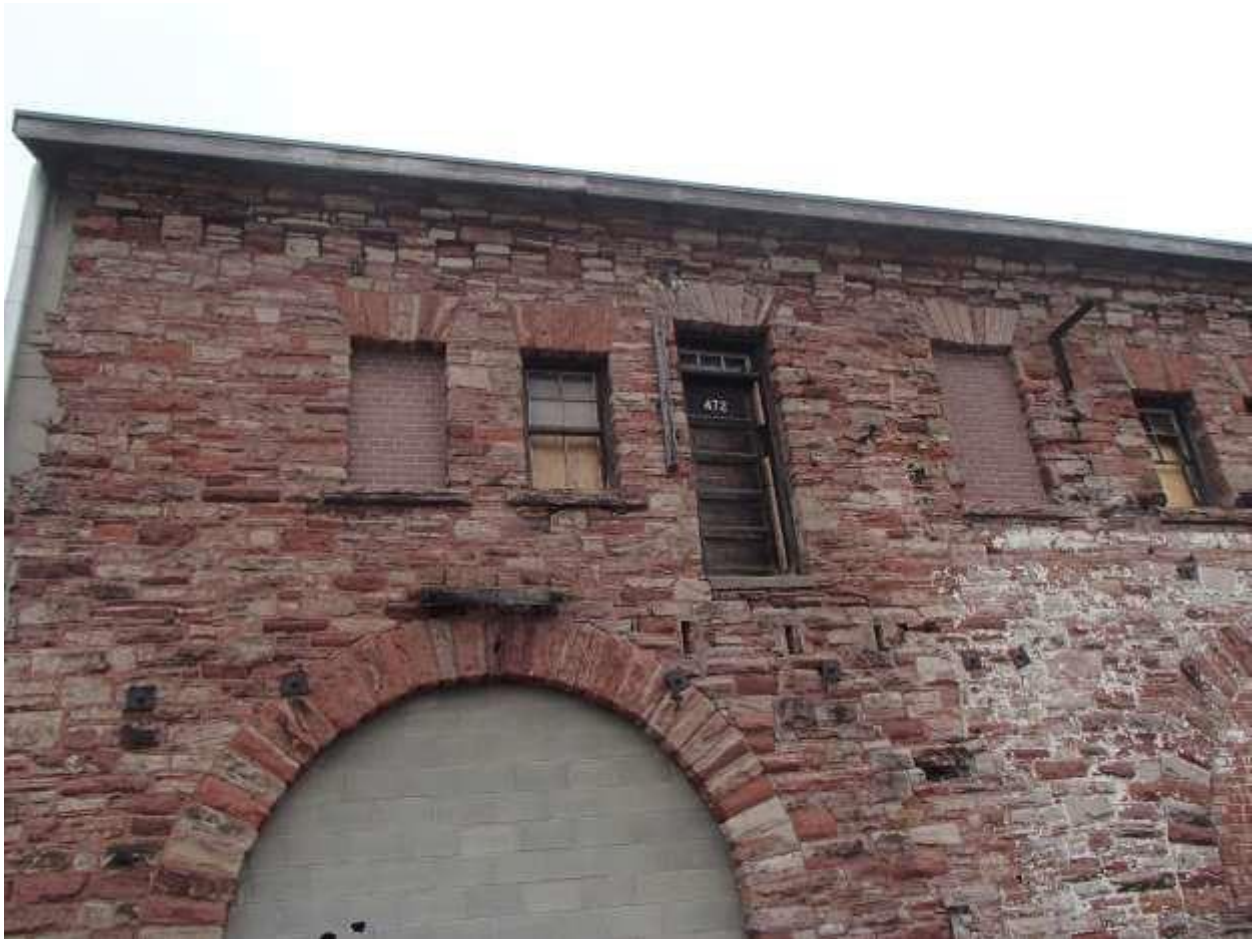
Fasia needs to be replaced and clad in metal and possibly guttered to direct rainwater away from walls. South side is in better shape than north side – see page 8

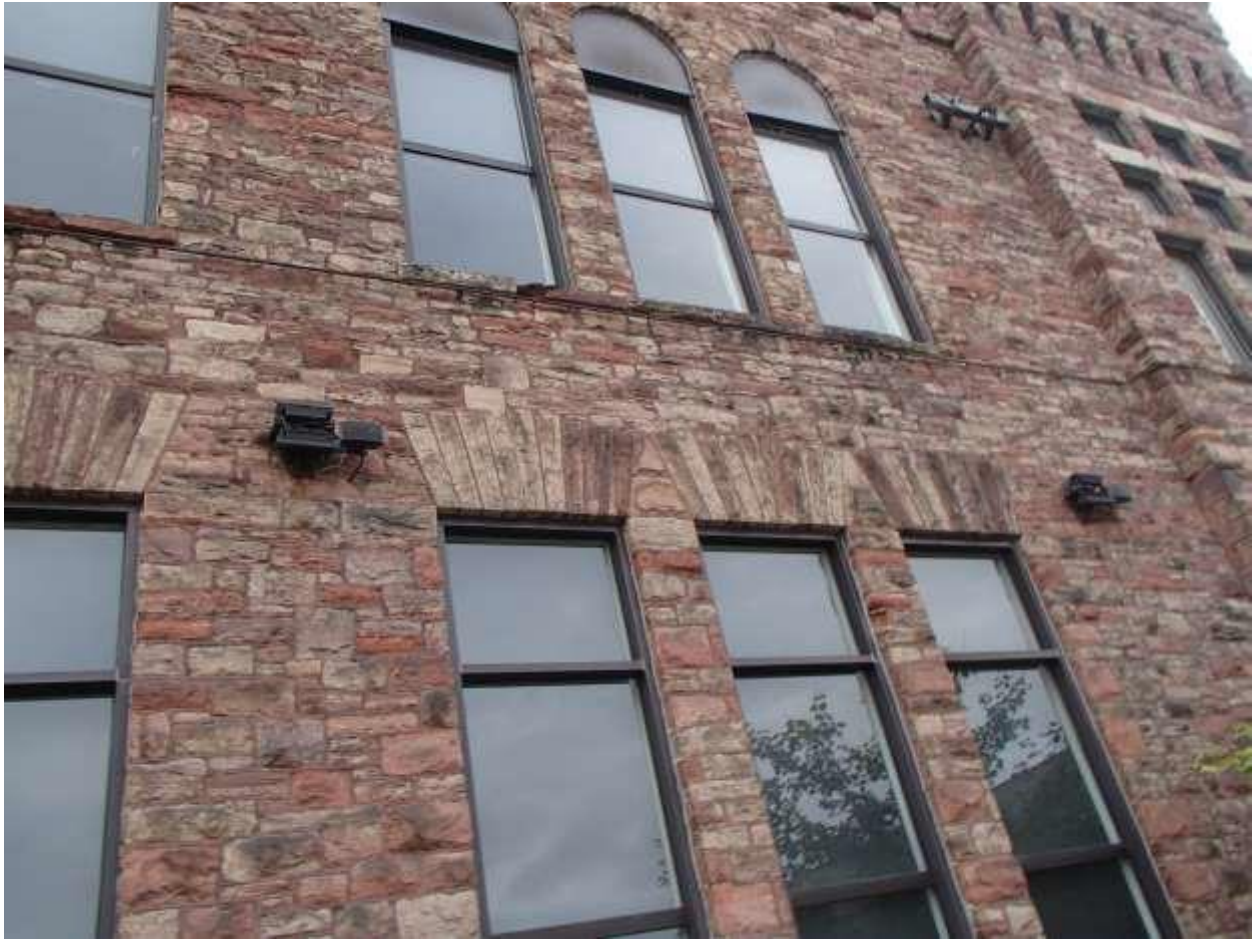
North wall - ongoing repairs to masonry

window sill repair needed here as well

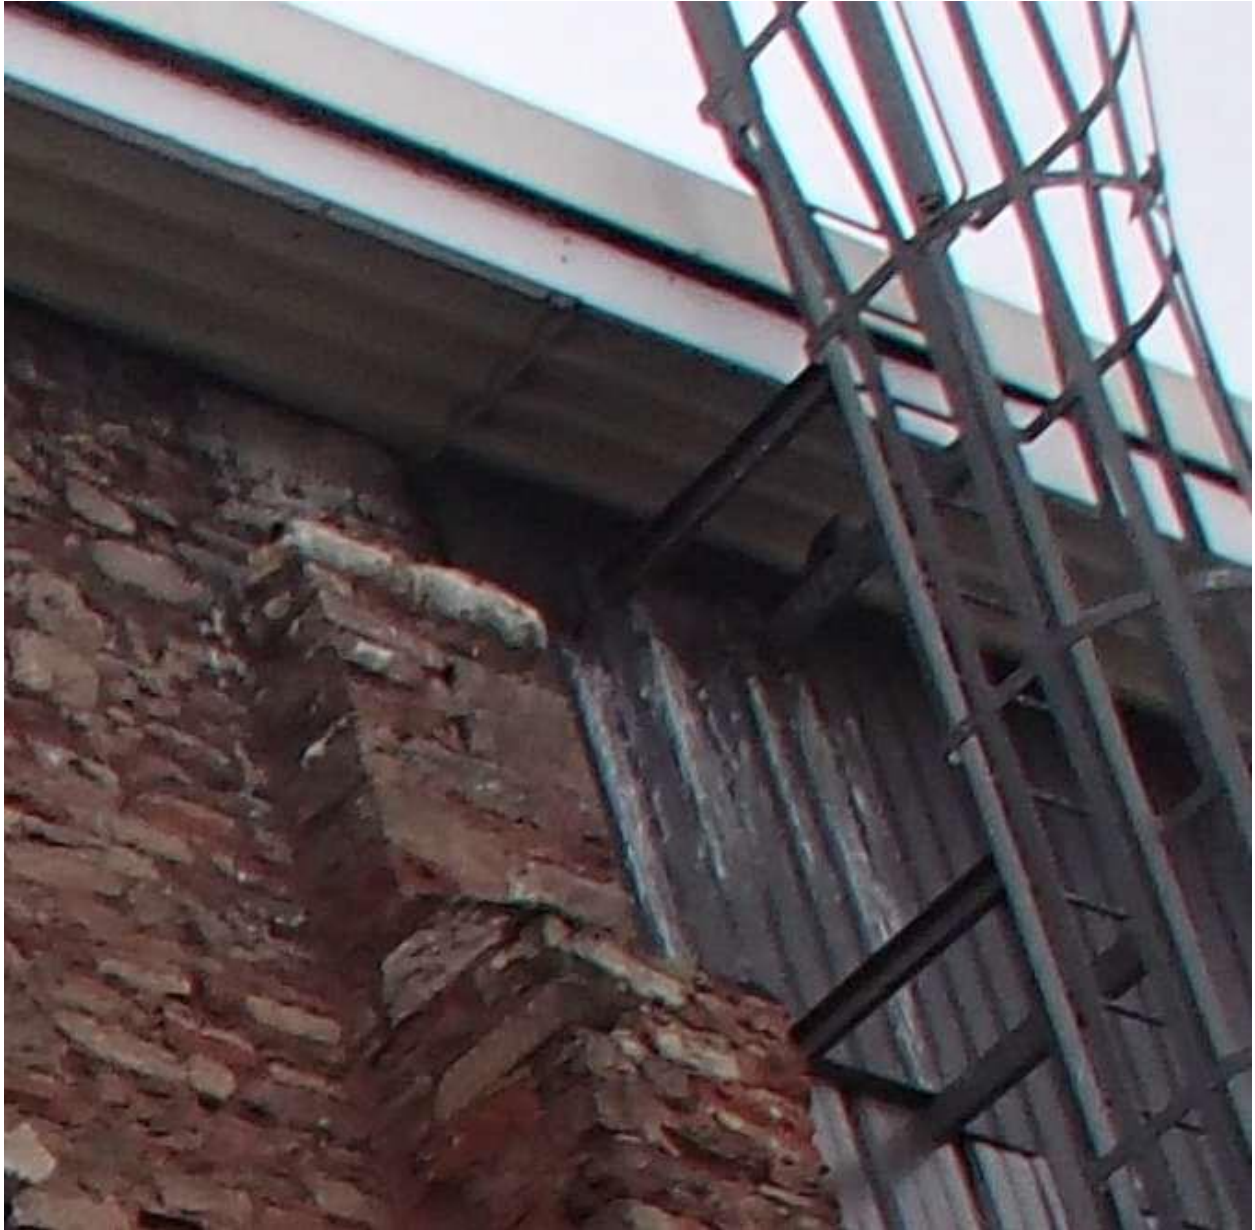
There is an issue at the top here where the brick wall ends and the rook begins – birds are freely nesting in the opening – needs to be sealed off and waterproofed. Close up photo

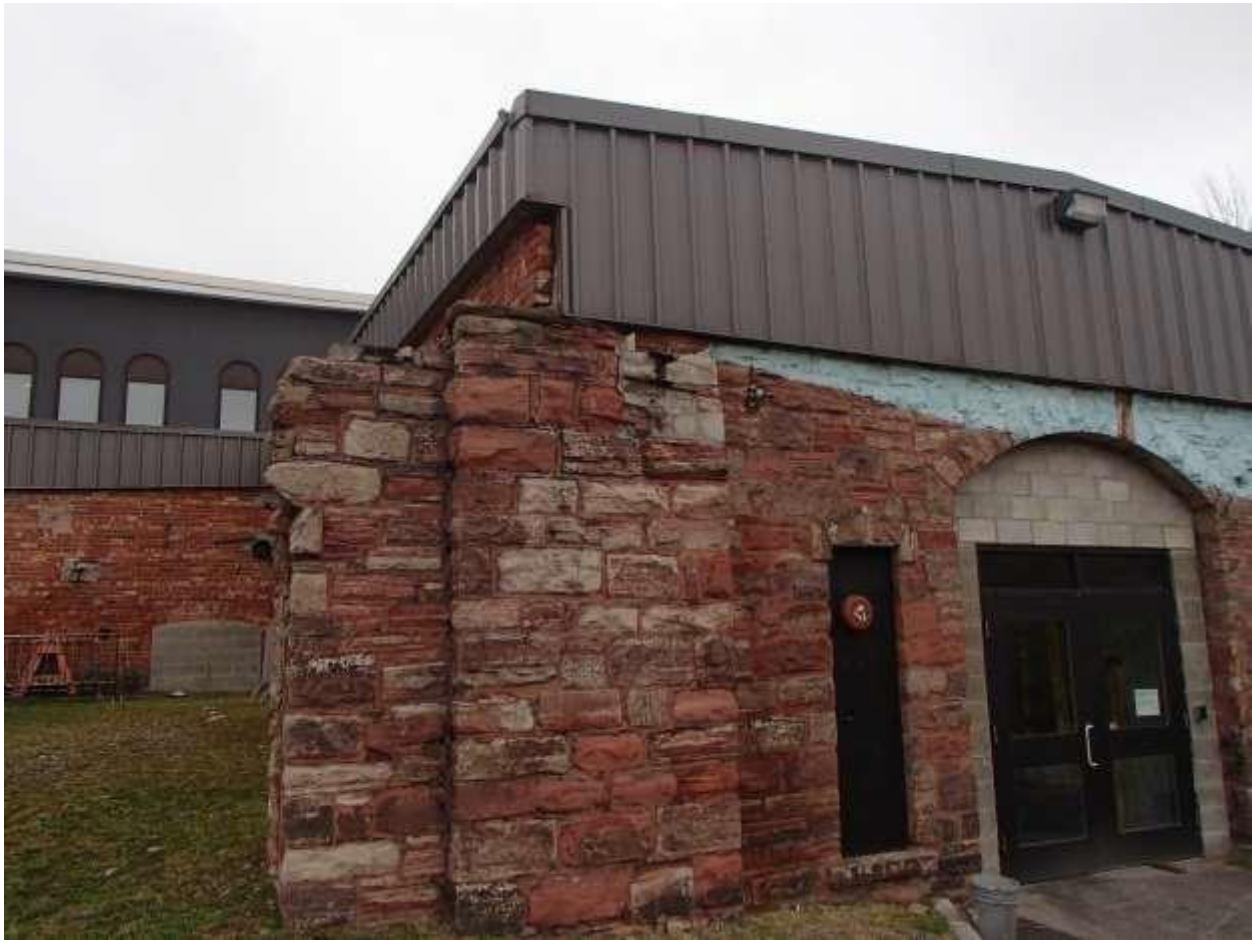
South side - Some broken bricks along this back wall

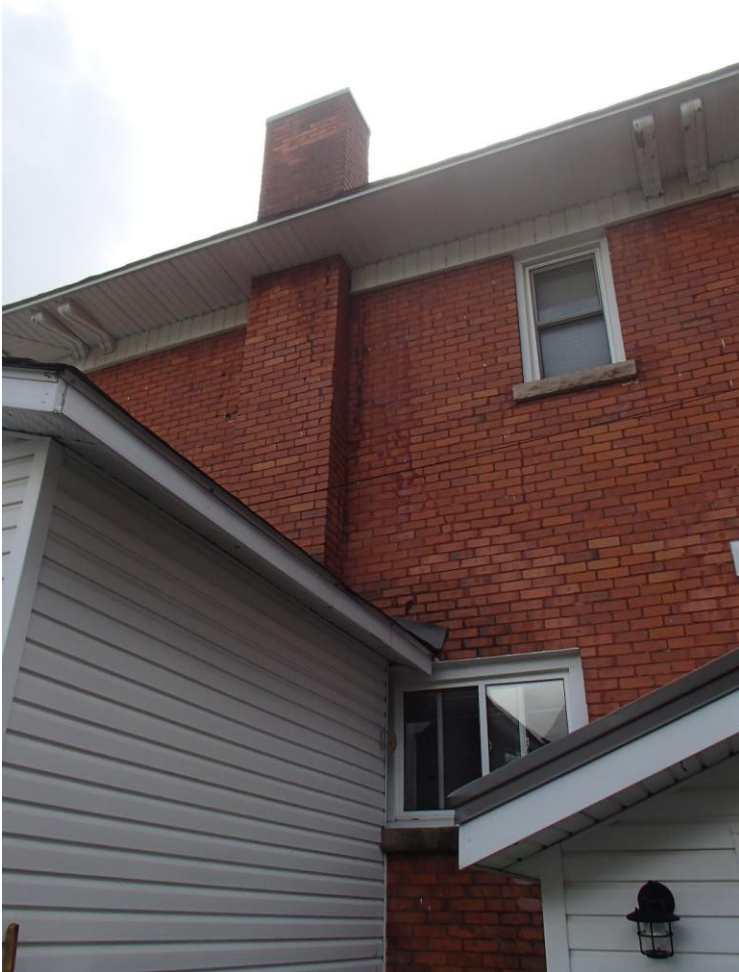
North Wall - Chimney above the roofline appear to be repaired, but below the roofline on the south wall brick appear rough and cracked

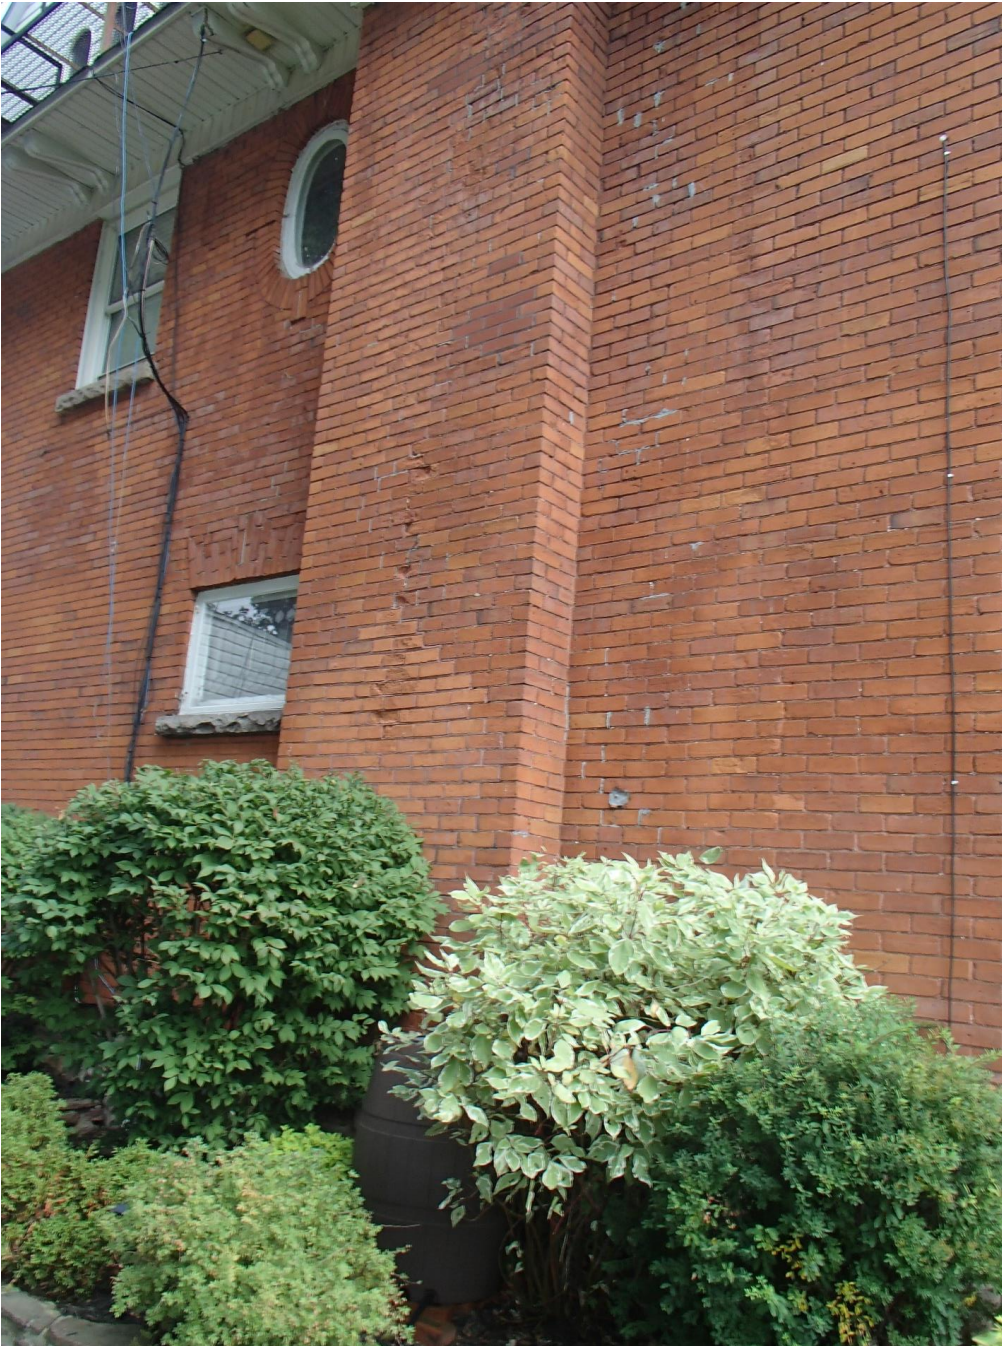
West wall – wires hanging - Some repairs attempted in brickwork, but bricks above this section need some attention

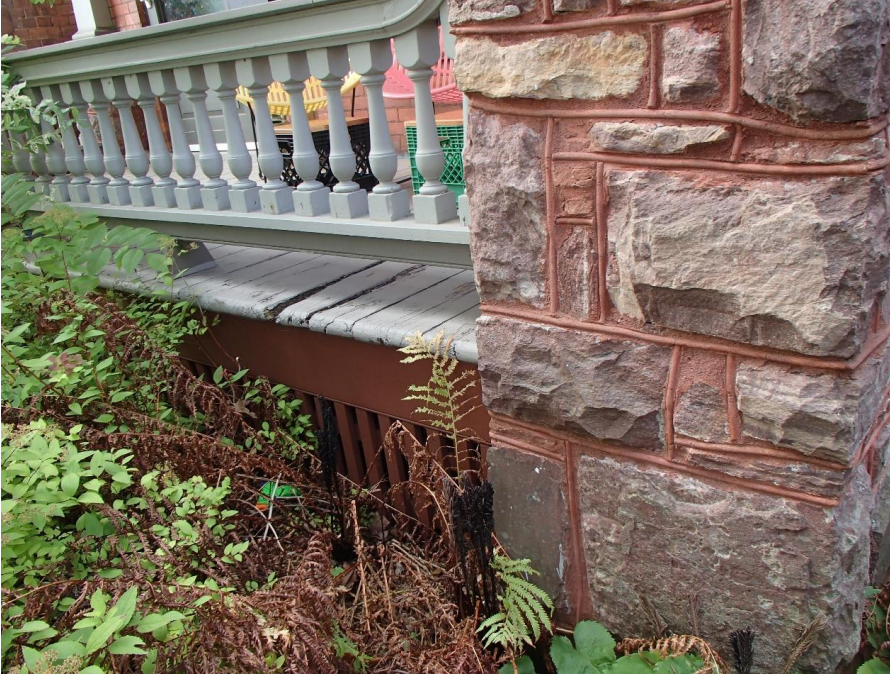
Floor of veranda needs repair

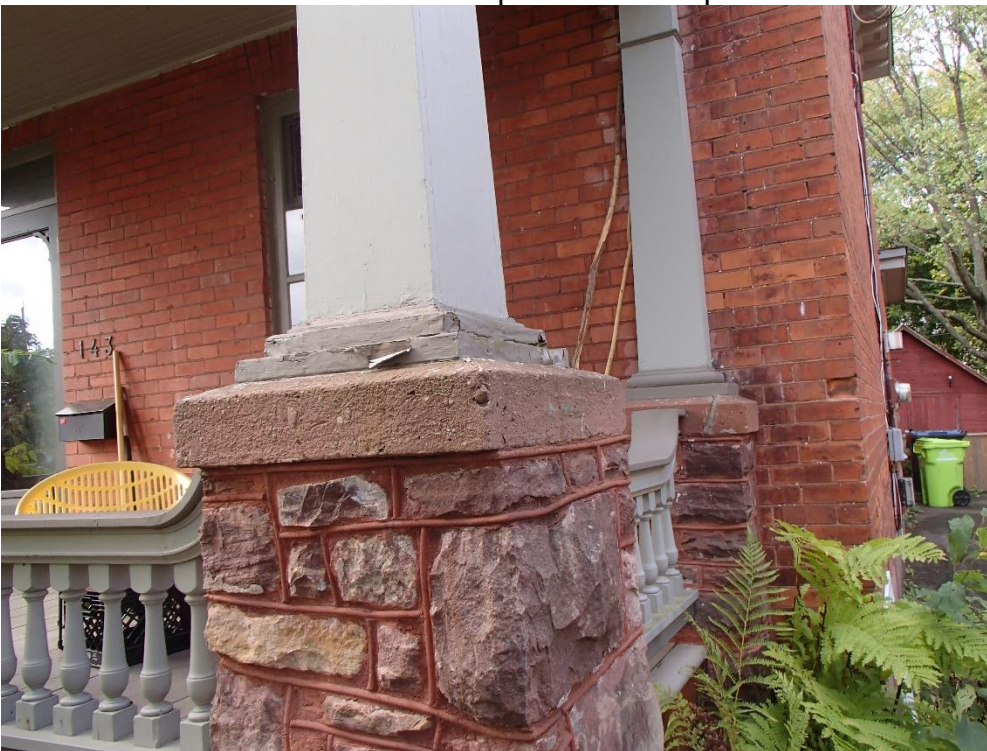
Base of columns needs some new paint and/or repair

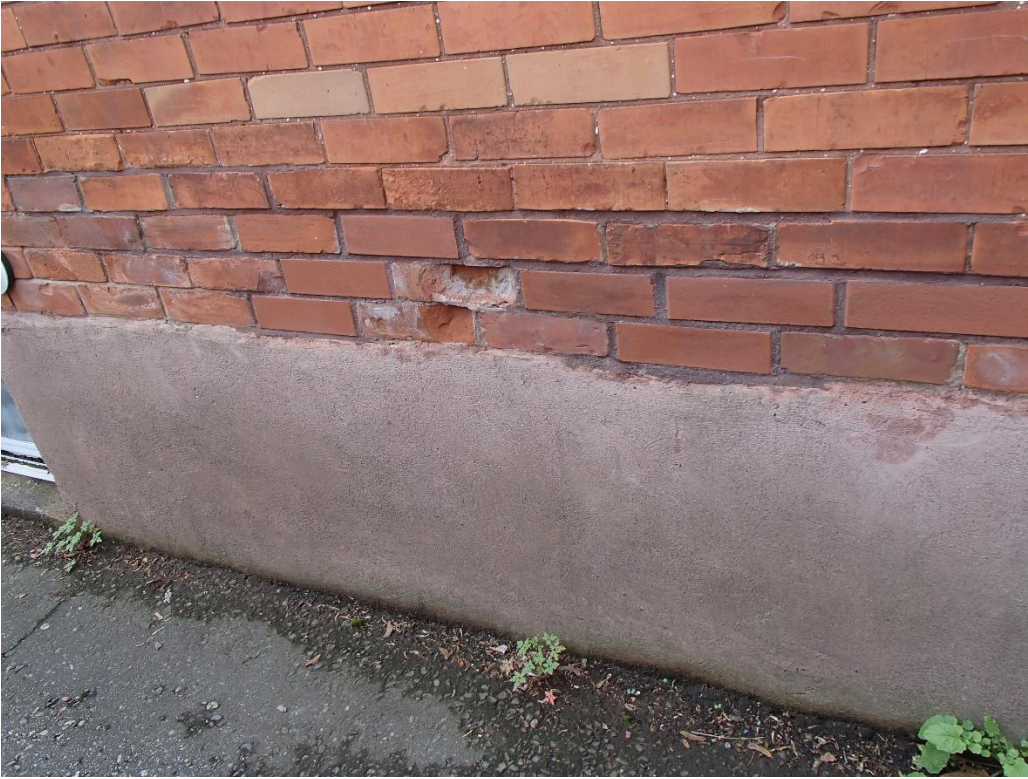
Some broken bricks above foundation
