TRANSIT RELOCATION FEASIBILITY STUDY

Class Environmental Assessment

Prepared For:
The City of Sault Ste. Marie
Project #: 16-1085
June 2017

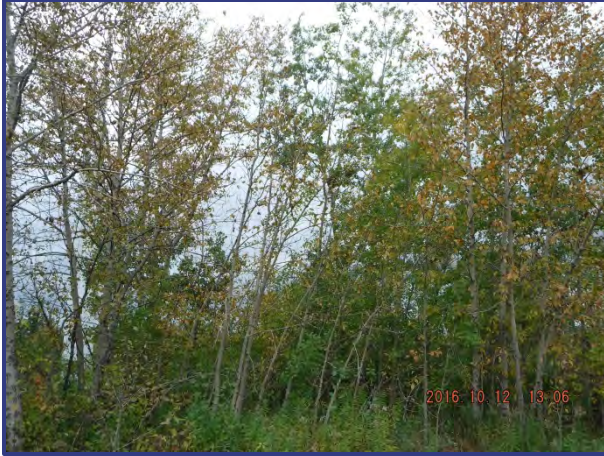
Photograph 1: Aspen/Birch stand could support migratory bird nesting in the southwest corner of the Huron Site.

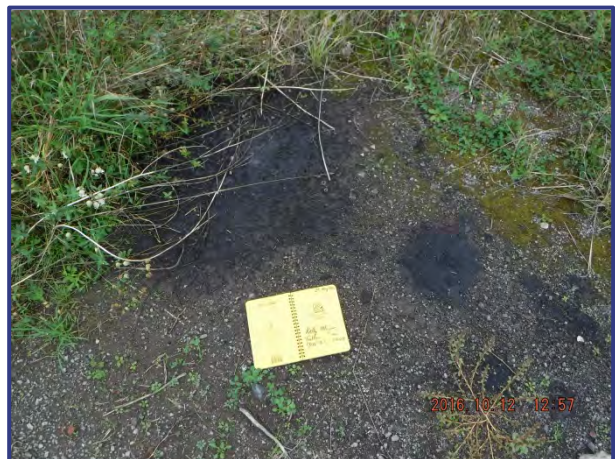
Photograph 6: Stains suggest soil contamination by automotive fluids at Huron Site.

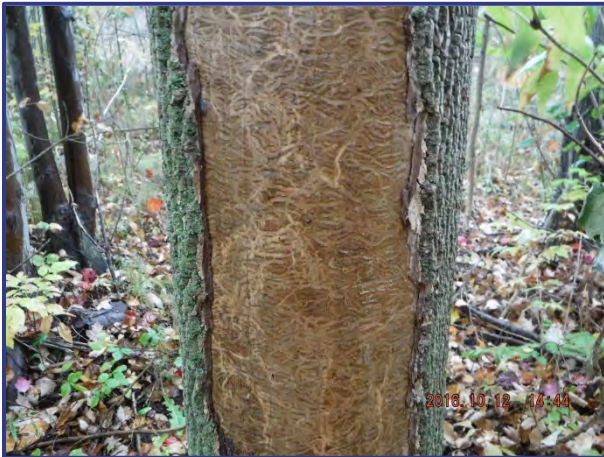
Photograph 15: Evidence of Emerald Ash Borer in northwest wooded area at Sackville Site.

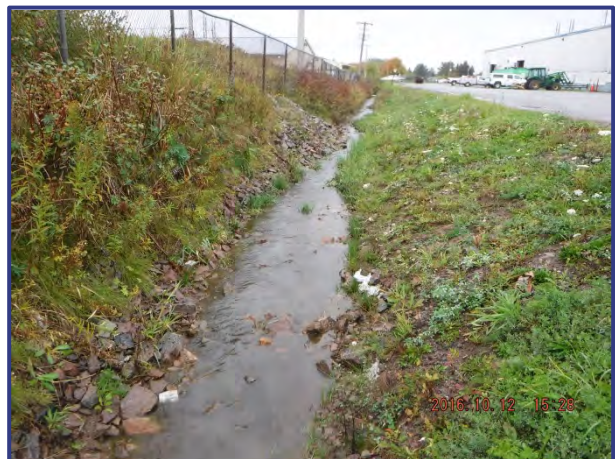
Photograph 186: Constructed drain at south edge of Sackville Site.

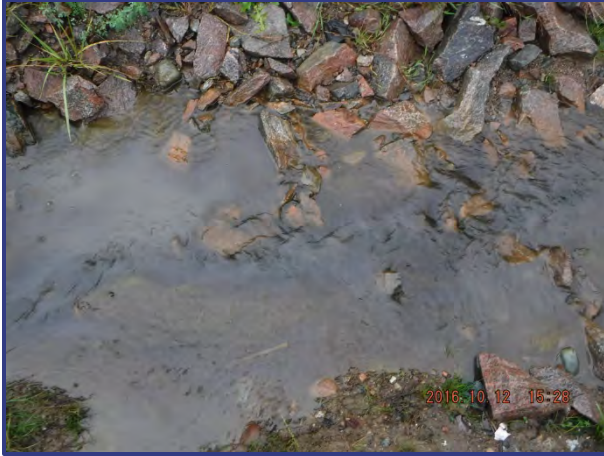
Photograph 19: Sediment of constructed drain at south edge of Sackville Site.

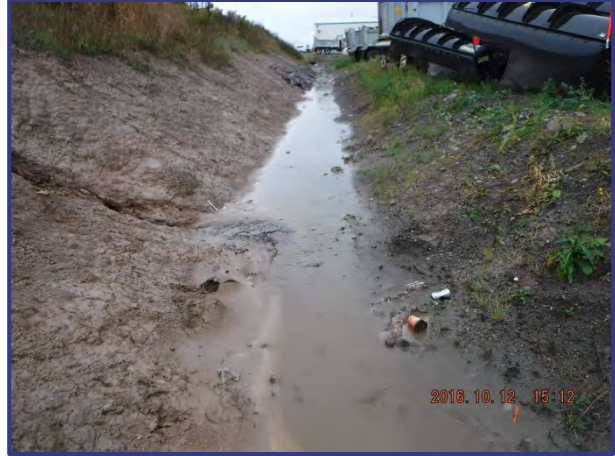
Photograph 20: Constructed drain at center of Sackville Site.

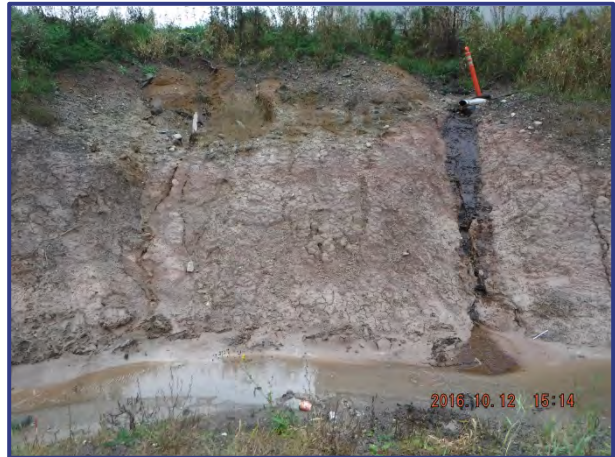
Photograph 22: Banks of constructed drain at center of Sackville Site.

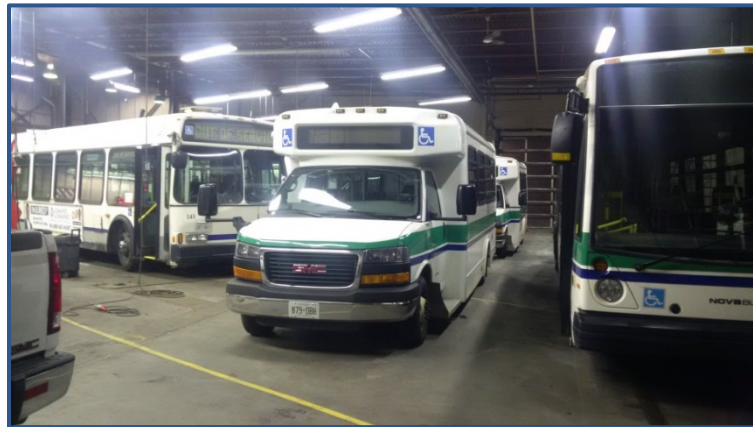
Overnight vehicle storage at crush capacity using maintenance area

Sault Transit and Para-Bus vehicles are parked overnight in the bus wash bay (2) and the maintenance area (2), which makes the transit garage appear to be at 'crush capacity'; however, this is not the case since one bus lane in the storage area is used for non-rolling stock items such as the Essar Arena emergency generator. As the day begins and buses pull out, the bus wash and maintenance areas are cleared. It works for now; however, an additional overnight storage lane would provide improved flexibility of the parking plan.

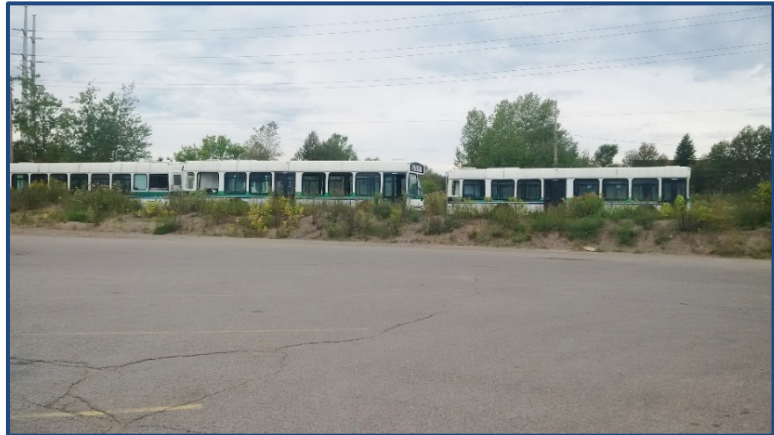
Since the retired buses are located on soil, there is a concern that oils and other lubricants would contaminate the soil.

Decommissioned buses stored on west side of property

Transit staff mentioned that a storage location closer to the garage would be welcomed by the mechanics since it would be more convenient to remove needed parts. This would also eliminate oil and lubricant leaks into the soils. If buses do leak, the leaks would occur on the asphalt area, which can be easily cleaned up, as required.

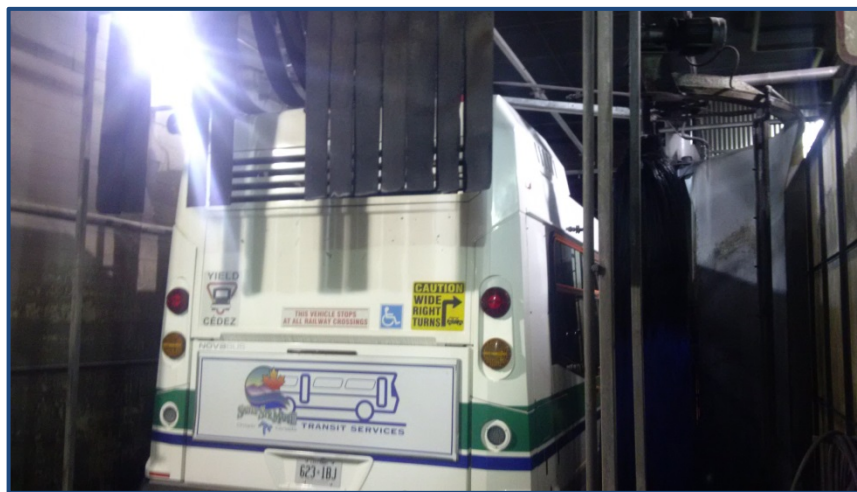
The interior of the bus is cleaned manually due to the limitations of the bus wash equipment. It is also worth noting that the water used is not recycled (or partially recycled).

New Bus with Air Conditioner and Radiator Units on Roof of Bus

Recommended action: Purchase a new bus wash system that accommodates current and potentially future bus designs and maximizes recycling of water.

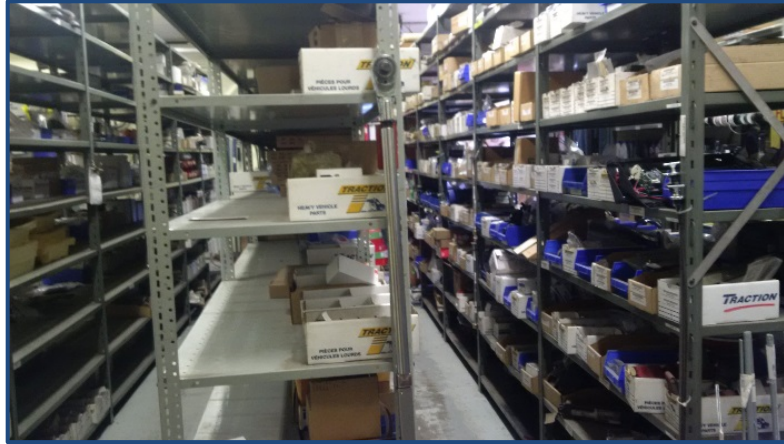
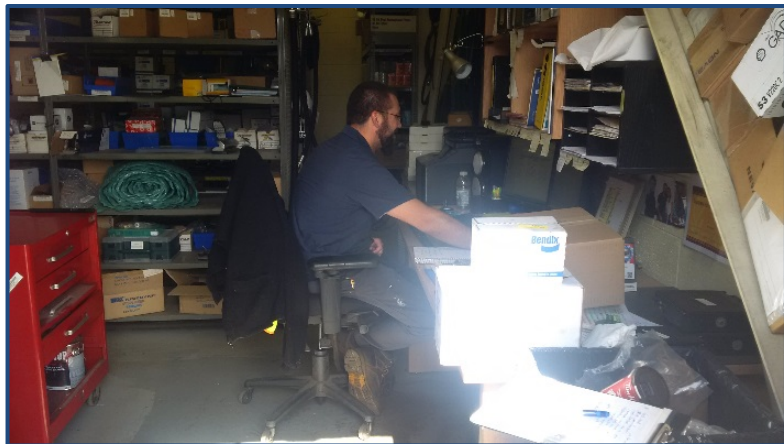
- There is no stores attendant on weekends while on weekdays from 4:30am-8:00am and after 4:00pm, no stores attendant is available. A lead hand is designated the responsibility at these times.

Stores Room

Stores Attendant Work Area in Proximity to Outside

Recommended action: Reconfigure the stores area to improve functionality and employee comfort, add parts counter, and improve parts receiving area.

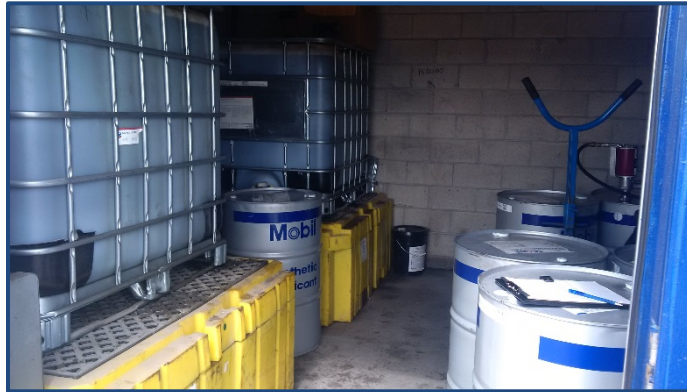
Issue: Empty barrels are sometimes placed at exit door, which is a fire violation while liquid storage containers need to be vented at the top in order to have adequate air pressure when pump is being used.

Lubricant Storage Room

Recommended action: Enlarge or redesign lubricant storage area to accommodate larger bulk containers.

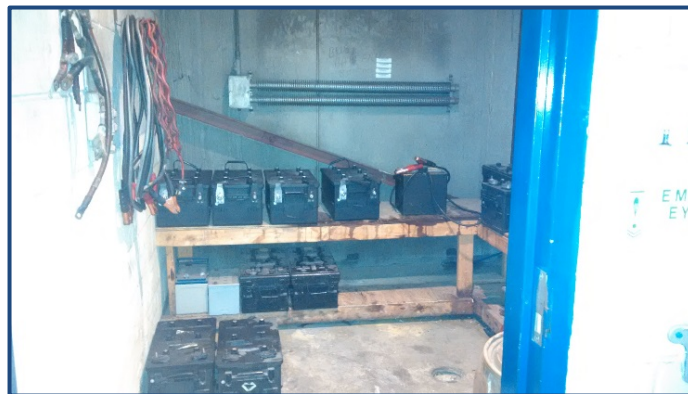
Issue: Battery room and access does not allow for forklift access of batteries which weigh 40 kilograms (100 pounds). They are now carried manually; this requires two individuals to lift the battery or risk injury if one person attempts to carry the load.

Battery Storage Room

Recommended action: Enlarge battery storage room and door to accommodate a forklift and movement of the forklift within the room.

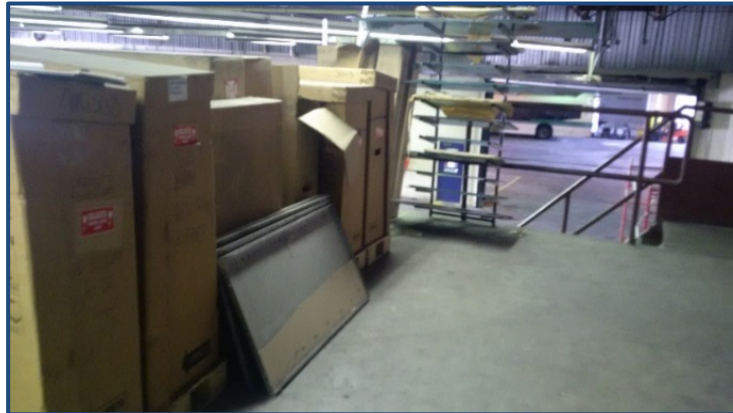
Issue: Windshields are stored on the second level of the vehicle maintenance area, which requires a person to carry windshields, weighing at over 22 kilograms (50 pounds) down the stairwell, which could be considered a safety issue.

Windshields Stored on Second Level

Recommended action: Add a storage room on the main level in proximity to the mechanic work area. An unheated exterior storage room would be sufficient.

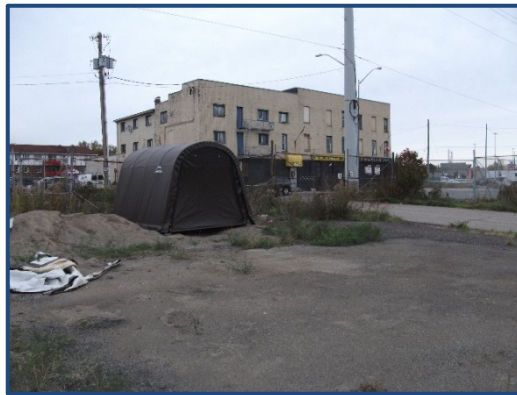
Issue: Sand storage on-site is provided in a temporary tarp enclosure on the westerly portion of the site. The tarp enclosure is replaced after two years.

Sand Storage Enclosure near Hudson Street

Recommended action: Replace tarp sand enclosure with permanent sand storage enclosure.

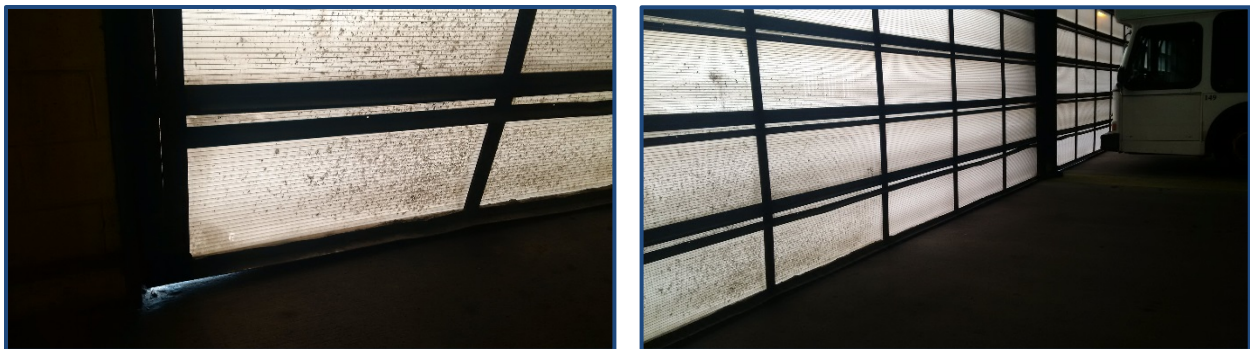
Issue: With the exception of the front main door, all overhead doors are have some degree of damage, rust and/or air leakage into the bus parking area. This was clearly identified in the AMFCA report.

Recommended action: Replace all overhead doors with the exception of the recently replaced the main front door.

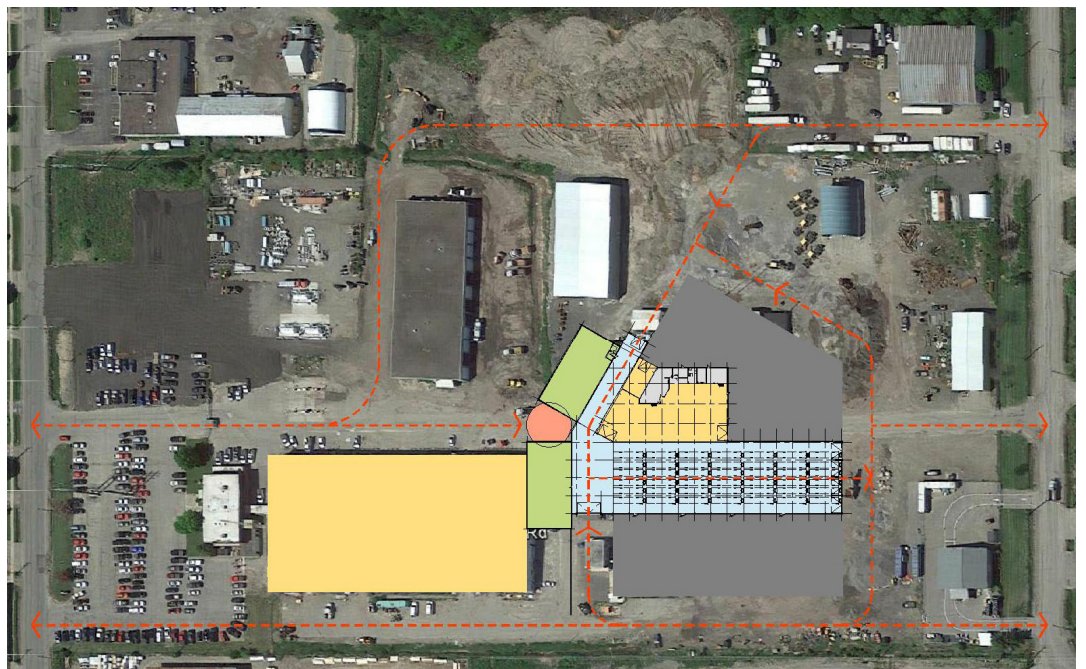
Proposed Site Plan – Integrated Option A
