Sault Ste. Marie Municipal Heritage Committee
Designated Heritage Property Tax Rebate Program
2024 Annual Property Inspection

Date of Inspection: September 18, 2024

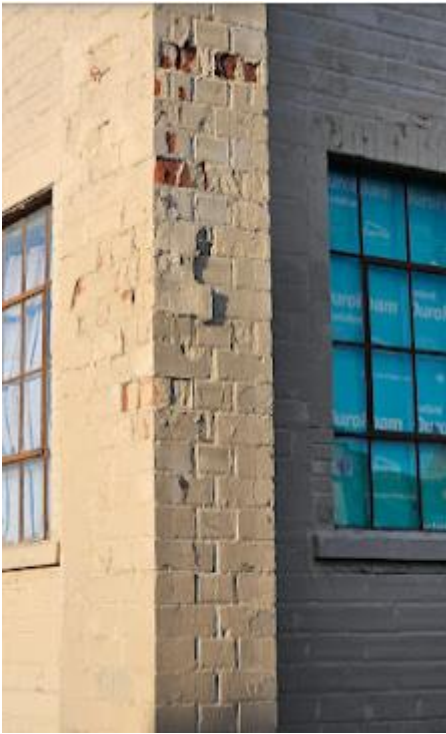
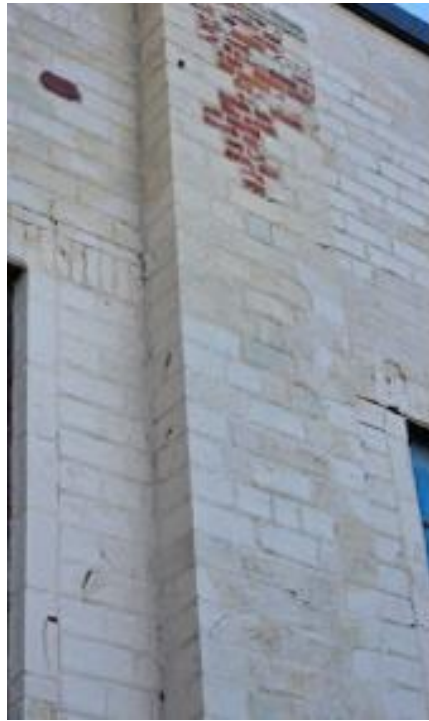
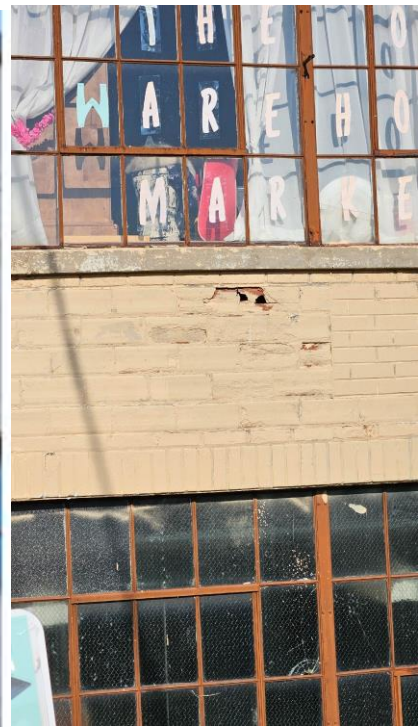
- Spalling in several areas around the building, most issues appear on light stone.
 - For future crack in brick at south (no concern-monitor)
 - Crack in brick at west side cracking north face brick at sills

- Spalling brick west towards queen
 - Cracking of brick and top of North Columns
 - On the northwest side of the building, next to the Bush plane giftshop, appears to be leak in the brickwork

Photos of brickwork

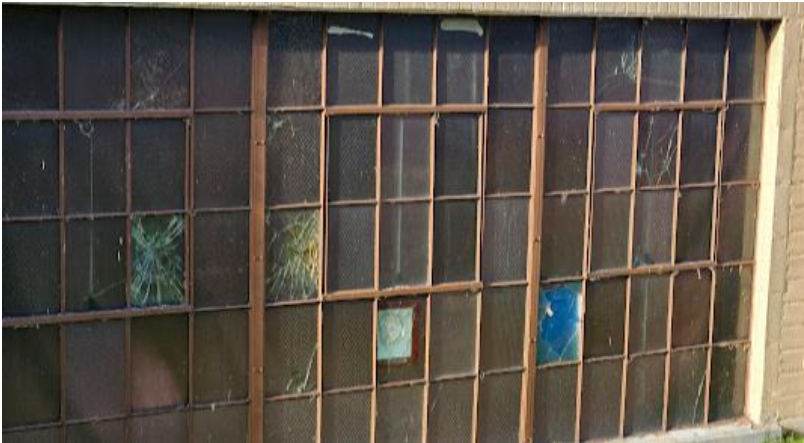
- Steps on the east side of the antique entrance are being replaced
- Some windows have been fixed recently
- Broken glass in windows (suspected vandalism) north and west

Photo of broken window.

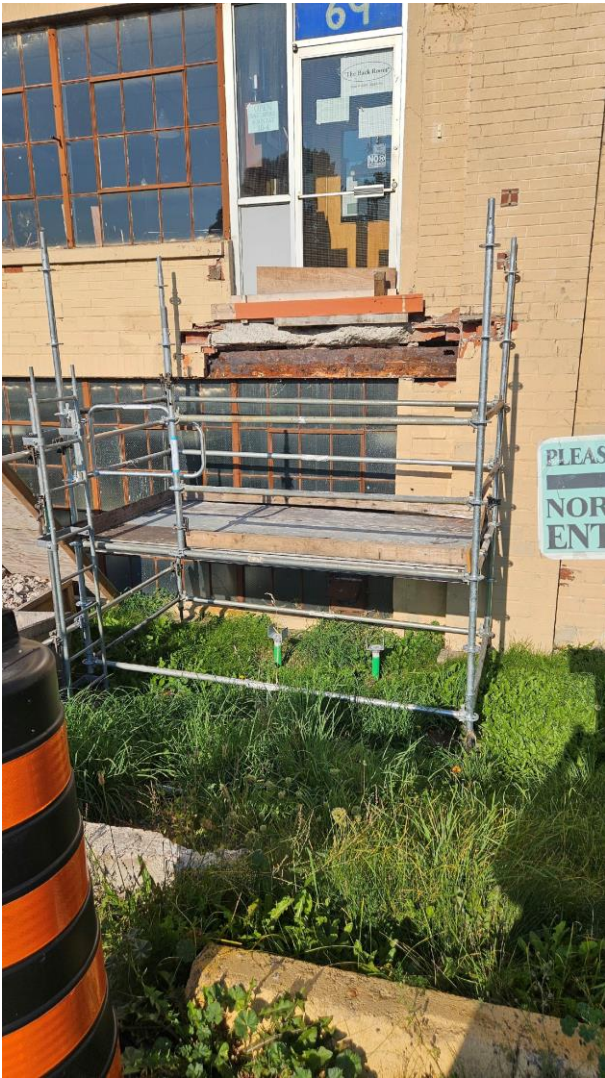
- The wall where the stairs join needs work to be stable after stair renovation
- Damage to the door as they have drilled through it
- A few shingles missing below “M” (south side)

Photo of staircase being replaced

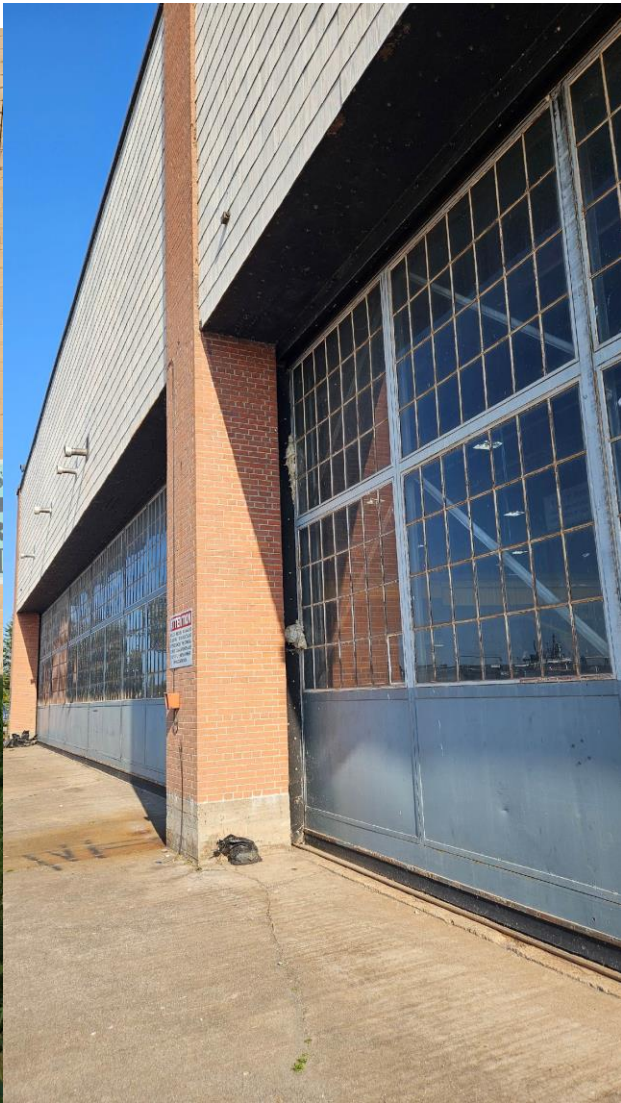
- On the northwest side of the building, next to the Bush plane giftshop, appears to be leak in the brickwork
- Paint peeling, repaint white roll-up door

Photo of hanger doors

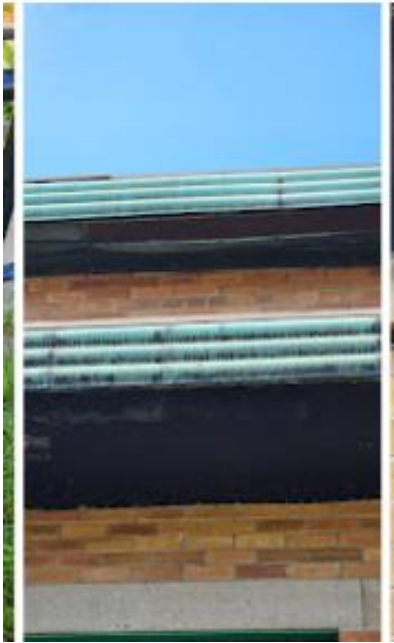
- Fascia on northeast side on upper level is bubbling out and still needs repair.
- Damage is progressing fascia at east side entrance
- Metal grate or vent on south side facing west is bent and is staining the wall

Photo: Fascia is bubbling

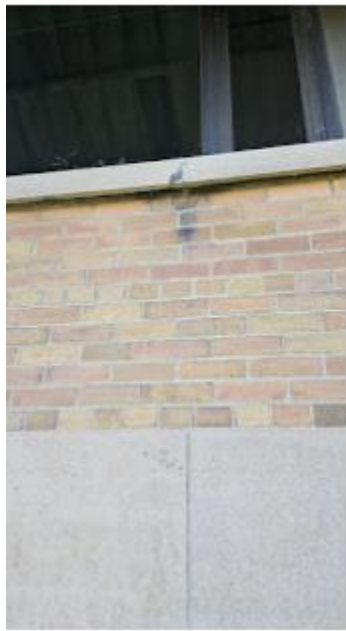
- South east corner of building next to parking lot has great deal of spalling and mortar damage
 - Spalling of canopy
- Window sills on south side need to be repainted

Photo: Sill needs repair

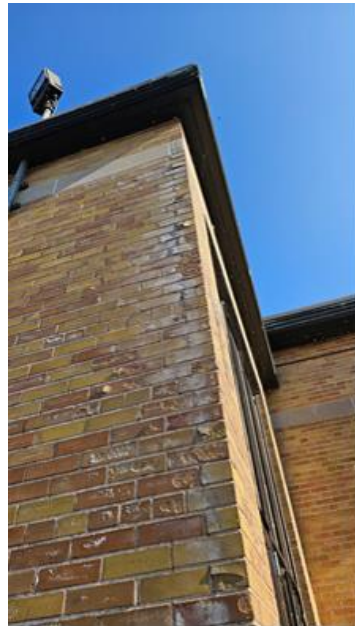
- Spalling brickwork
 - Spalling of brick at front entrance and rear of building
 - Cracking and holes on foundation under windows under metal stairs on south side

Photo of brickwork

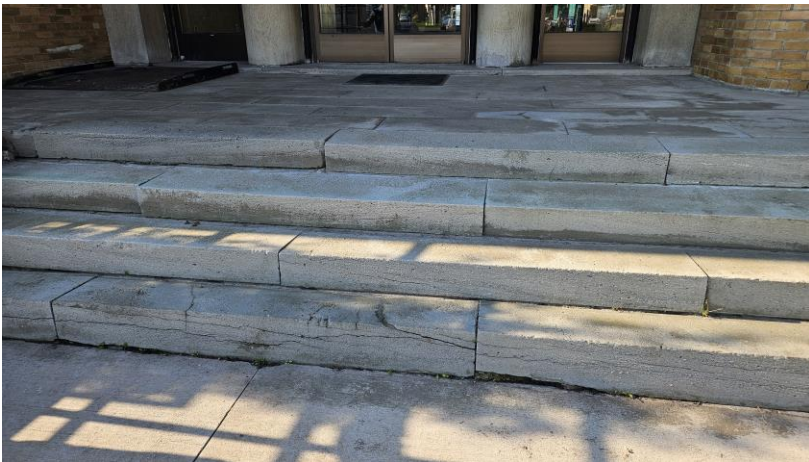
- On the east side the small grate/vent has cracks and holes in the surround stonework
- Front steps: Top 2 steps were fixed but not bottom two which are cracked. Ramp is cracked

Photo of front stairs

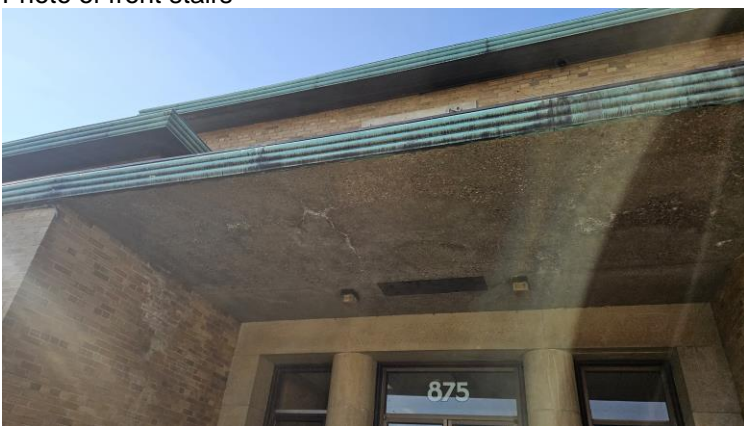
- Leaching at front entrance canopy suggests poor roof / water damage
- Flooding in the building recently points to foundation issues
- Soffit repairs: Paint from soffit dripping down brick and entry door soffit to be fixed (water damage)

Photo of front Canopy

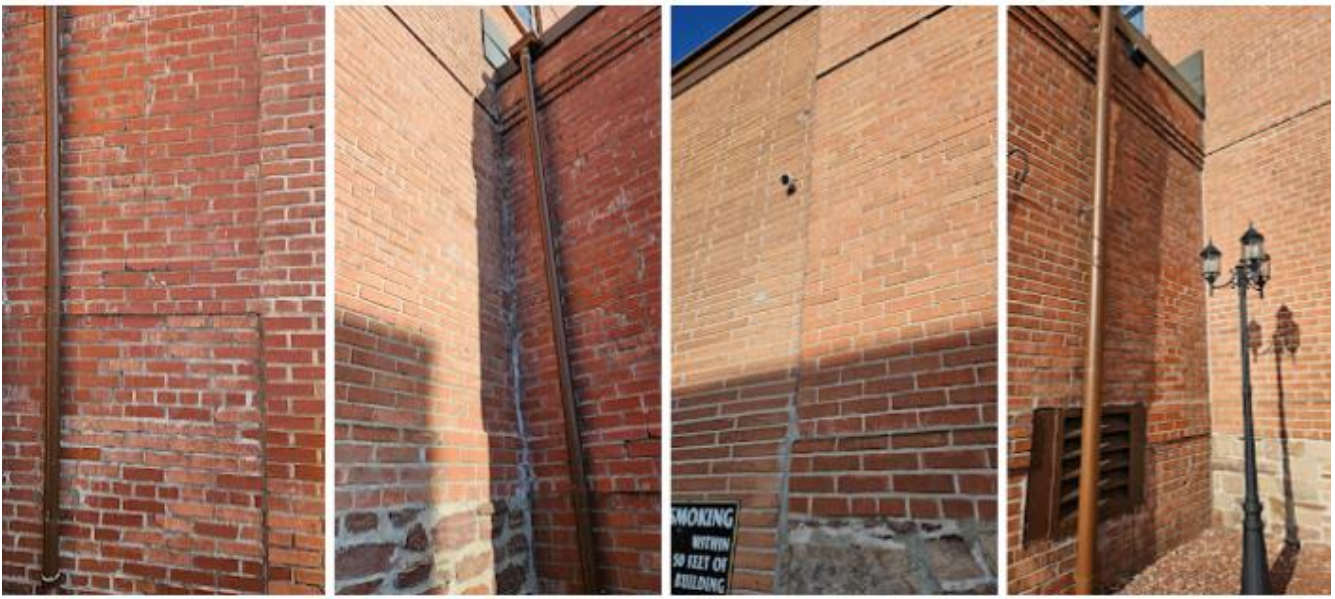
- Spalling brickwork: on the south facing wall next to the down spout, and spalling sandstone on north window (minor)
- Mortar missing and chunks of stone breaking off the foundation
- Bricks cracking and mortar missing around doors on east entrance
- Gutter on the east side has been repaired
- Outlet exposed on the south side next to main entrance
- Only minor issues that they are gradually repairing
- Concerns for cracked bricks in newer part of main entrance.

Photo: Brickwork near drainage pipe

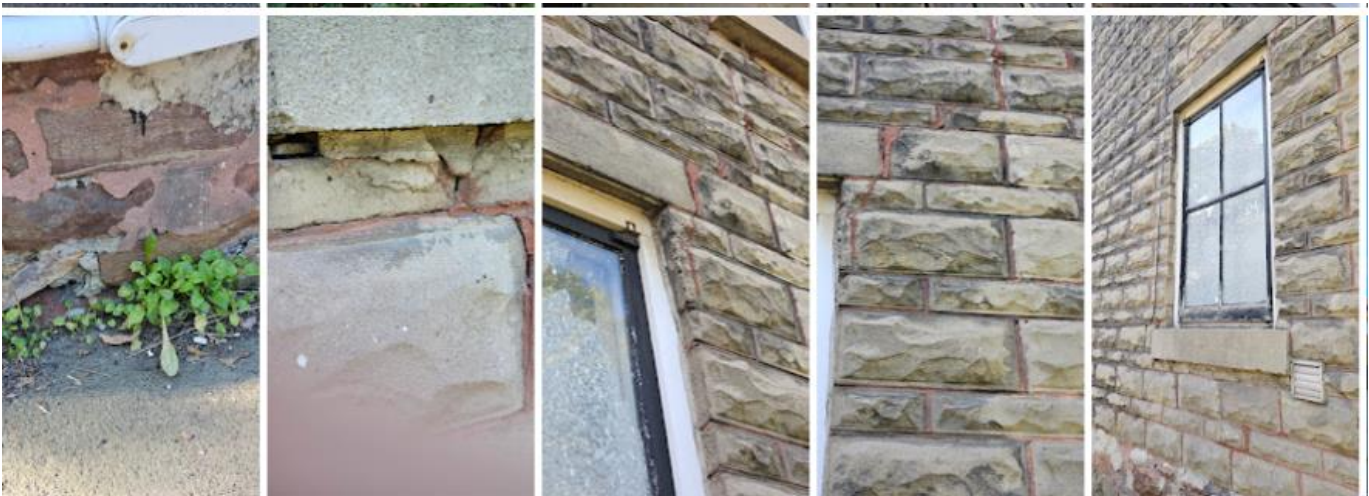
- Foundation stones around back door
- North and west sides have cracked stones and missing mortar
- Moss growing on windows and foundation on north side
- Basement window on south side has cracking in stone work
- Multiple air conditioning units are poorly placed in windows.
- Hanging wires and air conditioners on make-shift platforms
- Vegetation growing out of gutter on south side
- Wire hanging down from roof on south side
- Chimney severely spalling/cracking
- Columns on porch have and around windows and doors have cracked stones
- No change to mortar holes by window
- Cracked concrete lintels
- Moss in basement window sill
- Front porch needs repairs

Photos of brickwork

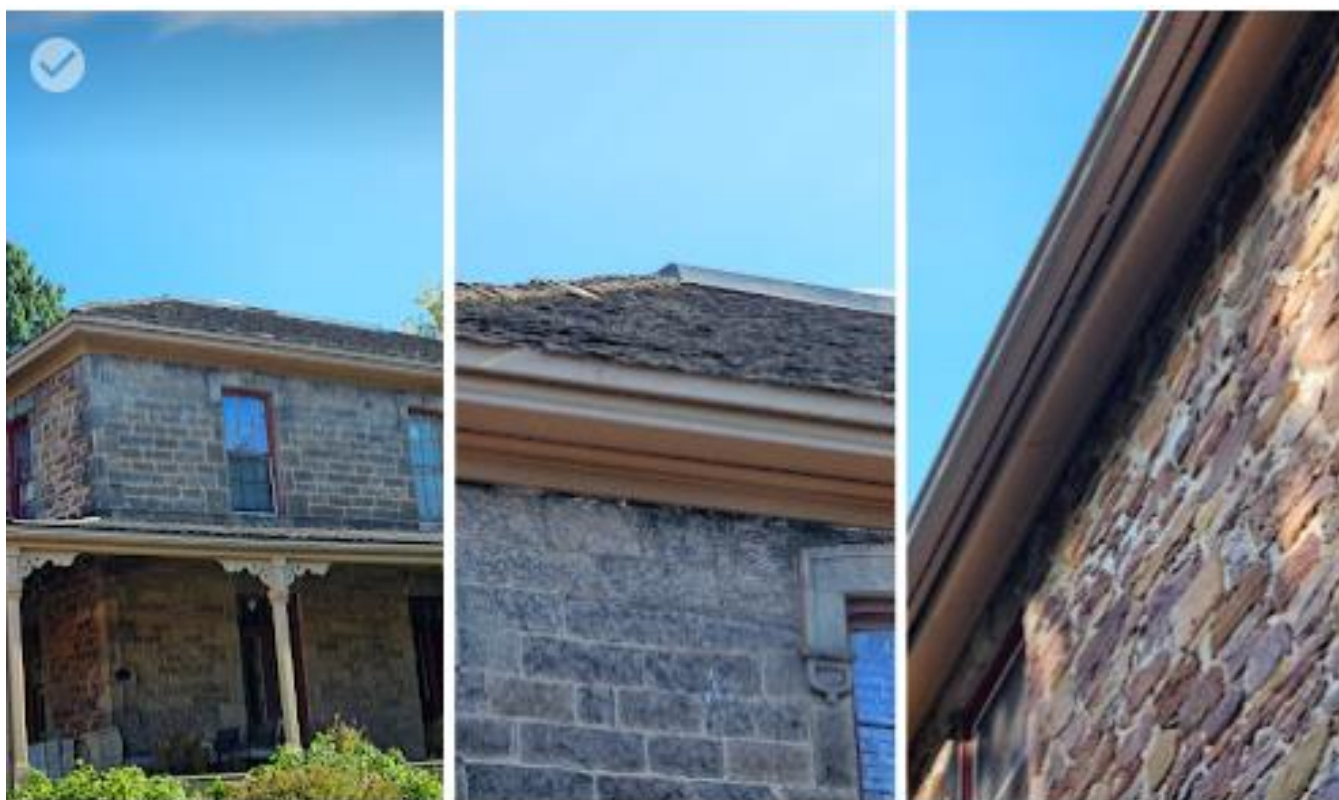
- Windows are in the process of being repainted
- Roofing has been replaced and looks great.
- Mortar missing on chimney, work will be scheduled as per owner

Photo: Kensington Terrace roof and windows

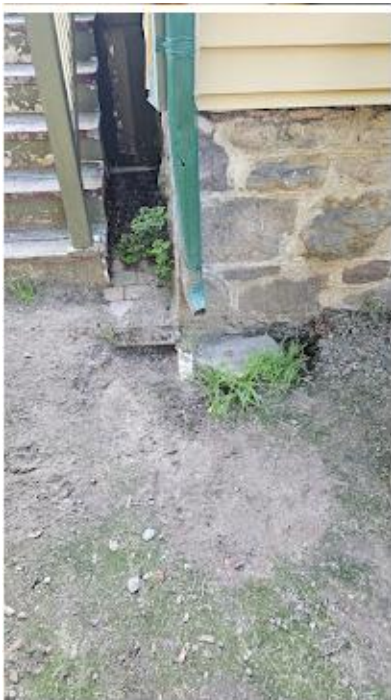
- Cracks in foundation stone on west side, hole in the mortar
- Veranda nicely painted deck
- Siding:
 - peeling away where the eaves are leaking.
 - Chipping / cracked on north side near lower stone section
 - Siding on south side near side entrance is cracked in several places
- Window on west/backside needs repainting
- Wood decoration above window on south side needs repair and refinishing and fascia and wooden decorations on north side of house need repainting
- South-east gutter not installed properly – causing damage to siding below
- Trim is bubbling above window on south side
- Paint is peeling on upper porch features and on columns
- Columns in process of being re-done, the column on the right side towards the road is loose
- Recommend starting repaint spindles
- Cornice (right) severely damaged

Photo: Foundation repair

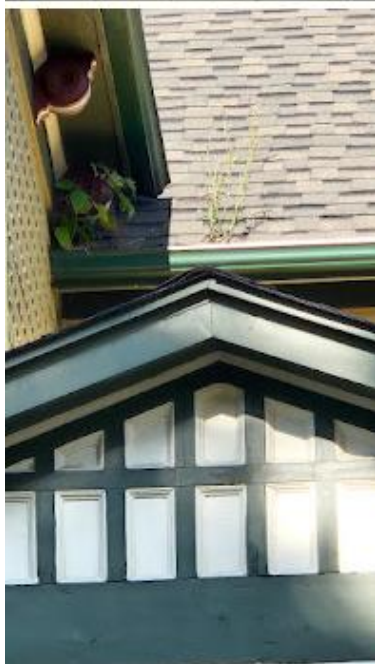
Photo: Gutters

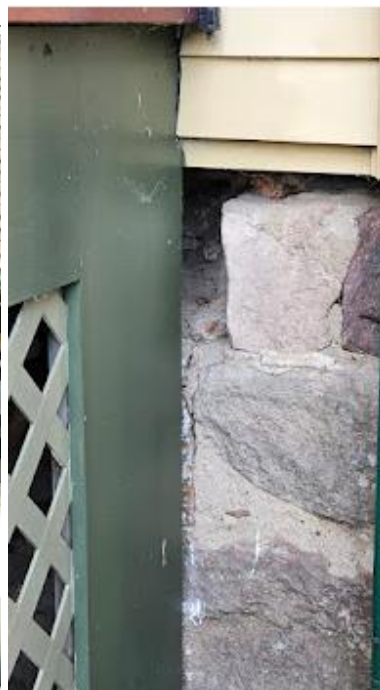
Photo: Foundation Repair

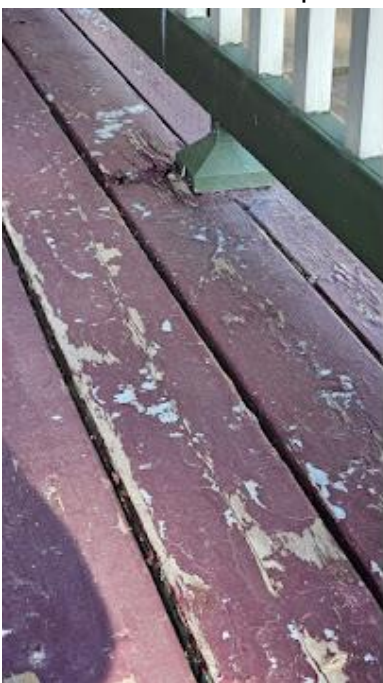
Photo: Veranda

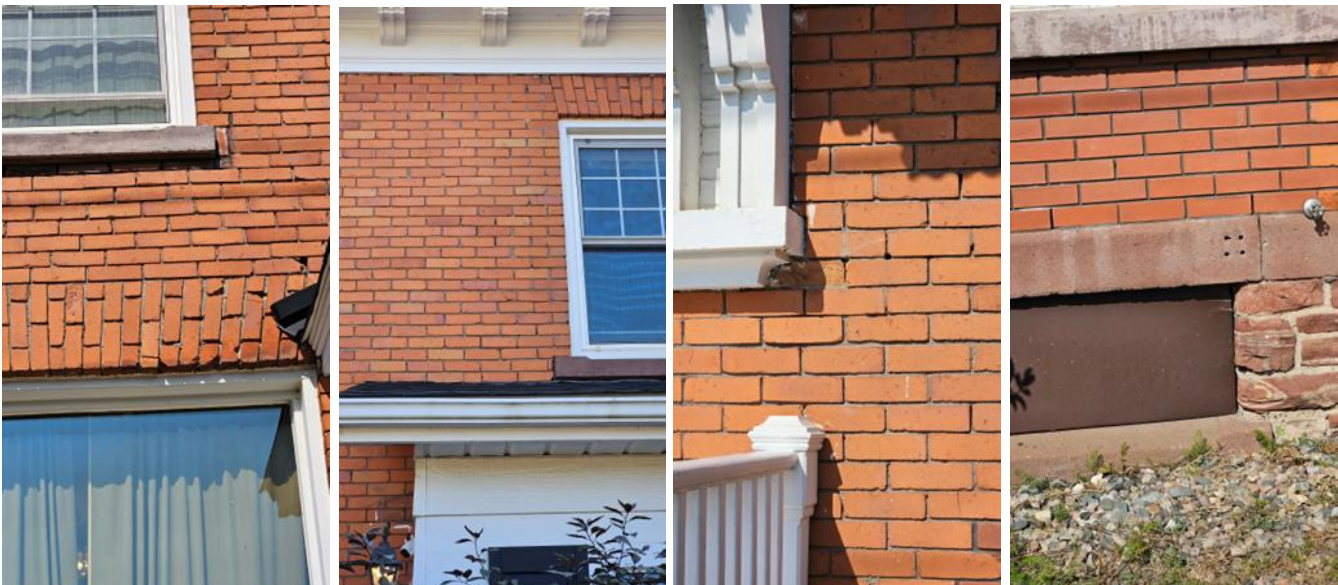
- Mortar missing on wall north side and around windows on east side
- Holes above basement window on east side should be filled
- Grout work could be done on brick (minor)
- Cracked brick under octagon window

Photo: Spalling brick

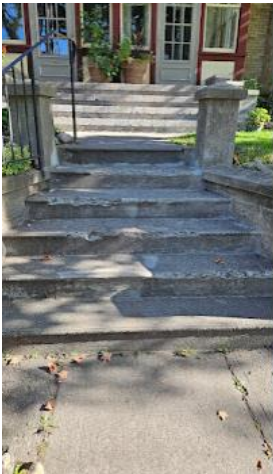
- Spalling in bricks near roof above windows on south side / front
- Spalling and mortar missing on north side/back wall
- Drain from air conditioning unit on east side should be moved out from the wall
- Spalling on chimney, mostly north side
- Lower front steps need repairs
- Fix / patch below cornice / moulding
- Stairs need to be fixed

Photo: Stairs

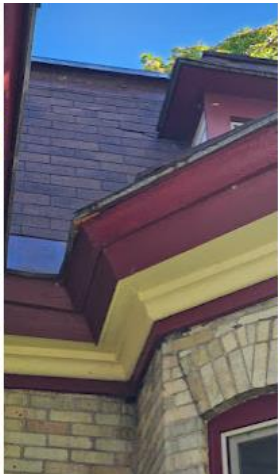
Photo: Molding and Chimney

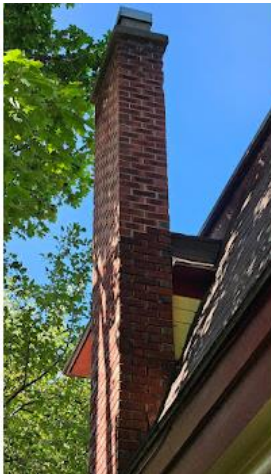
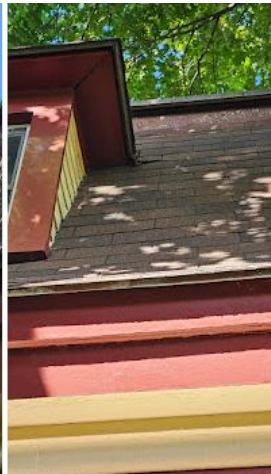
Photo: Roof and brickwork

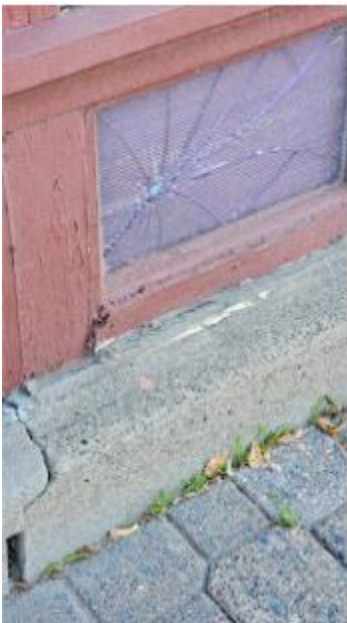
- Cracked stones and concrete all along foundation especially at the entrances
- Wires are still protruding from the wall and need to be removed.
- Some repairing of entrance possible but large white spot is still there from last year.
- Broken window beside entrance, right entrance near ground level
- Needs repainting in a few spots

Phot: Broken Glass

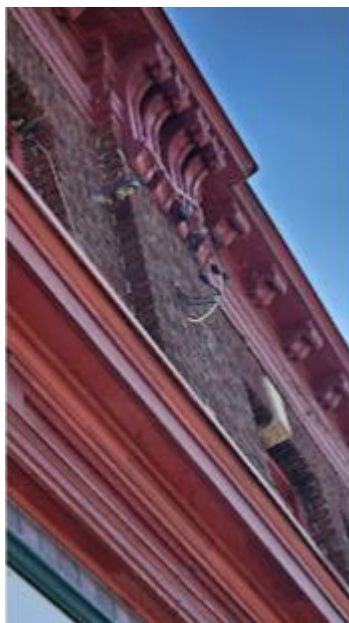
Photo: Loose wires

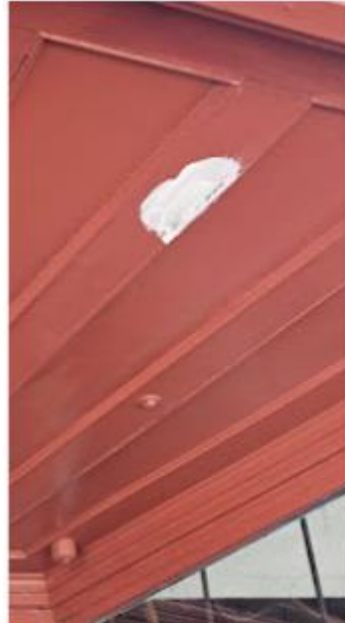
- Board joints at corner of entrances need fill.
- Loose wires not addressed.
- Repaint porch / entrance ceiling.
- Fix concrete steps all along south side not addressed from last year.
- Broken glass on the eastern entrance near the ground.

Photo: Porch Ceiling

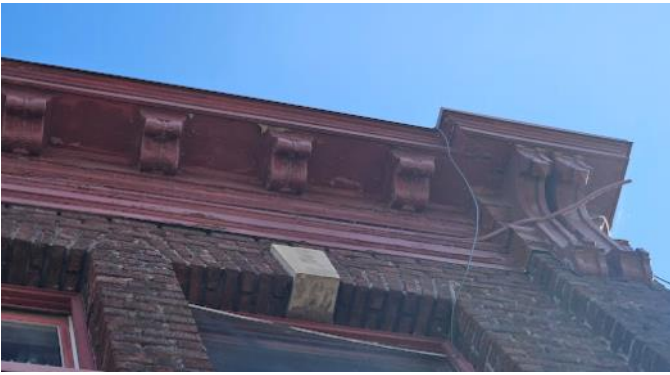
Photo: Loose wires

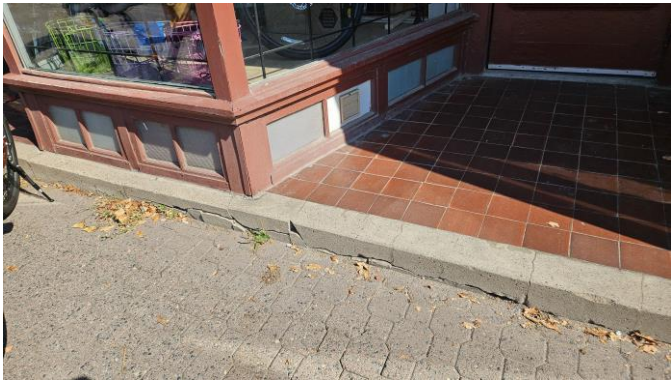
Photo: Cracked concrete

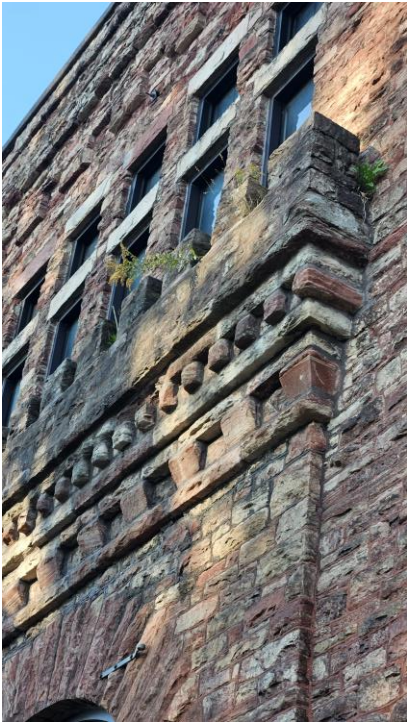
- Spalling and piece of stone reported in 2023 has been repaired.
- Mortar repairs on the east side have been completed along with temporary fixes to the windowsills around the building. Future work includes permanent solution.
- Northside there is foam in the window where cables pass through recommended to put a cover to conceal the hole
- Some spalling on the stones and mortar needs fixing on entire building but it still looks in good condition and no immediate concerns
- New chinking looks fantastic. Continue restoration in phases for remainder of building
- South eave to be fixed
- Recommended alternate cap that blends with window casing

Photo: Spalling brickwork

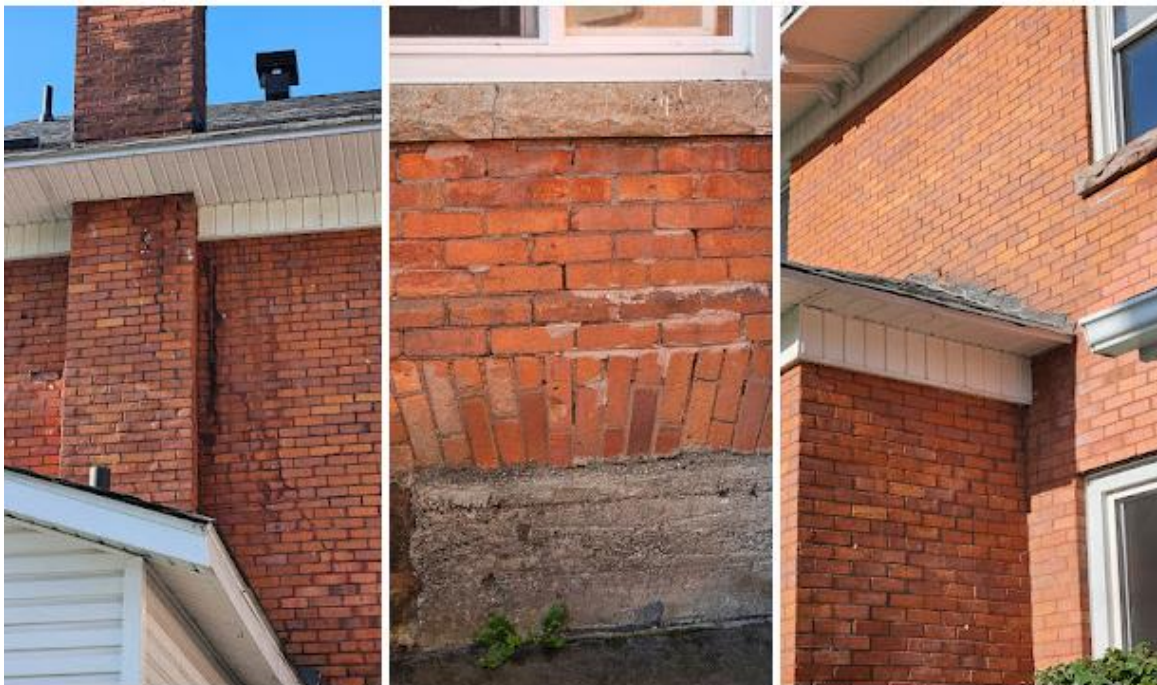
- Cracks, spalling and missing mortar on north and east sides
- Fascia needs repainting on all sides of the building
- The chimney on the north side needs to have cracks fixed.
- Front porch needs repainting
- Fascia on front porch is bowing and cracking
- Uncovered wires on front porch steps
- Spalling and cracks on west column / chimney
- Wires hanging down from the roof on west side are an eye sore and not conclusive with the heritage façade
- Cornices to be repainted as starting to peel

Photo: Spalling brick work

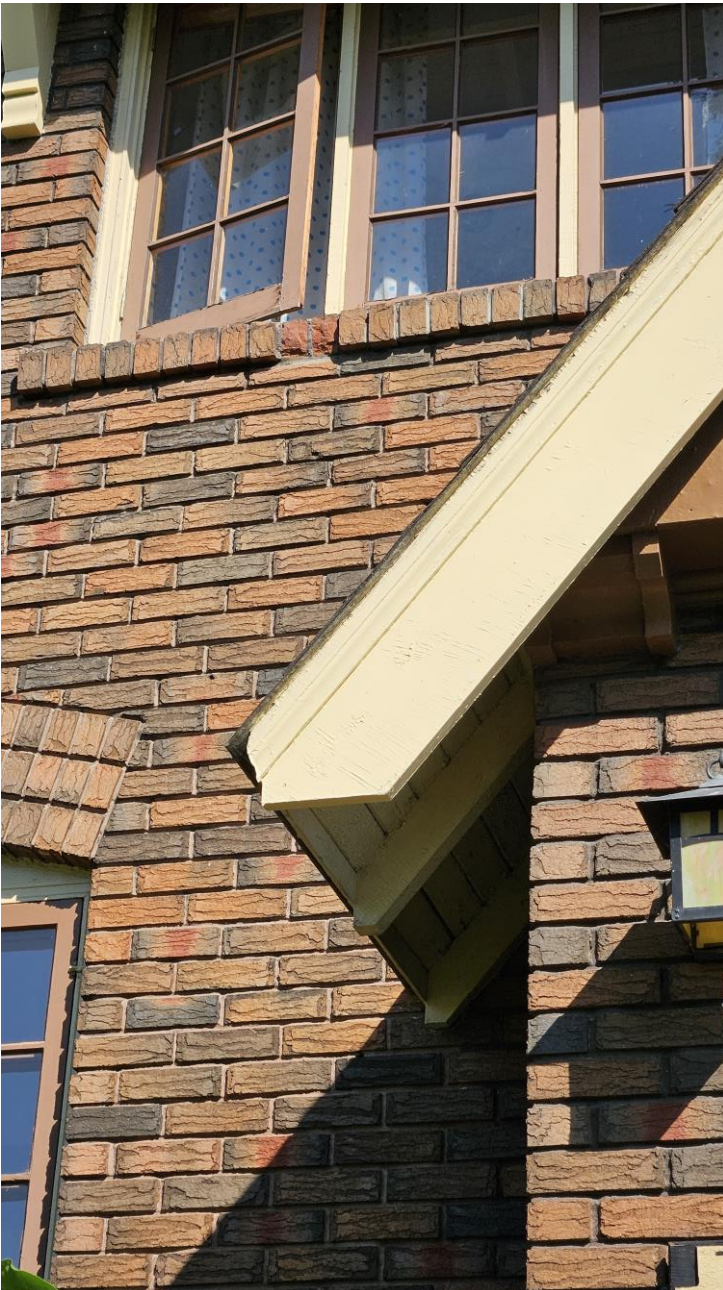
- Spalling of 2 stones / bricks below 2nd floor window on south side
- Spalling brick below window (minor)
