**THE CITY OF
SAULT STE MARIE**

**FORT CREEK AQUEDUCT
PROJECT FILE REPORT**
SCHEDULE B CLASS ENVIRONMENTAL ASSESSMENT

**August 2016
15-1192**

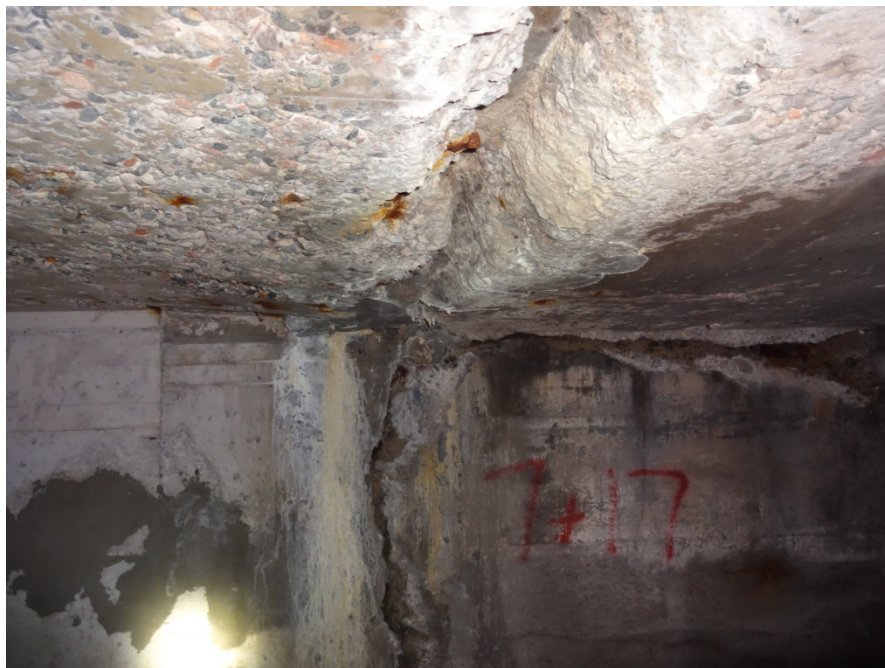
Deteriorating joint just north of St Andrews Terrace –photo by STEM Engineering

An inspection summary from the 2015 Biennial Inspection by STEM Engineering Group Inc. for the Wellington Street West section can be found in Appendix 3. The report concludes *“the culvert from St. Andrews Terrace to station 11+69 (Wellington Street West at Carmen’s Way) is in poor condition in many areas and requires replacement or repair.”*

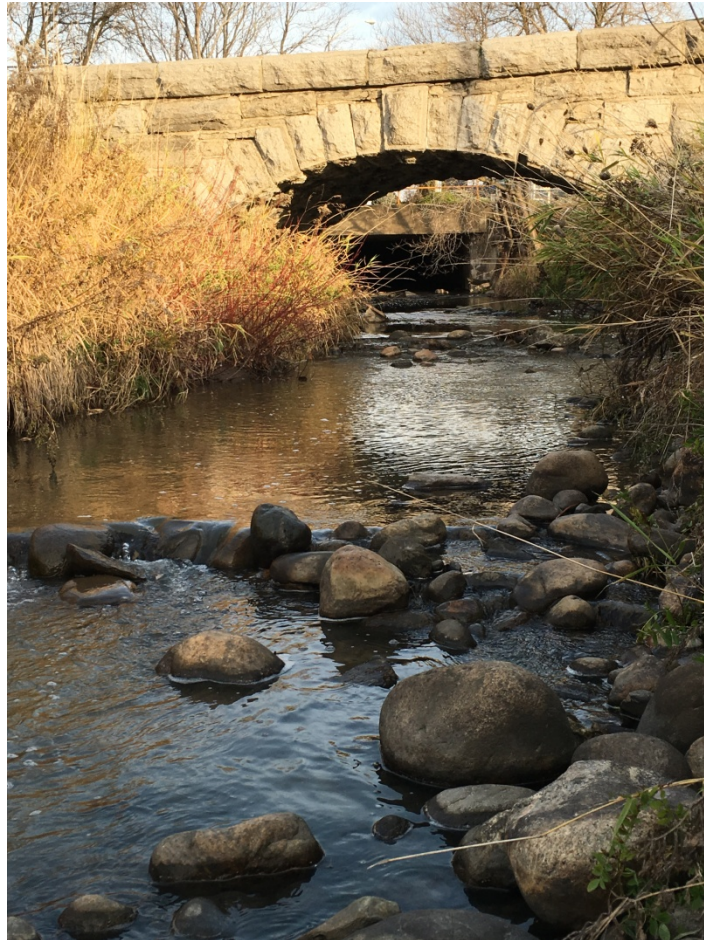
Original creek bed under the Canadian Pacific Railway bridge

The result is a continuous underground drainage system that now extends from north of Wellington Street West at Carmen's Way to its outlet south of Queen Street West, with just a short open section at the CPR railway bridge (a stone arch) near John Street. This short section of open channel under the CPR appears to be original creek bed.

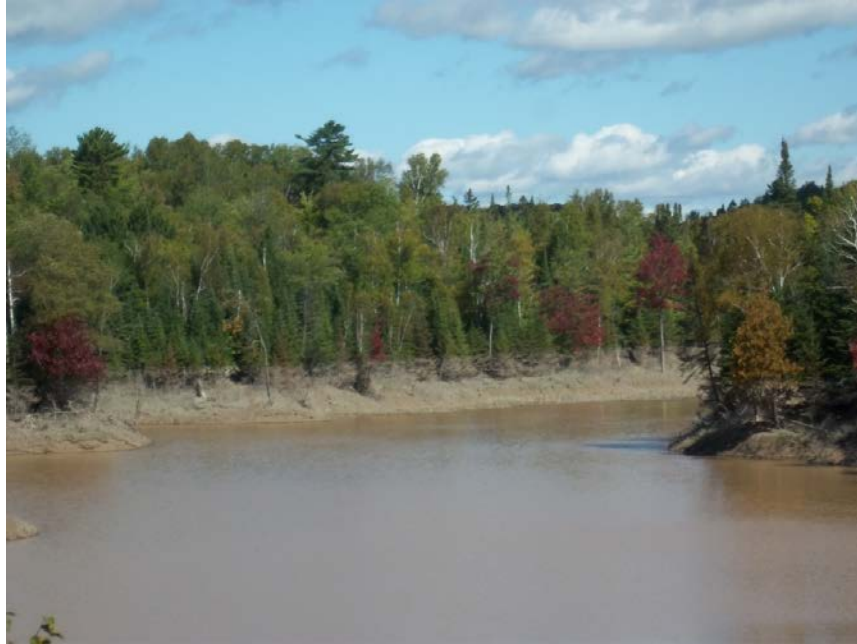
Fort Creek Dam Reservoir- photo taken September 13, 2013

The dam is a 113 m long earthen structure with a clay core. The outlet consists of a 1.067 m wide stainless steel slide gate into a 91.4 m long chute spillway that passes through the dam. There is a hexagonal shaped concrete drop inlet structure/overflow weir designed to be used for extreme events once reservoir elevations are high enough. There is also an emergency overflow spillway blocked by a series of erodible berms (fuse plugs) to prevent catastrophic failure of the dam.

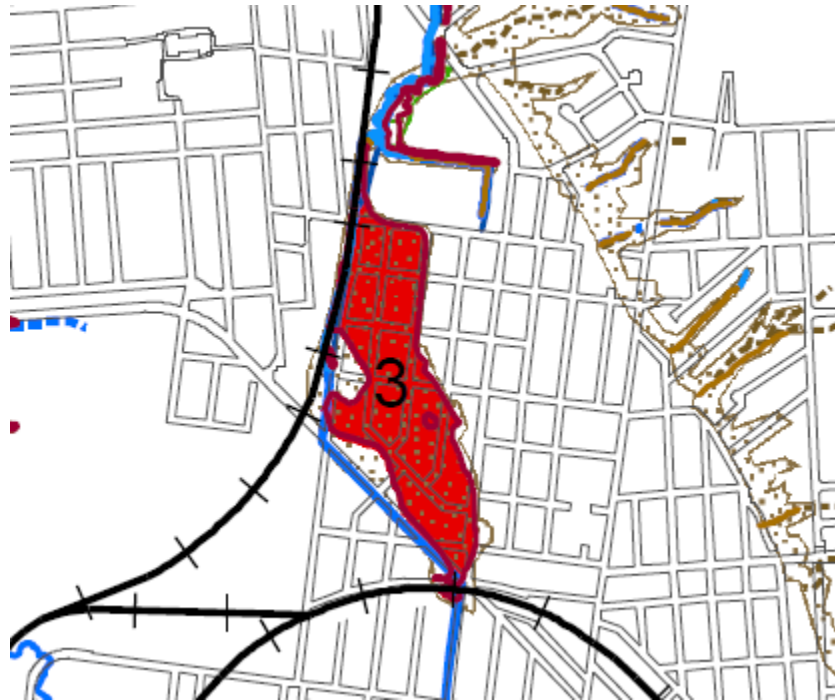
The Steelton Area in the SSM Official Plan Schedule B - Red Indicates a Specific Flood Area

The flood line or flood plain area shown above is as identified by the Conservation Authority using the Timmins regional storm. The Steelton area is considered flood zone #3 in the Official Plan. It is noted that it follows the original creek location, which is to the east of the aqueduct location, shown in blue.

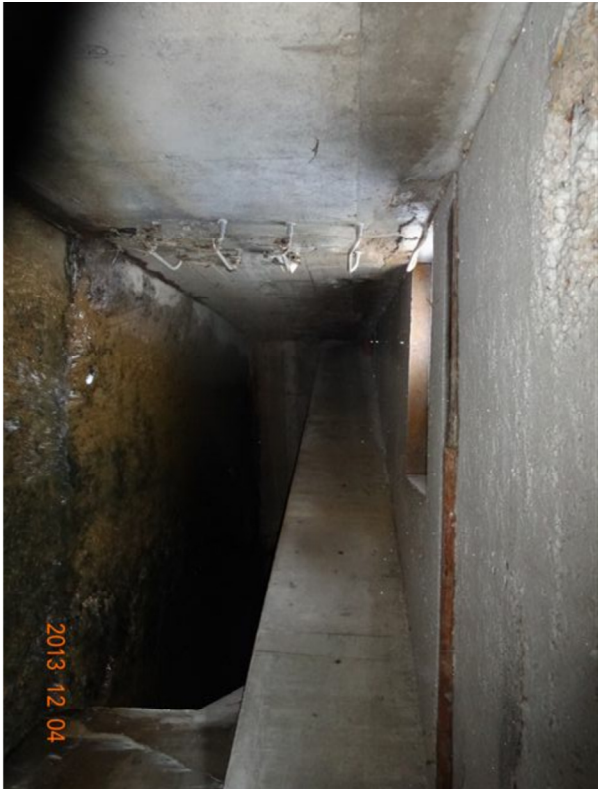
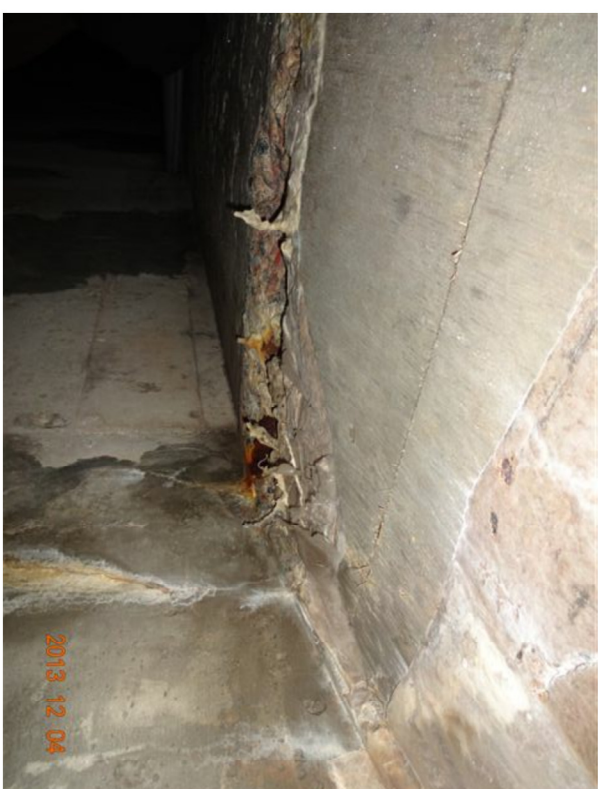
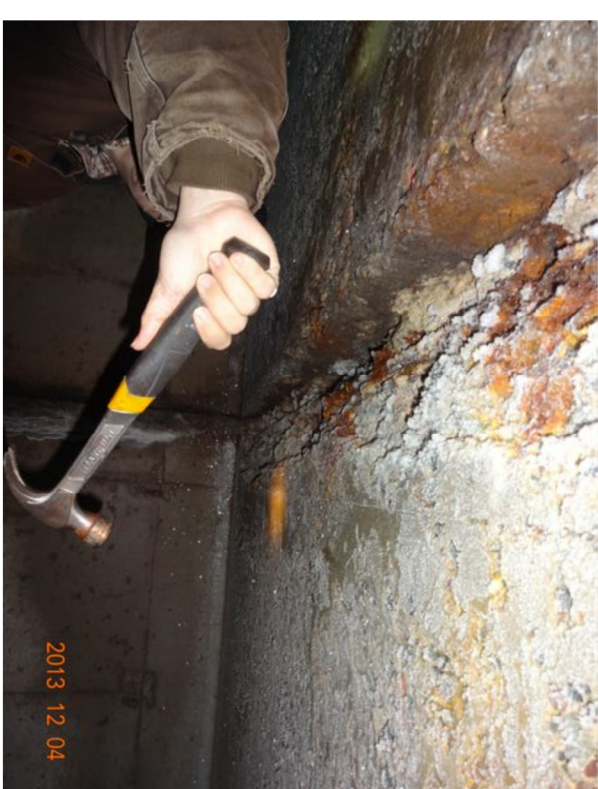
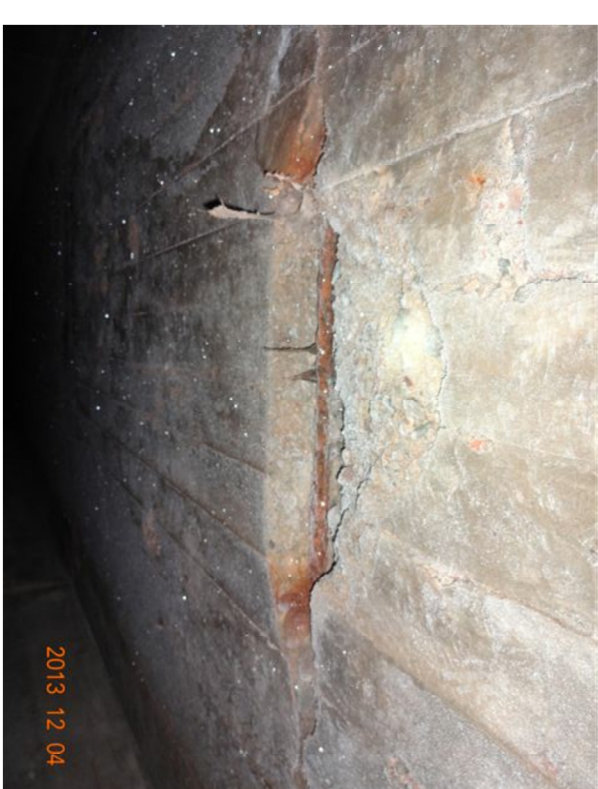
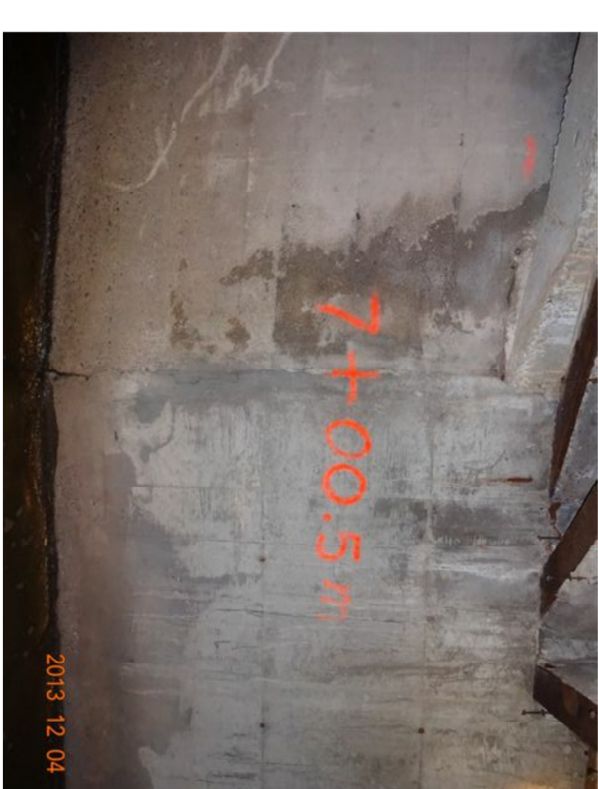
TYPICAL STRUCTURAL DEFICIENCIES

- substantial cracking
- severely rusted I- beams in poor condition
- exposed rebar
- delaminating concrete
- spalled and missing concrete
- holes in slab

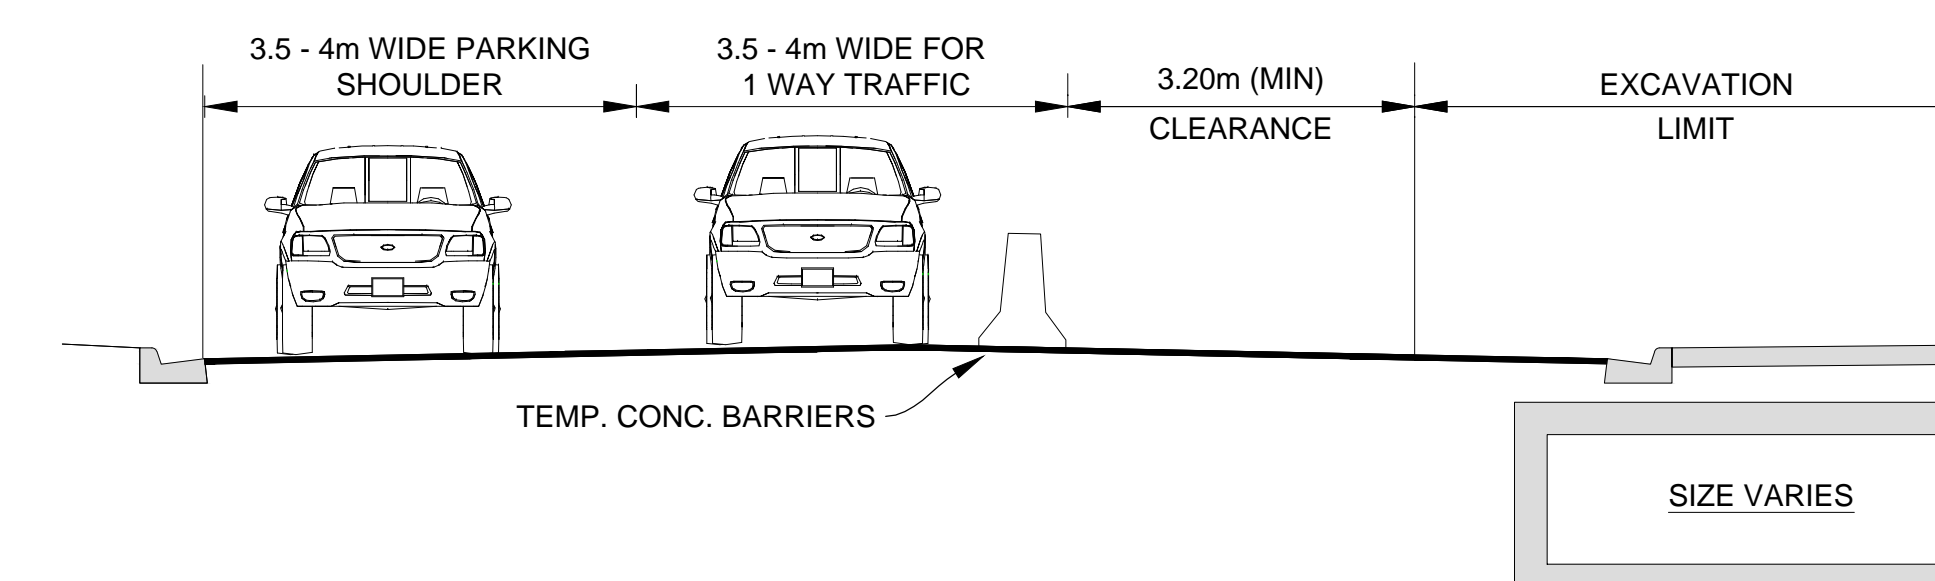
ALTERNATE TRAFFIC LAYOUT
FOR WELLINGTON STREET
1 WAY TRAFFIC WITH PARKING

These options are shown in Figure 6. A decision on the preferred option will be made prior to project start once timing is known.
