The Corporation of the City of Sault Ste. Marie  
Municipal Heritage Committee  
Agenda

Wednesday, November 5, 2025

### **2025 Inspector's Notes**

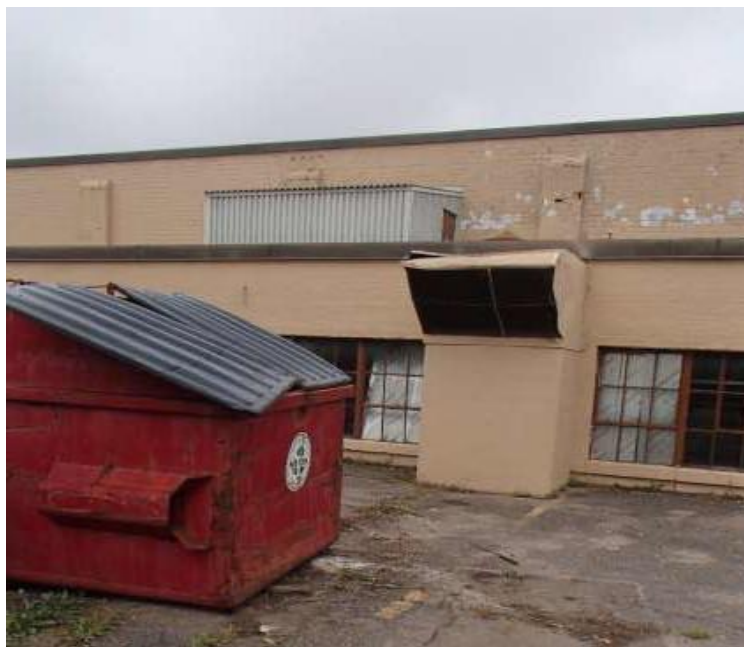
East Wall - Vent duct behind dumper is bent

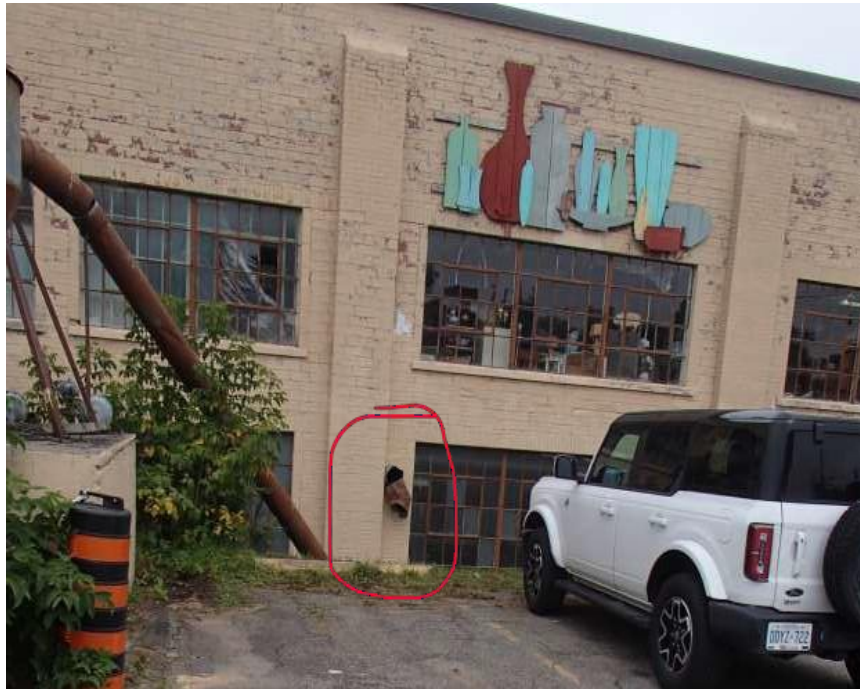
Additional piping hanging from

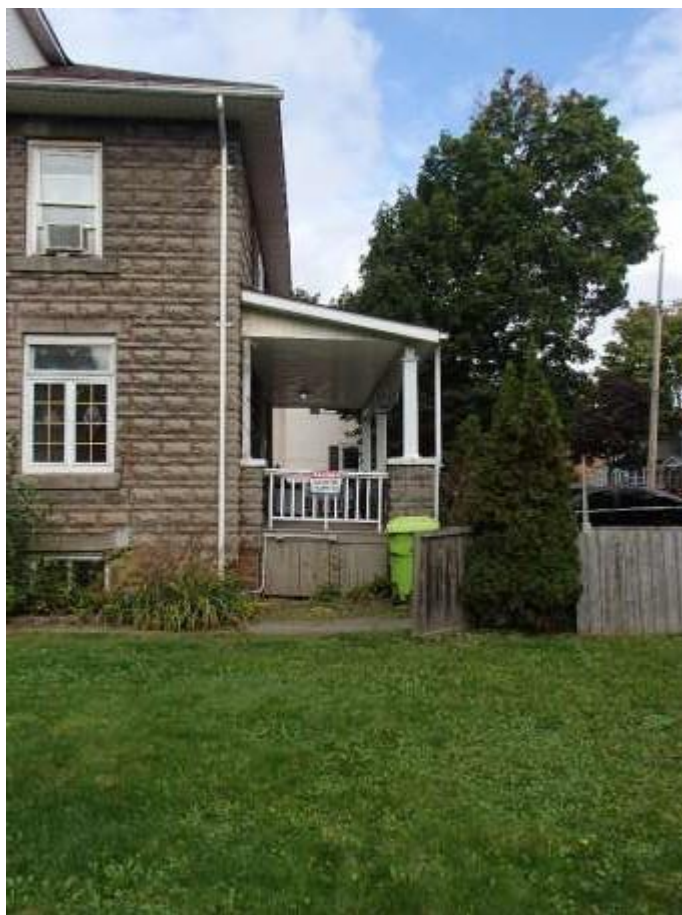
Front veranda has a definite downward slope

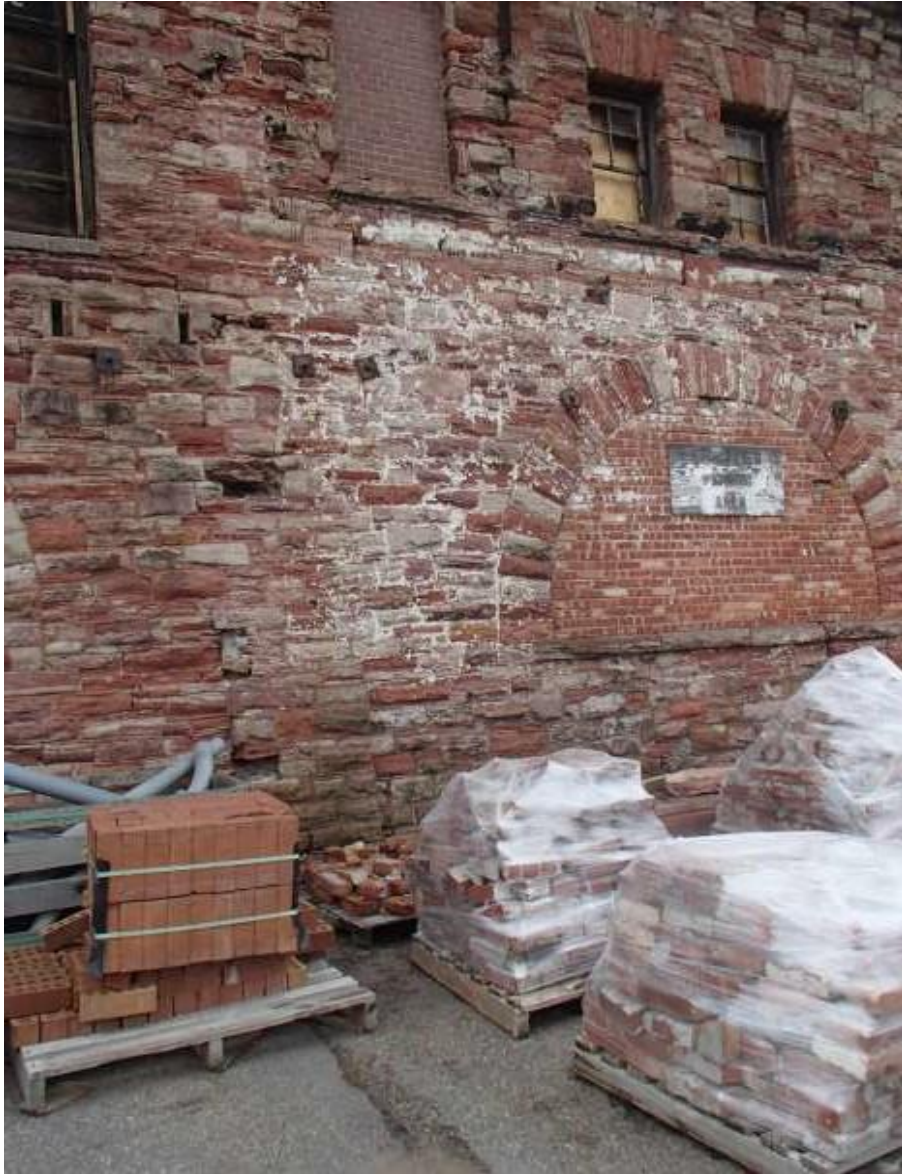
South side - Issues here are similar to those at Machine Shop in terms of mortar work and repair to broken stones.

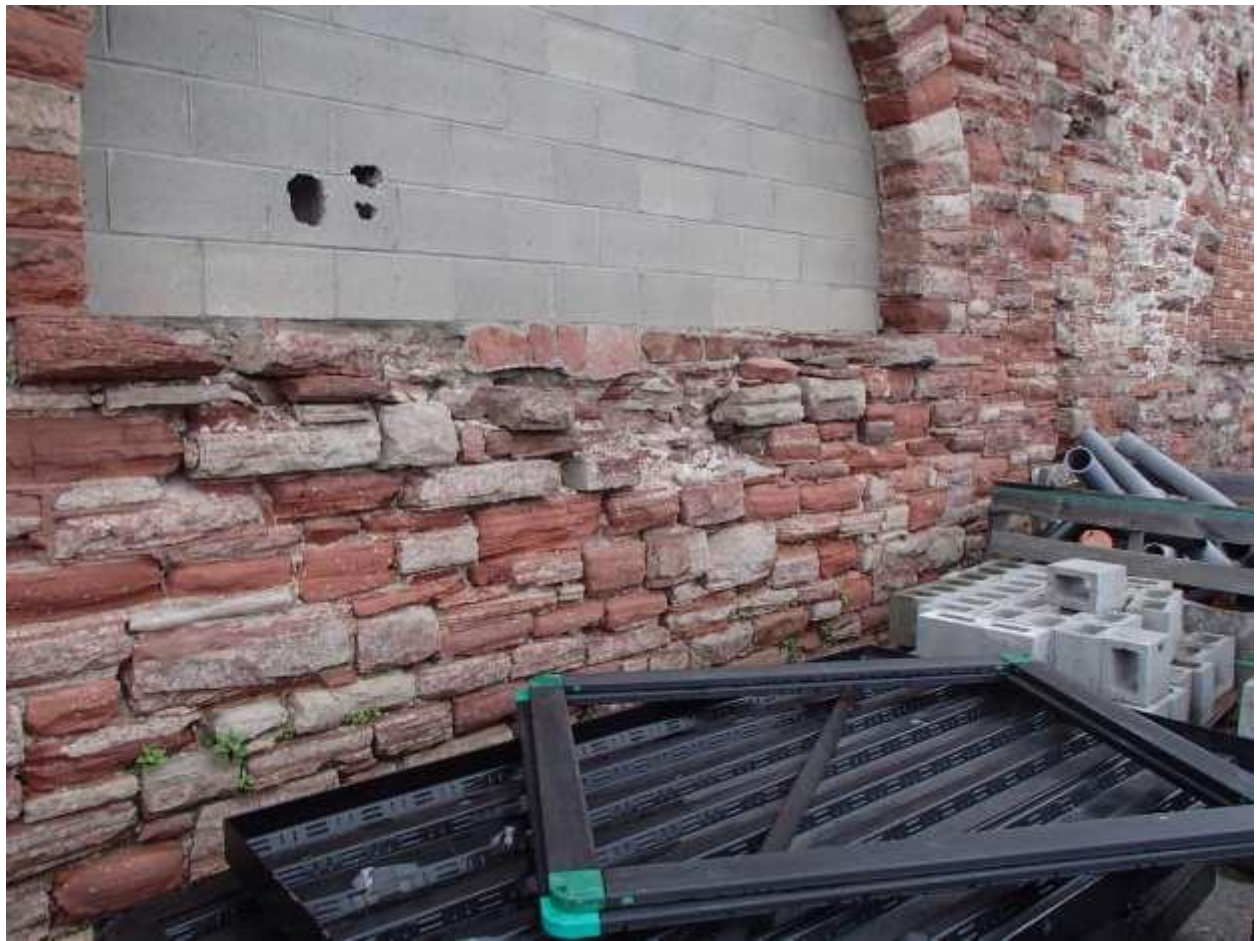
Fasia needs to be replaced and clad in metal and possibly guttered to direct rainwater away from walls. South side is in better shape than north side – see page 8

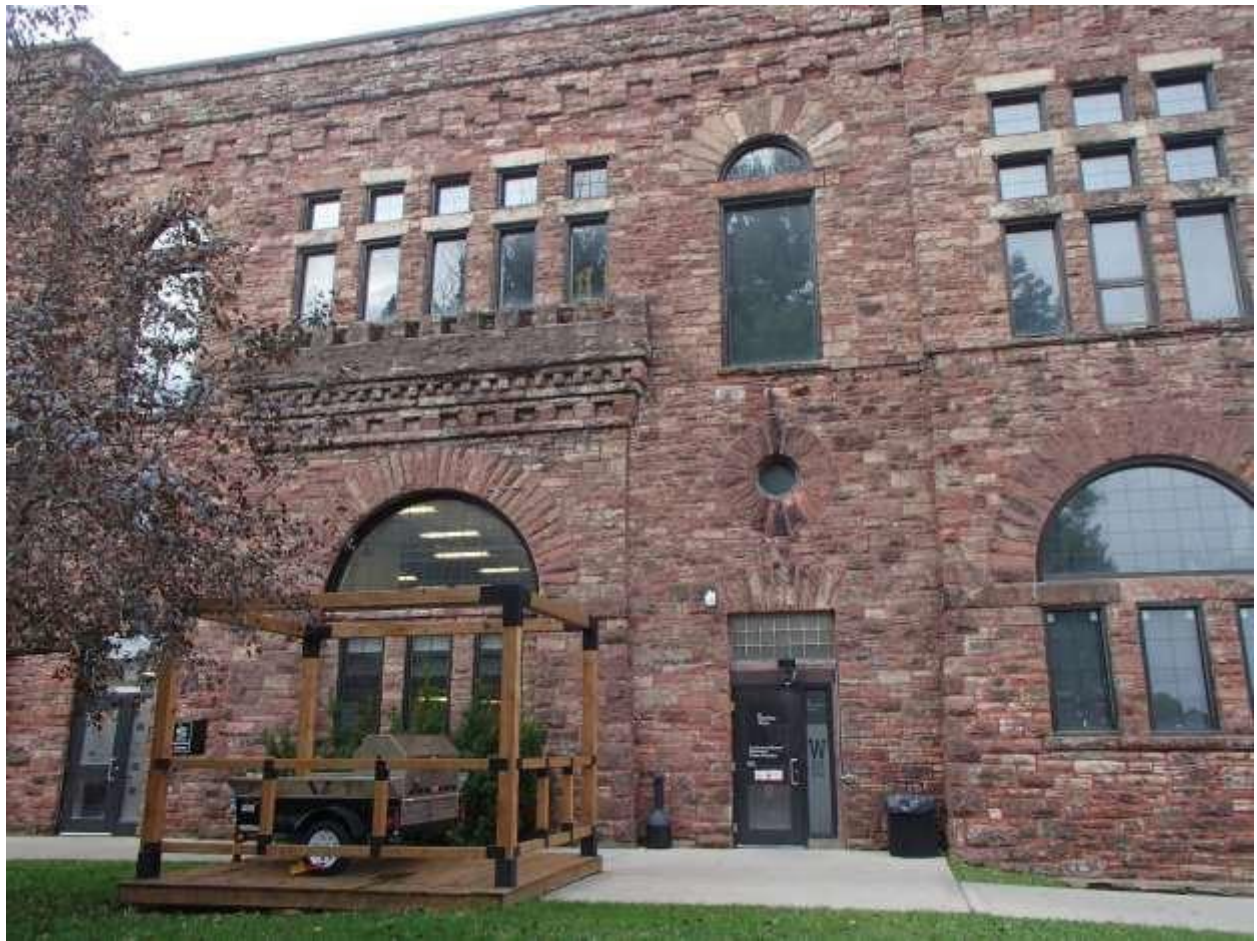
North wall - ongoing repairs to masonry

window sill repair needed here as well

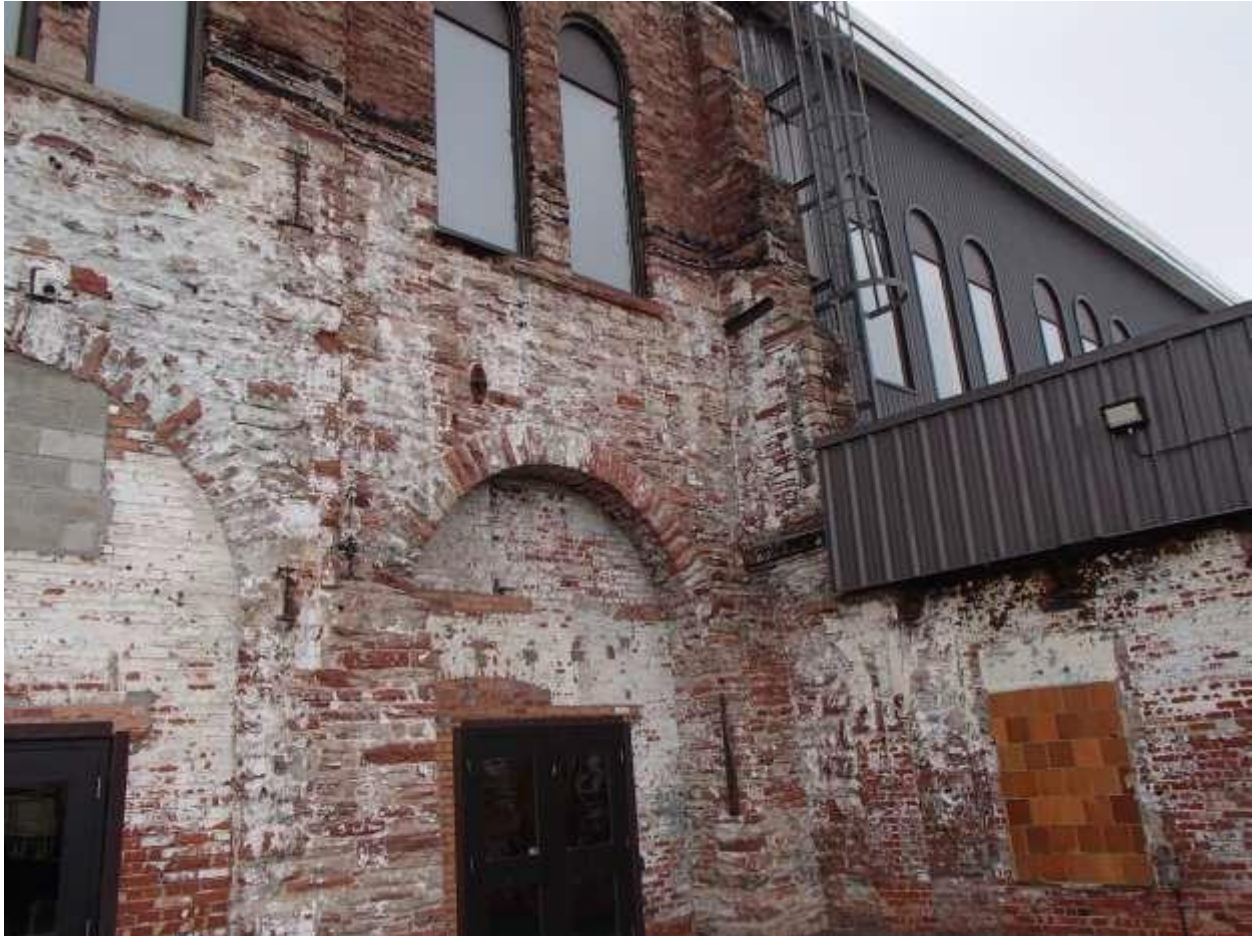
This is the south wall - This area had an addition at one time, and the brick wall became an interior wall that was painted
